## Carburetor Icing Probability Graph – ANC25LA019

Airplane: Piper PA-18-150

Accident Date: 02/20/2025

Accident Location: Wasilla, AK

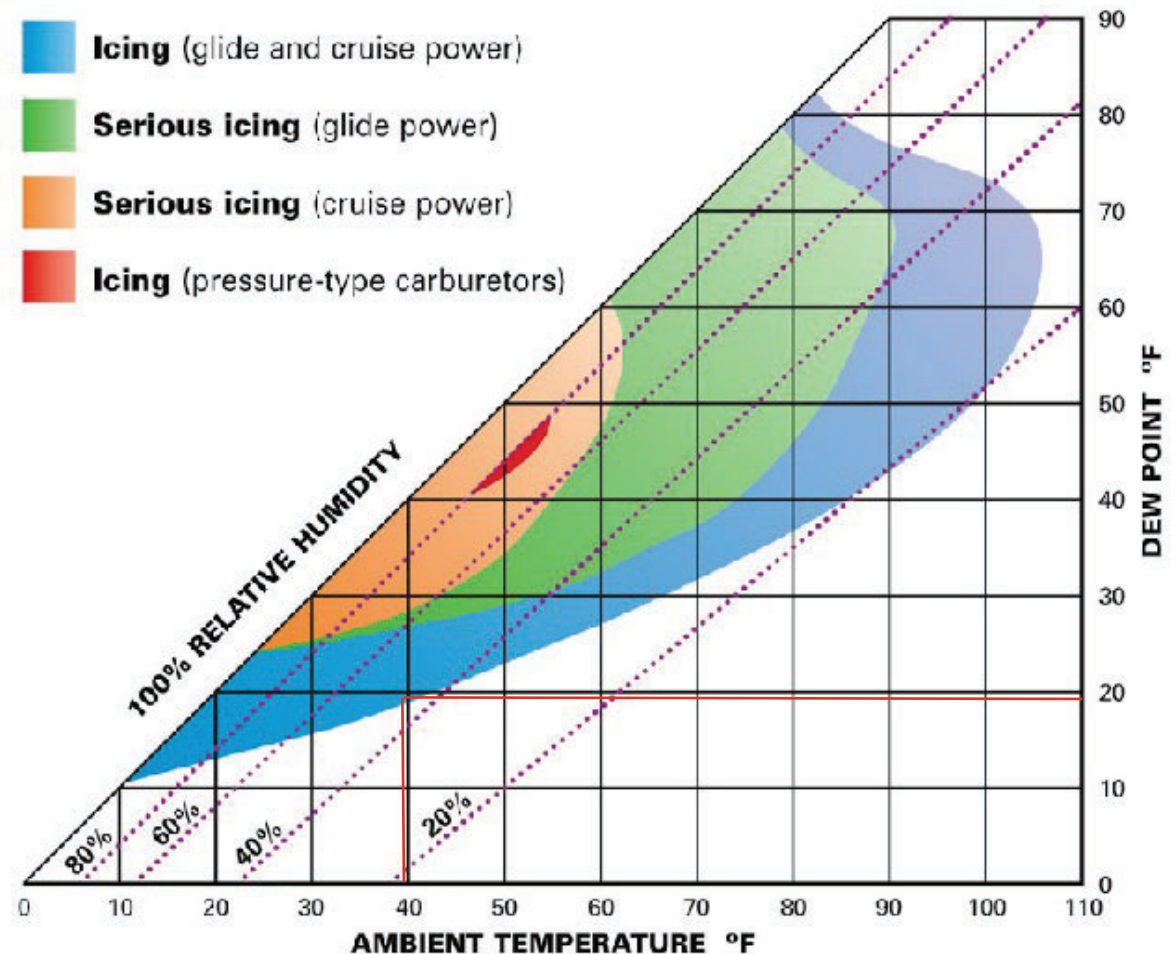
Weather: Observation Facility (AWS) reported  
temperature 39° F; dew point 19° F
