# National Transportation Safety Board

ANC25LA021

## **MATERIALS LABORATORY**

Factual Report 25-053

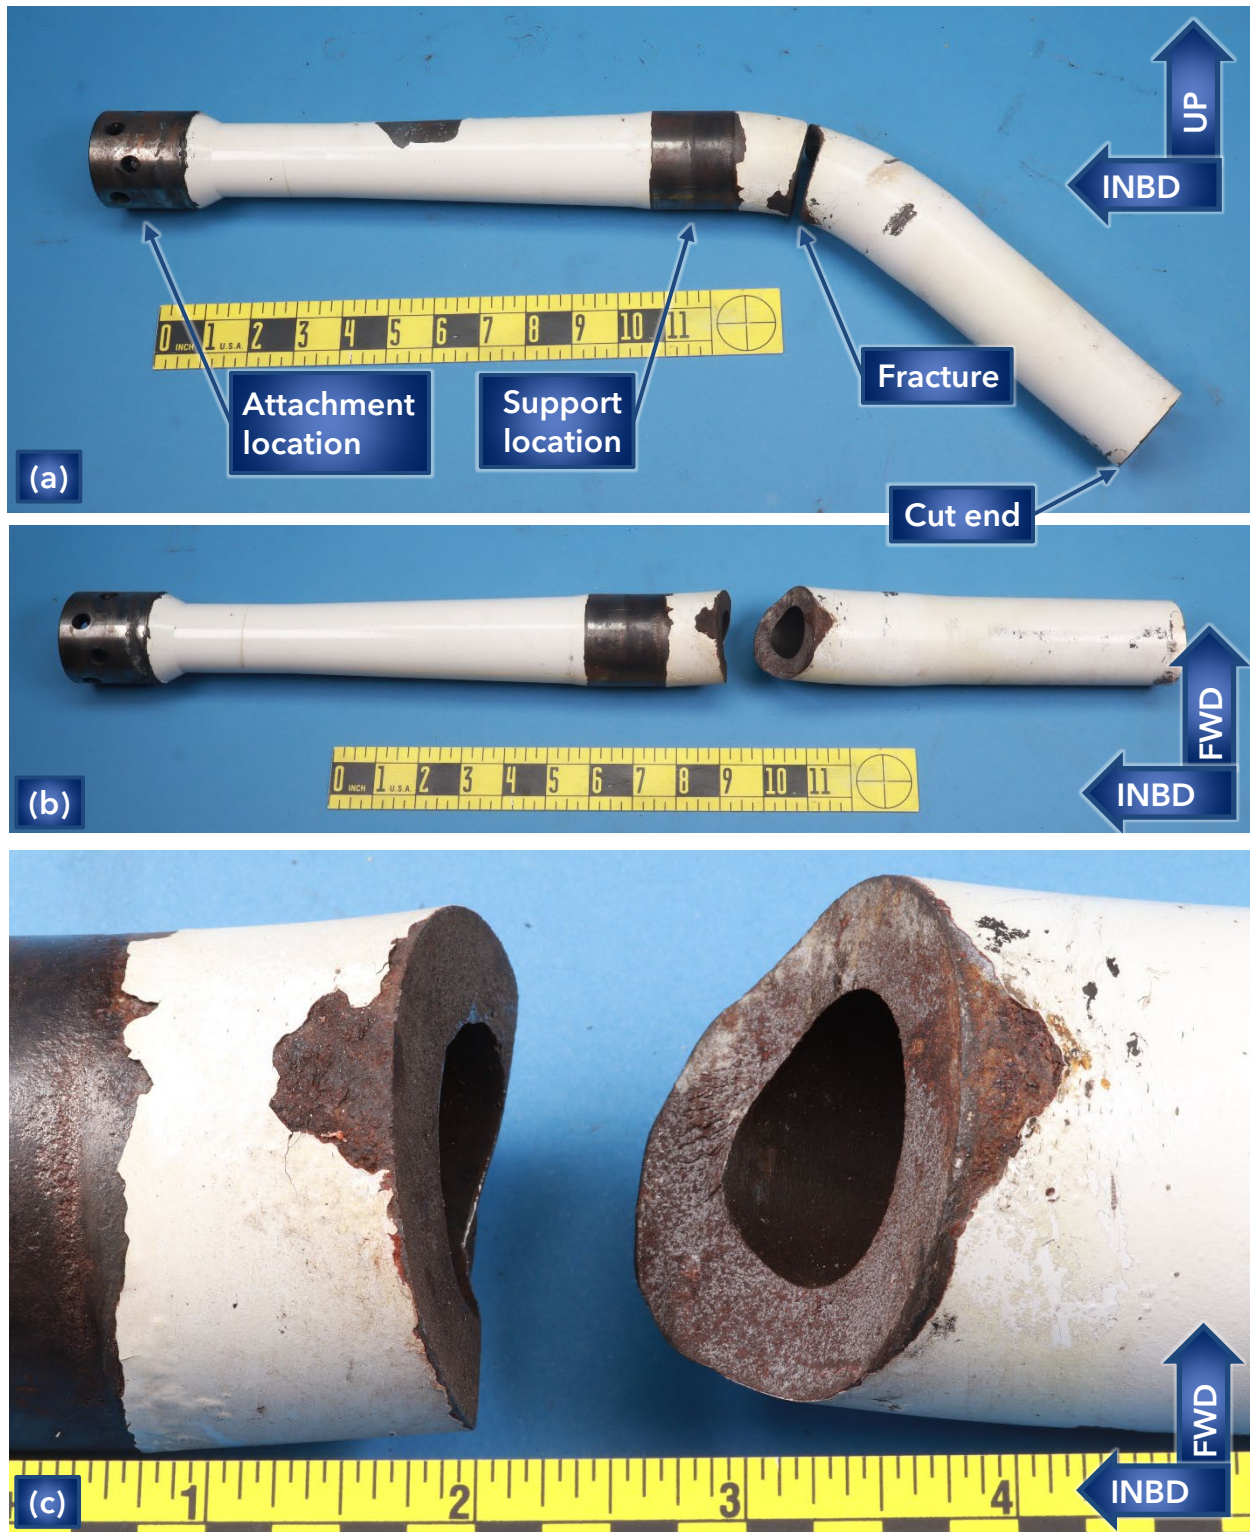
Overall views of the submitted right main landing gear leg pieces are shown in figure 1 as received. The leg was fractured near the middle of the bend at the upper end of the leg. As shown in figure 1 (c), paint was missing from areas of the lower surface adjacent to the fracture, and the exposed surfaces were corroded. The outboard piece had been cut below the fracture to facilitate shipment and examination at the NTSB Materials Laboratory.

The outboard side of the fracture was damaged from contact with terrain. The inboard side was relatively undamaged but appeared to be covered with loose greasy deposits and debris. However, a flat area with dark features and a curving boundary was observed on the lower side of the fracture, features consistent with fatigue.

**Figure 1.** Overall views of the submitted main landing gear pieces as received showing (a) the aft side and (b) the lower side. (c) Closer view of the lower surface at the fracture location.

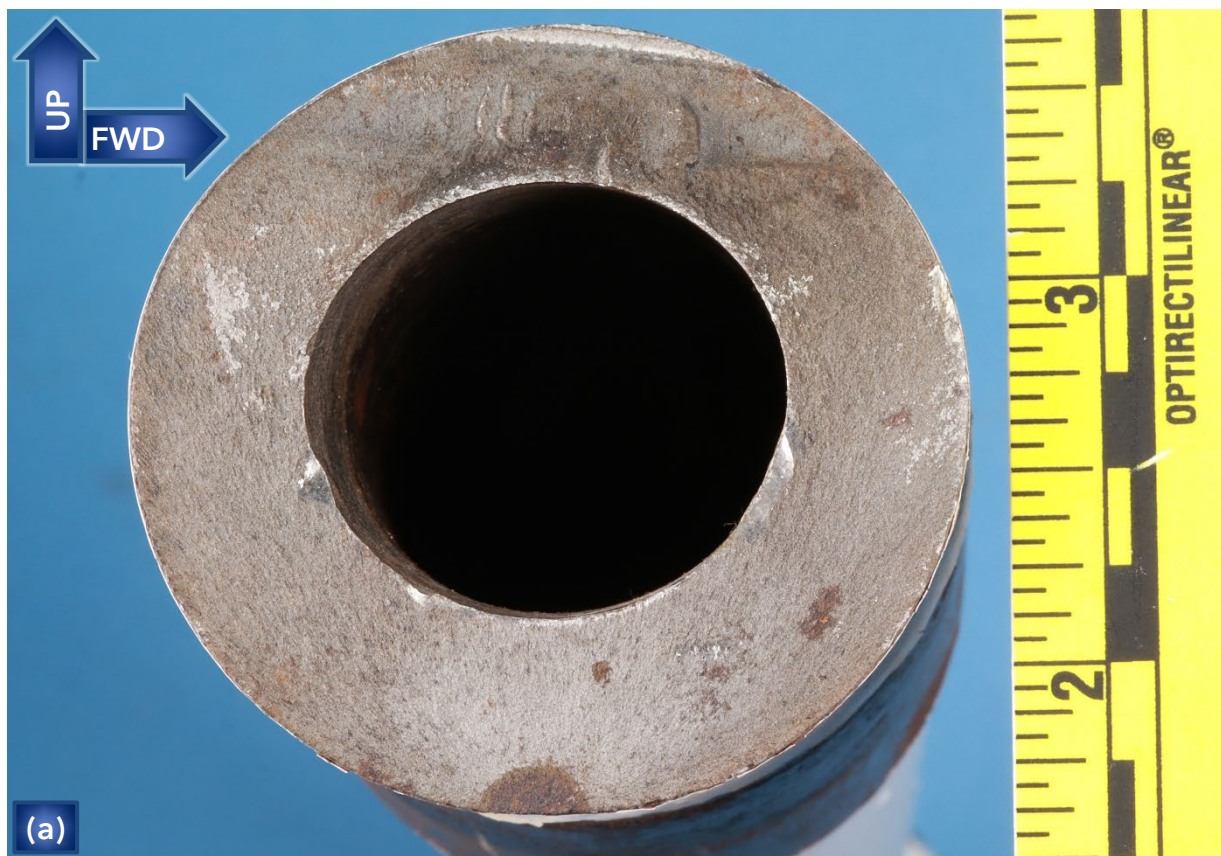
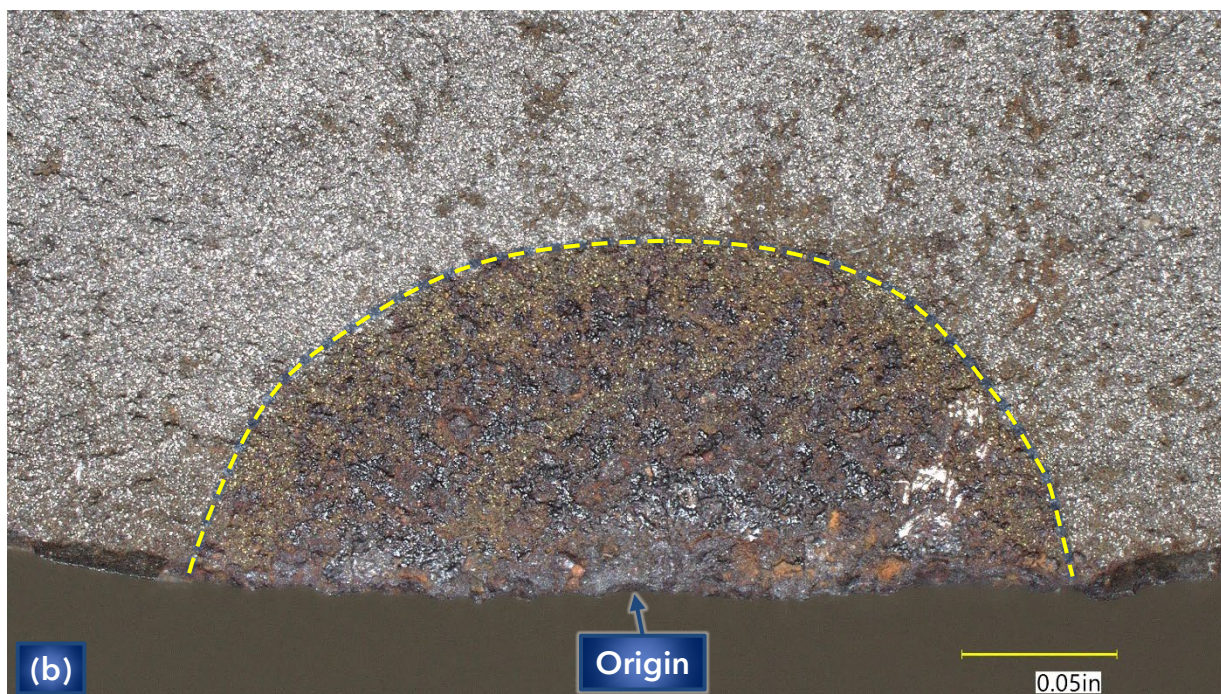
The cleaned fracture surface and adjacent lower surface on the inboard piece are shown in figures 2 and 3. At the lower side of the fracture surface, a portion of the fracture surface with no shear lip was covered with black, red, and orange oxides and had a curving boundary, features consistent with fatigue in relatively hard steel alloys

commonly used in main landing gear legs. Radial marks in the fatigue region emanated from a corrosion pit in the lower surface, identified as the origin in figure 2. The remainder of the fracture was primarily in the transverse plane and had a mostly matte gray appearance with small shear lips at the edges, features consistent with overstress fracture in the steel tubular section. The plane of fracture changed at the upper side of the fracture consistent with the final segment of fracture from bending loads.

**Figure 2.** (a) Overall view of the inboard side of the fracture surface after cleaning with replicating tape and acetone. (b) Closer view of the fatigue region on the cleaned fracture surface. The fatigue crack origin is indicated, and a dashed line indicates the boundary of the fatigue region.

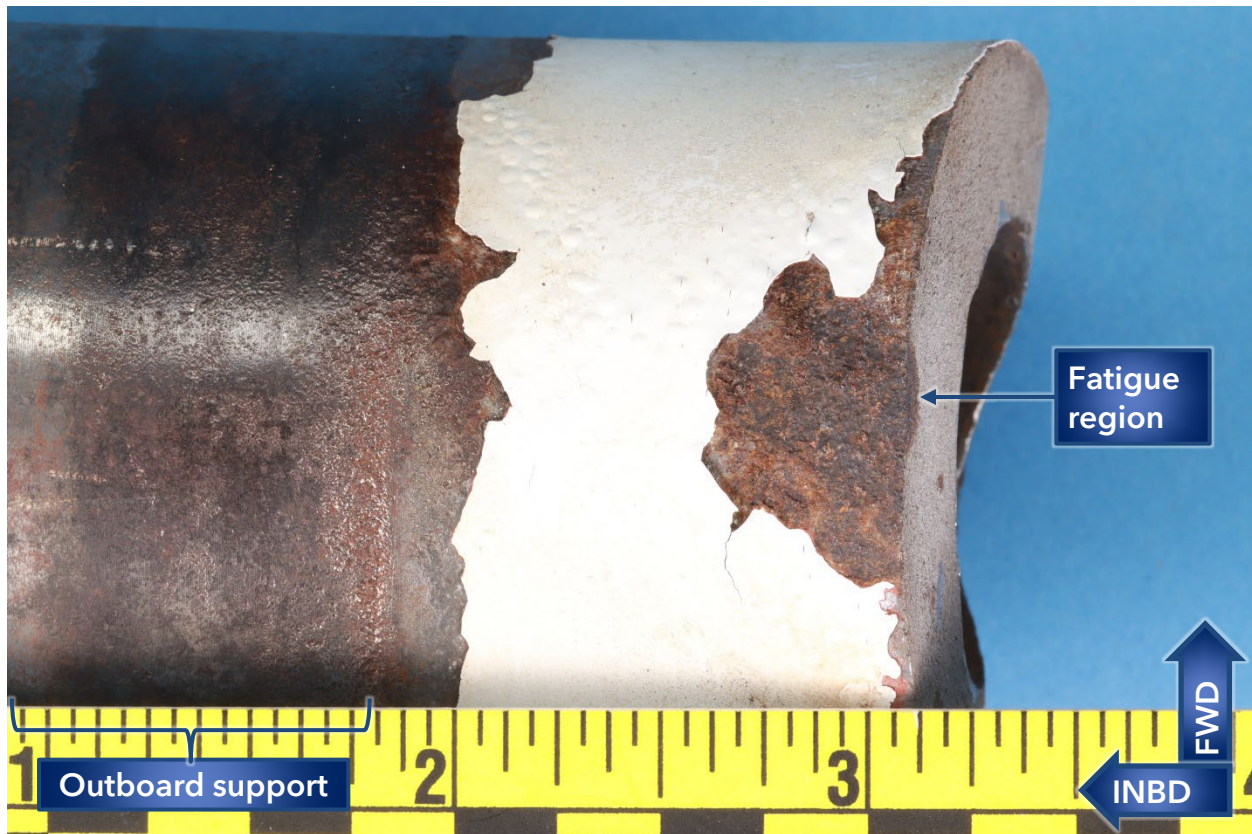
Oxides and corrosion pits were observed on the lower surface adjacent to the fracture surface as shown in figure 3. Paint covering adjacent areas was bubbled, consistent with the presence of underlying corrosion damage.

As indicated in figure 1, the main landing gear had been attached to the fuselage at the inboard end of the leg, and the leg had been supported by the fuselage at a location inboard of the fracture location. As shown in the close view of the lower surface in figure 3, corrosion pits were also observed at the outboard edge of the support location.

**Figure 3.** Closer view of the lower surface on the inboard piece of the right main landing gear after cleaning. The area showed bubbled and missing paint with substantial corrosion and pits adjacent to the fracture surface and at the outboard edge of the outboard support contact area.
