# National Transportation Safety Board

ANC25LA026

## **ENGINE EXAMINATION**

Location: Kenai, AK  
Date: March 20, 2025  
Time: 1400L  
Airplane: N2527B 1946 Aeronca 7CCM

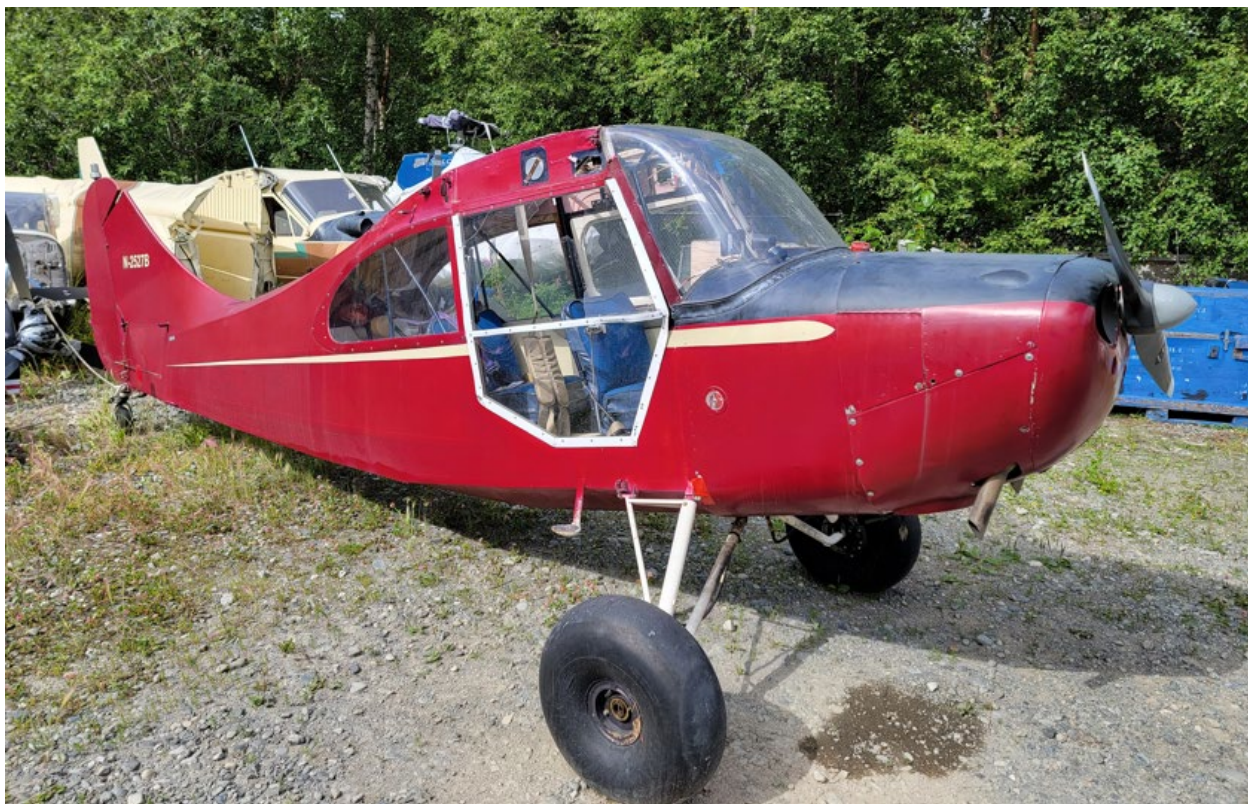
The pilot reported that during cruise flight at about 1,500 ft mean sea level the engine loss total power. The pilot initiated a forced landing on an old, abandoned access road. During the landing, the airplane collided with trees which resulted in substantial damage to the left wing.

**Figure 1 Accident airplane after recovery.**

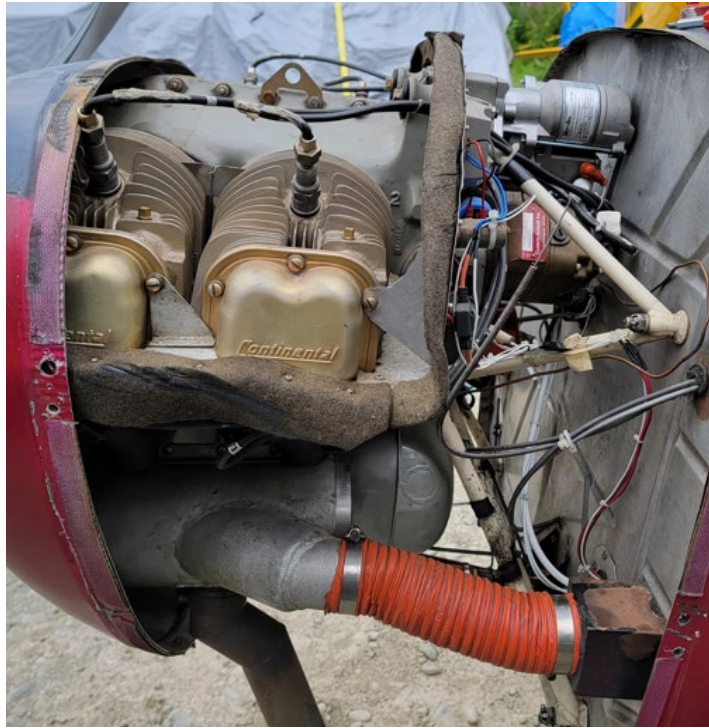
Both magnetos were secure. All sparkplugs were secure. All ignition lead wires were undamaged. No observed wire chafing, rubbing, or evidence of shorting in the electrical system. All electrical connections were secured and undamaged.

The engine oil was black in color and thick in viscosity.

The engine primer was used twice, and the engine started immediately and ran smoothly. The engine oil pressure operated in the green range on the instrument panel. The engine produced full power and operated on both left and right magnetos individually with no hesitation. An engine run up check was performed, and no abnormality was observed.

**Figure 2 Left side of accident engine.**

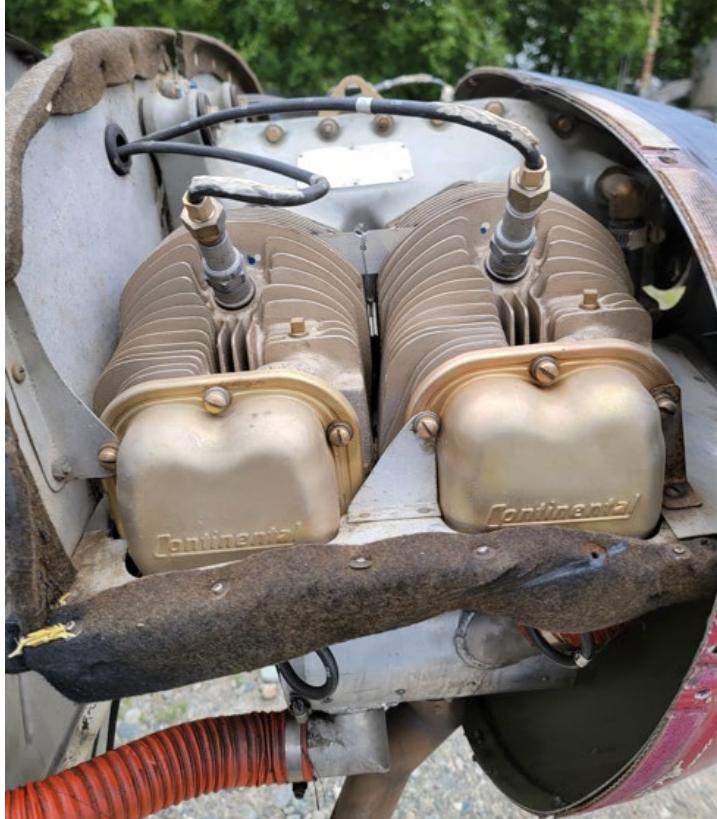
**Figure 3 Right side of accident airplane.**

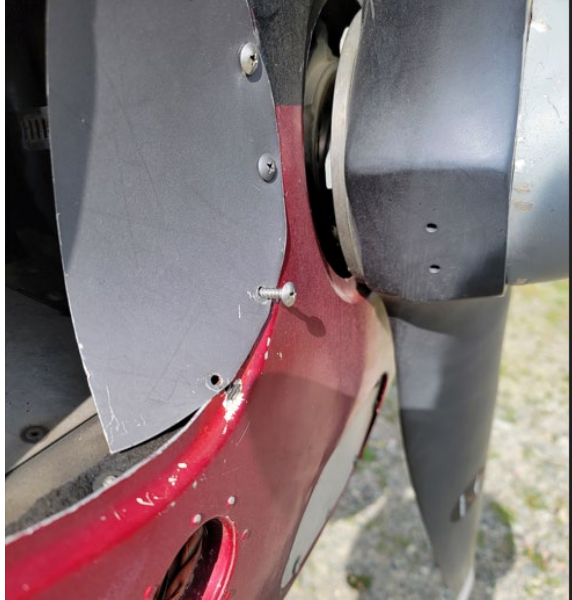
The propeller was undamaged except for a scratch from a screw that was backing out from the nose bowl.

**Figure 4 Screw backing out of nose bowl of accident airplane.**

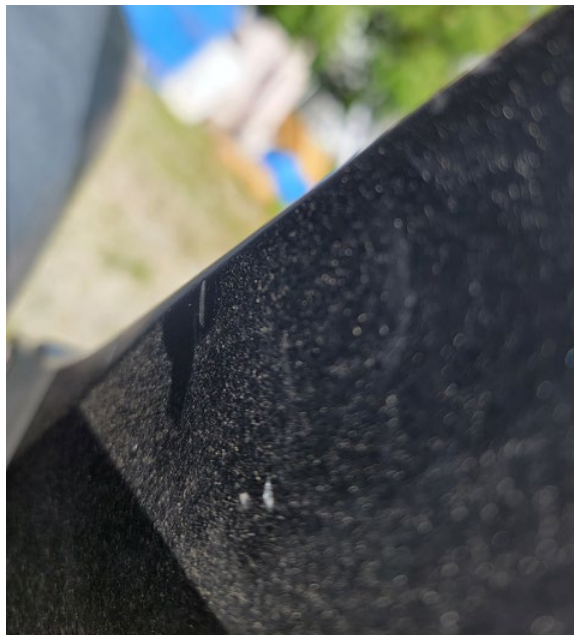
**Figure 5 Scratch on propeller blade.**

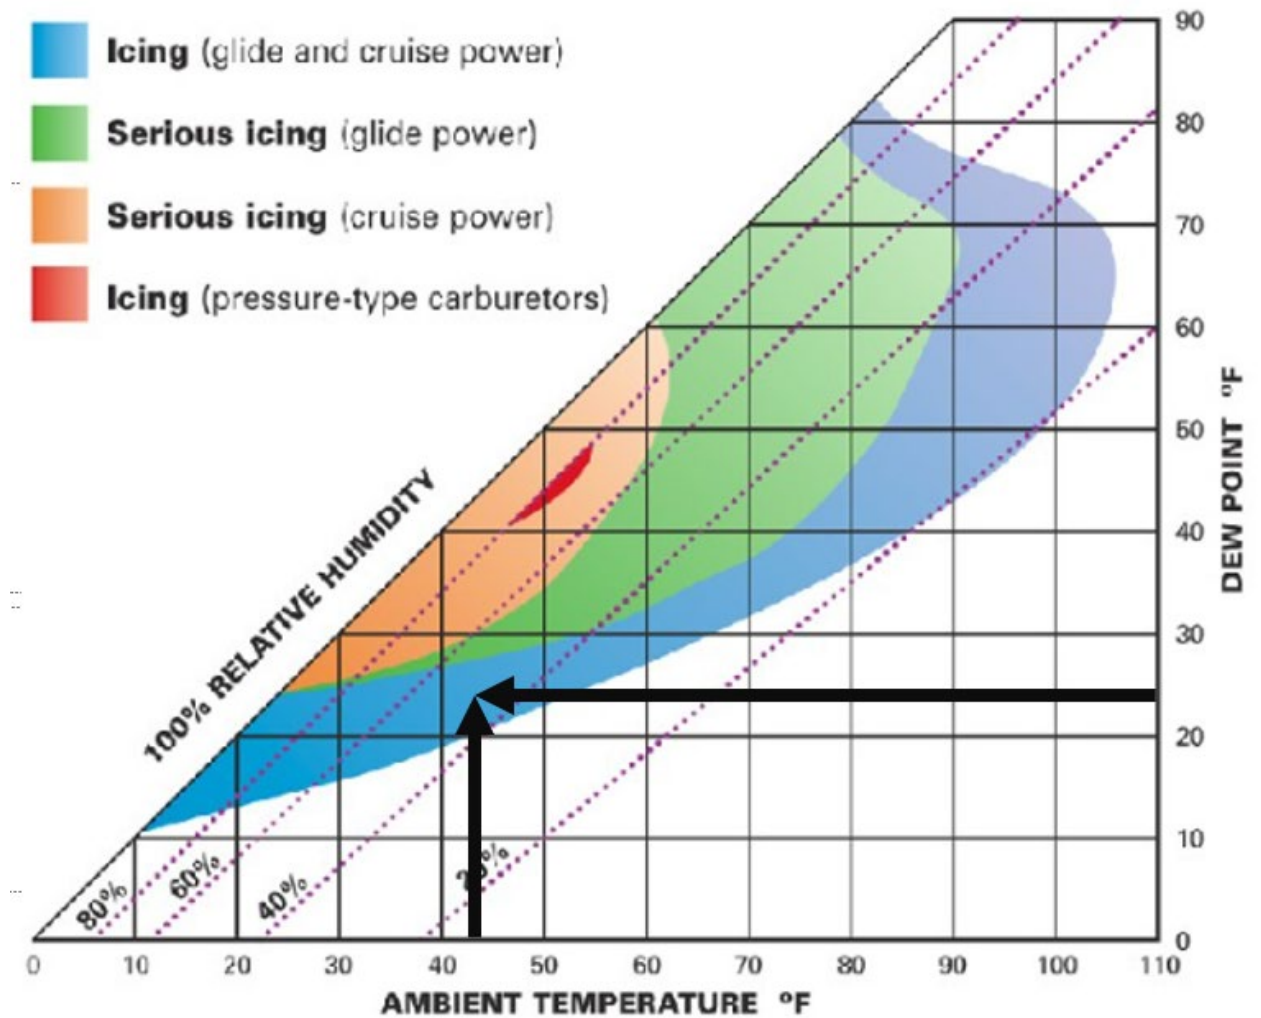
Reported temperature from about 2 miles from the accident site was 42.8 F with a dew point of 24.8 F

Figure 6 Carburetor icing chart.
