ANC25LA029

## INVESTIGATION PHOTOGRAPHS

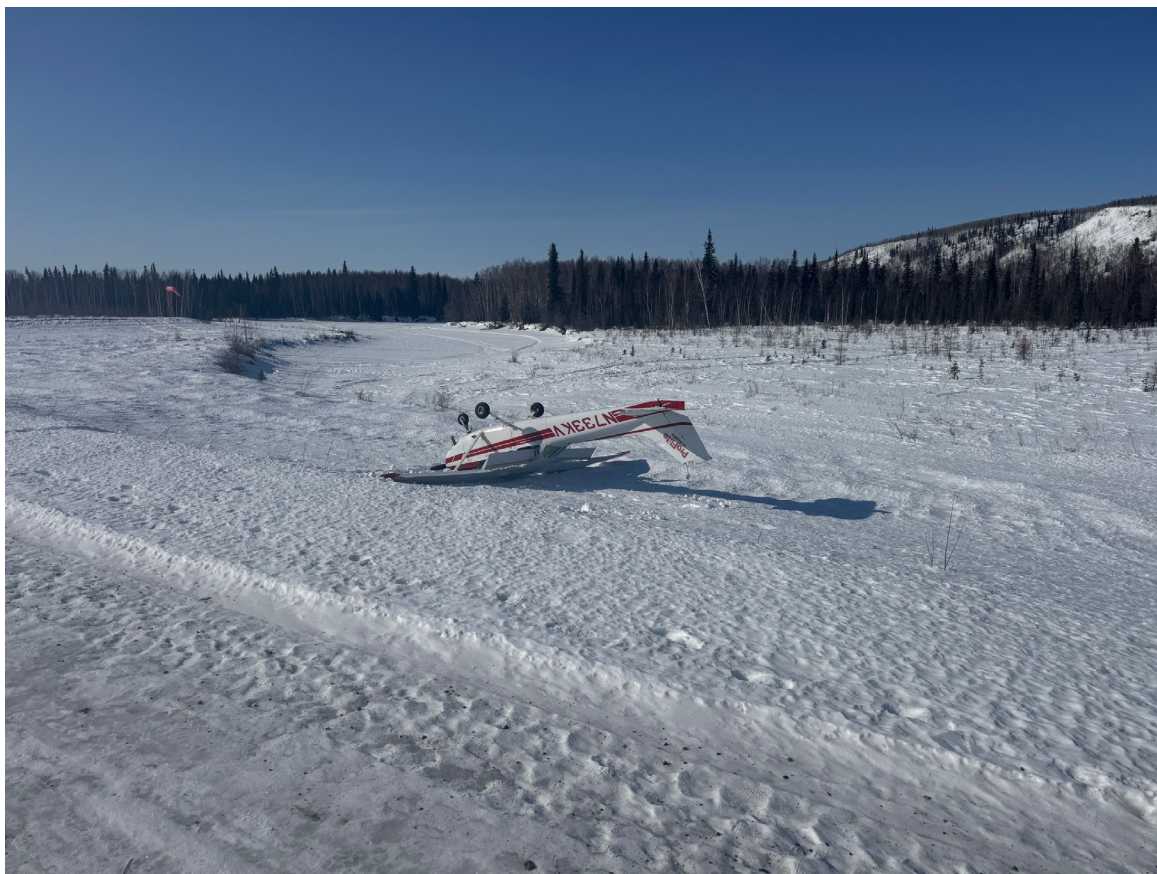
**Photograph 1 - Accident airplane inverted (Courtesy of Owner)**

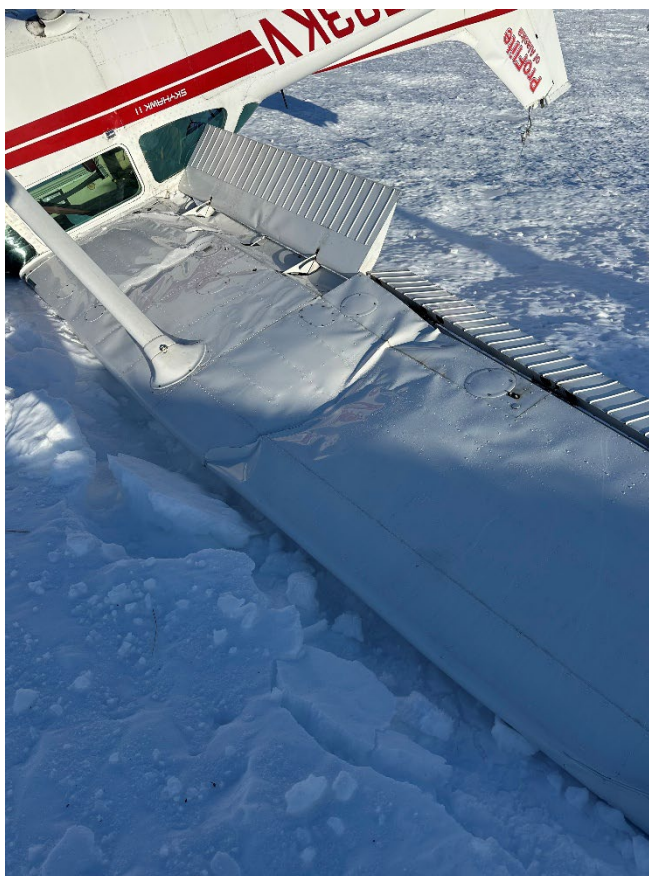
**Photograph 2 - Damage to right wing (Courtesy of Owner)**
