# National Transportation Safety Board

ANC25LA030

## **MATERIALS LABORATORY**

Factual Report 25-044

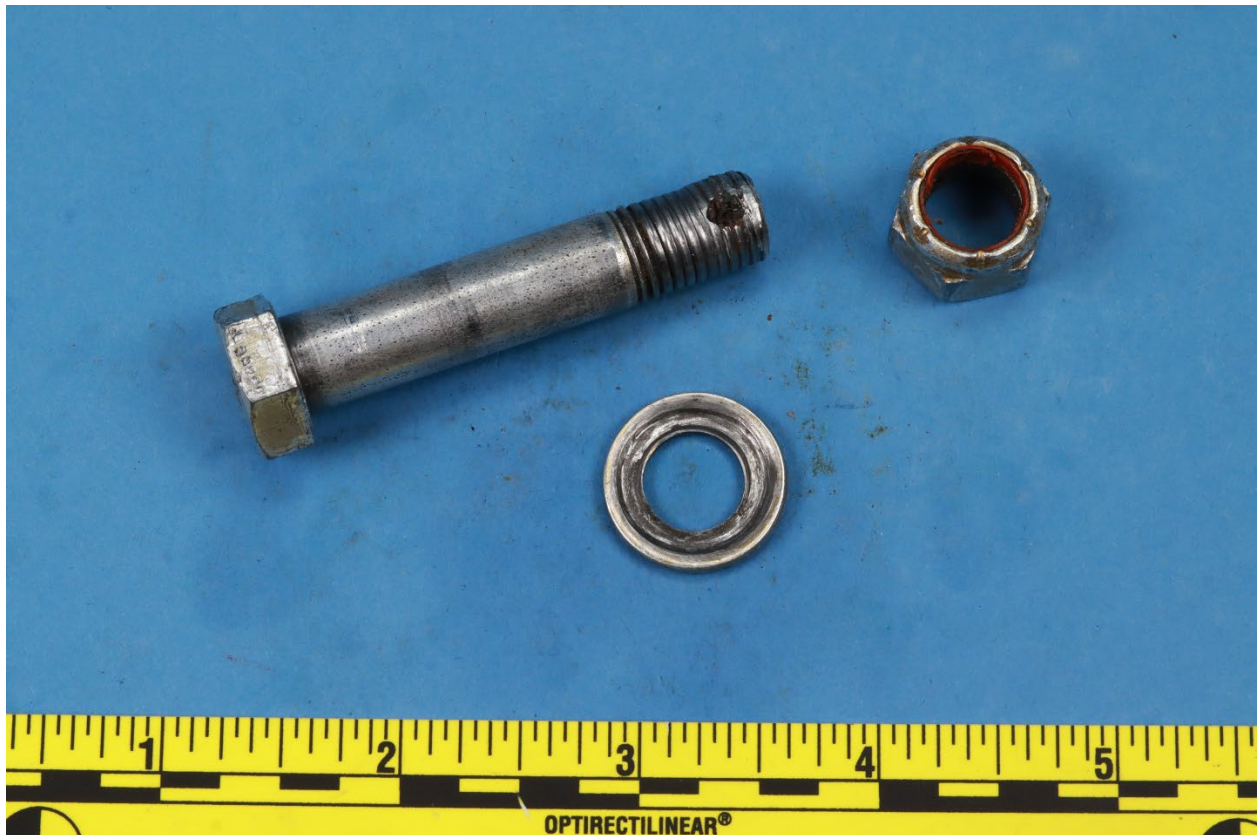
Bolt and nut from main landing gear (Figure 1)

**Figure 1.** Main landing gear bolt, nut and washer as received.

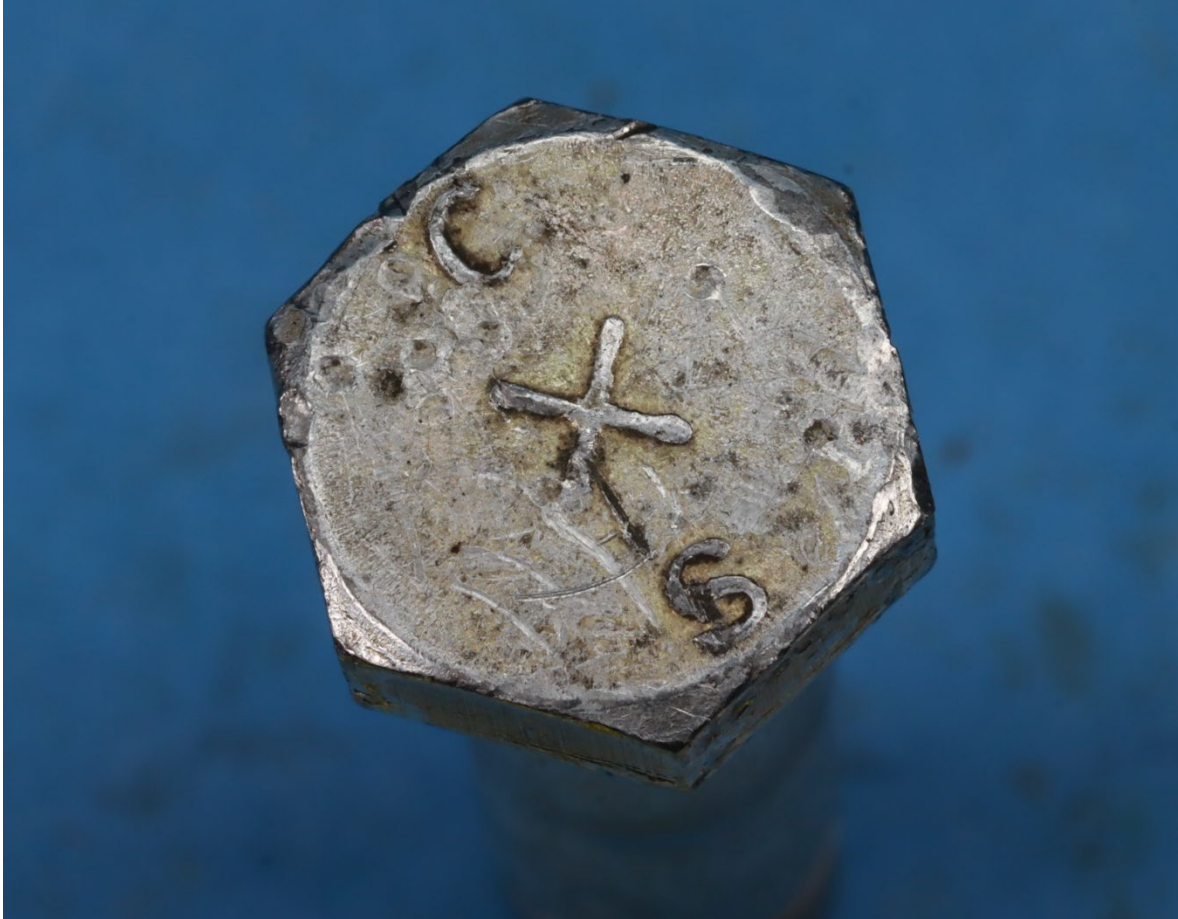
The dimensions of the bolt were consistent with an AN7-20 bolt. There was a cross drilled hole through the threaded portion of the bolt which is also consistent with an AN7-20 bolt. The bolt exhibited patchy and faint remnants of cadmium plating on the flats of the head. The shank of the bolt did not exhibit any remaining cadmium plating. The bolt head had the raised letters "C" and "S" on the periphery and a raised cross in the middle (Figure 2). The nut was a locking type of nut with a nylon locking insert consistent with an MS20365-720A nut. The nut had worn and patchy cadmium plating.

**Figure 2.** Markings on the bolt head.

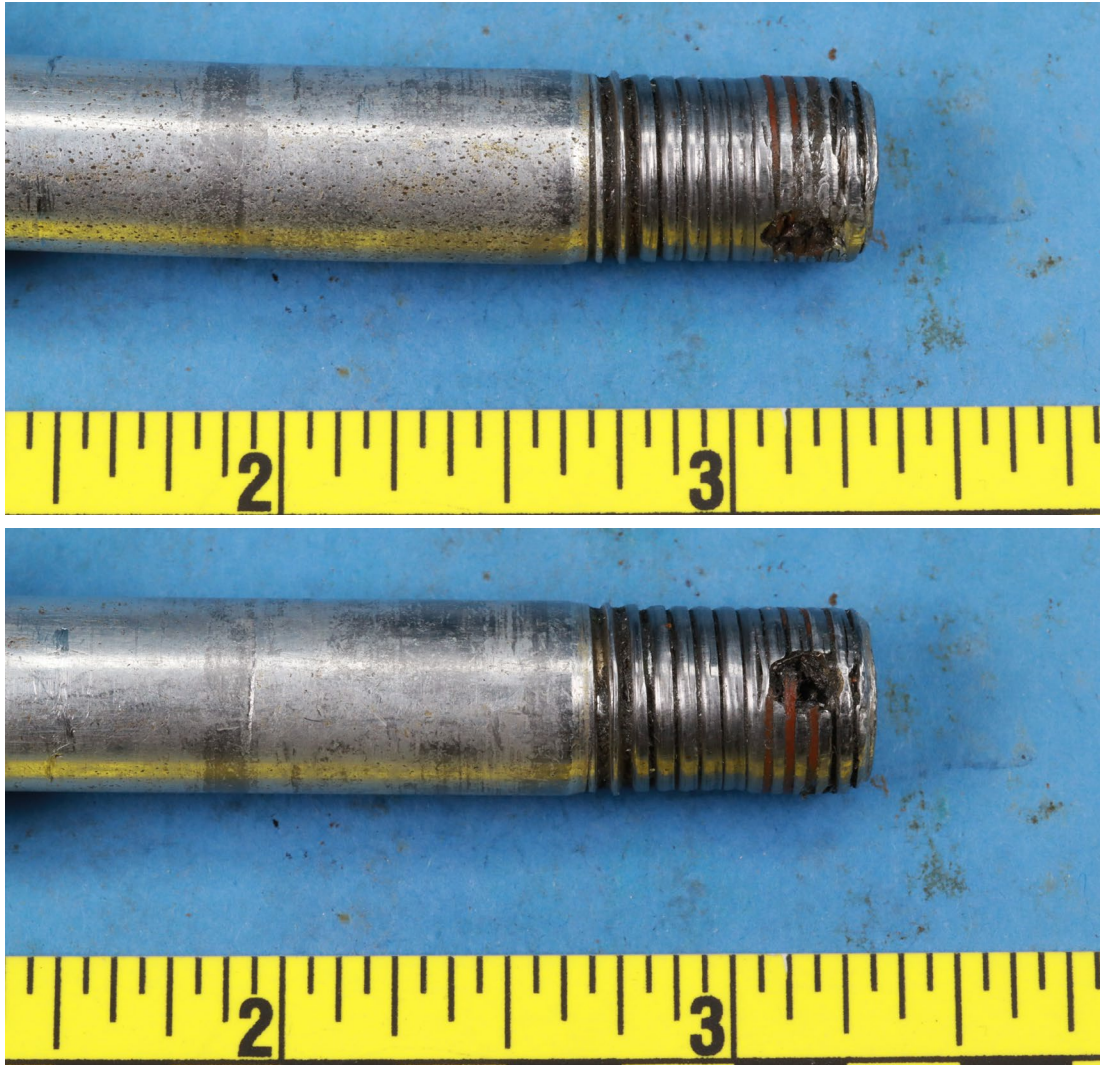
Both the bolt (Figure 3) and nut (Figure 4) exhibited worn threads. The worn threads near the end of the bolt contained bits of the nut's nylon locking insert. The nylon locking insert was worn down to the depth of the worn threads inside the nut. This wearing down of the threads would have occurred over time and not from a sudden instance of overload.

**Figure 3.** Two views of the worn threads on the bolt. The threads on the end contain remnants of the nylon locking insert from the nut.

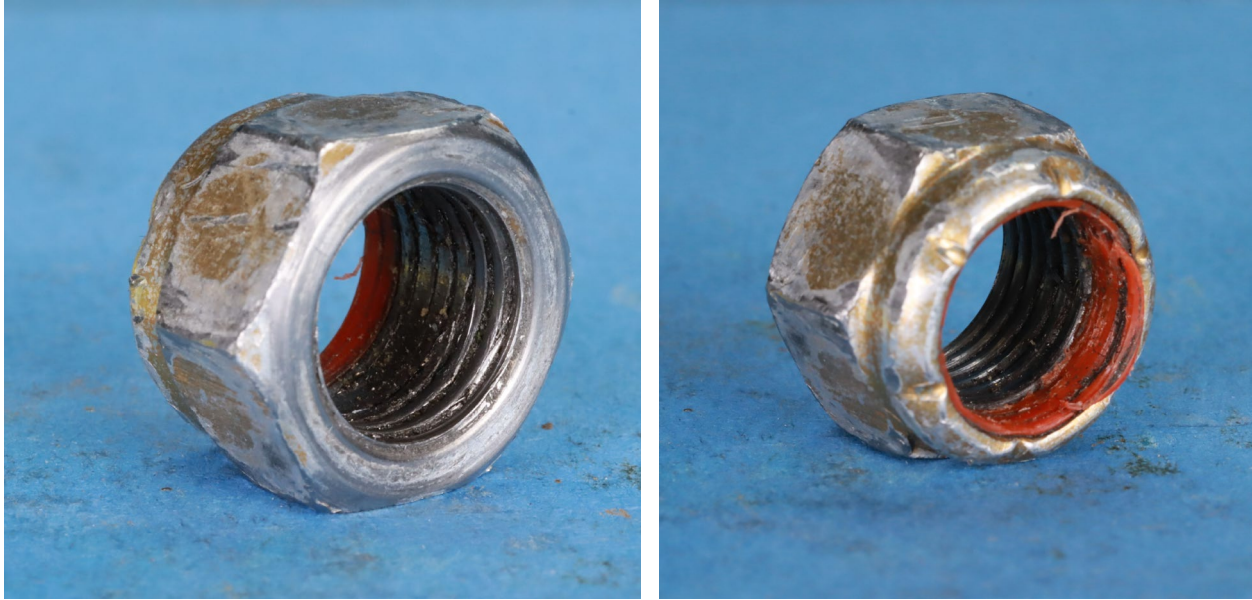
**Figure 4.** Locking nut exhibiting worn internal threads and a damaged nylon insert.

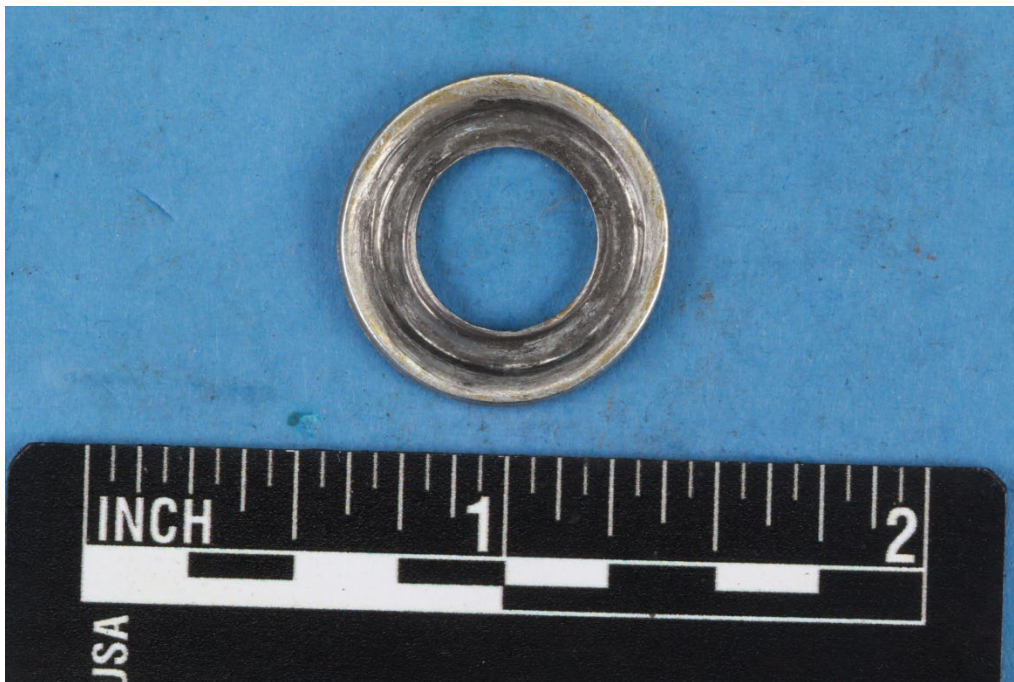
The flat washer (Figure 5) that would have been underneath the nut was deformed and had a wear groove where it had been in contact with the nut.

**Figure 5.** Flat washer with wear groove.
