ANC25LA030

## INVESTIGATION PHOTOGRAPHS

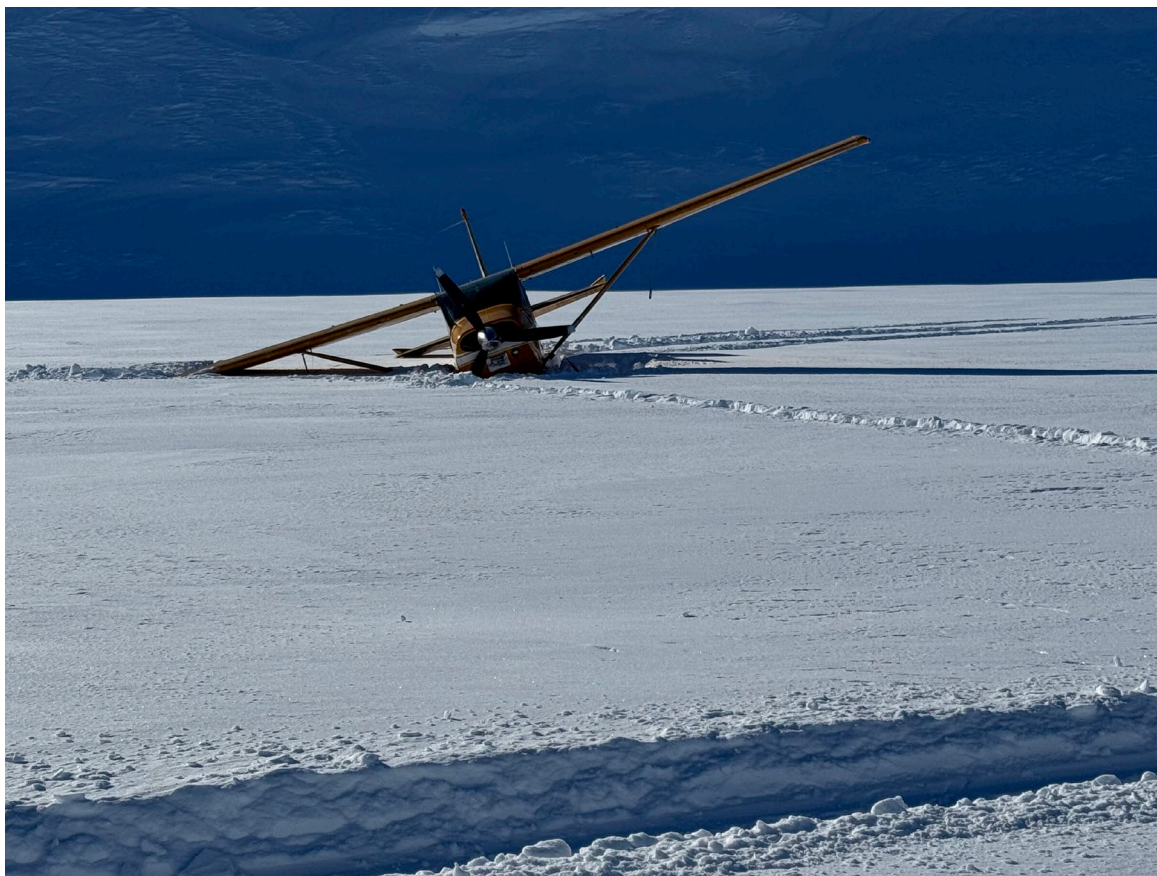
**Photograph 1 - Airplane with collapsed gear leg (Courtesy of Owner)**

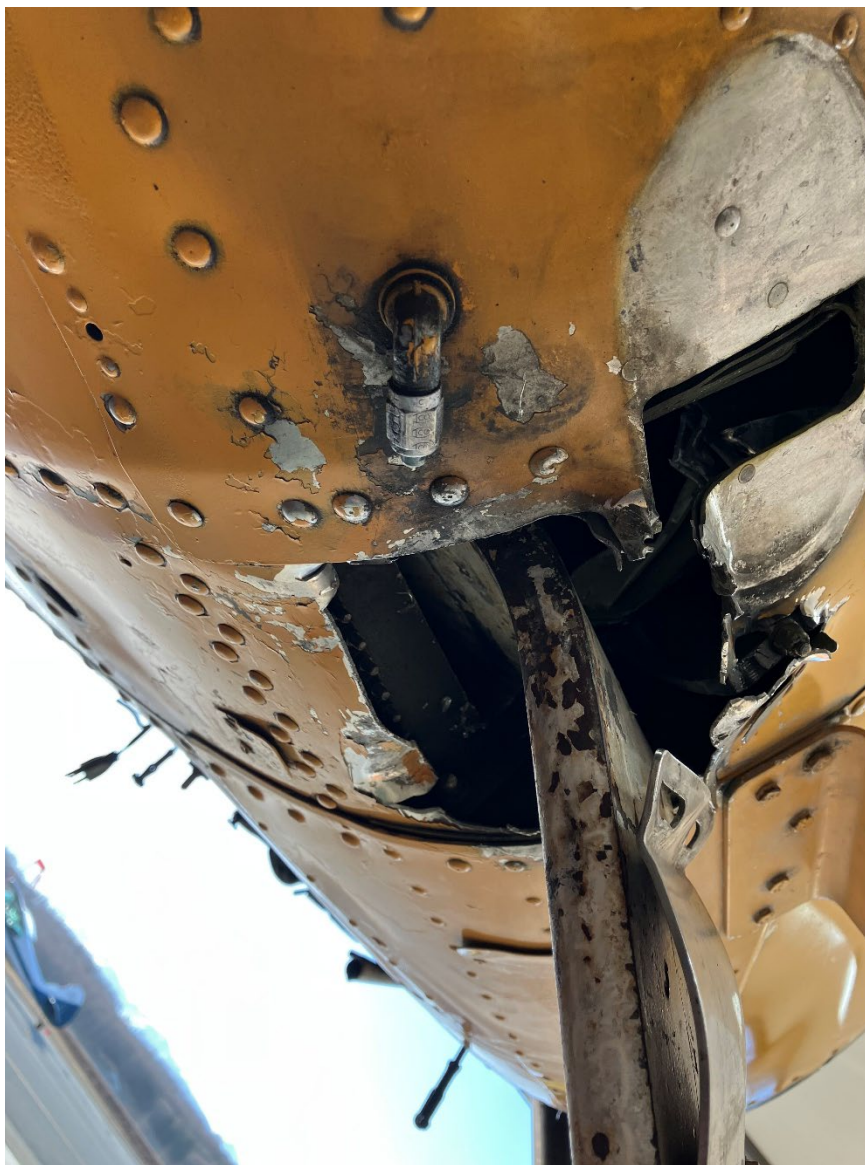
**Photograph 2 - Damage to landing gear box assembly (Courtesy of owner)**

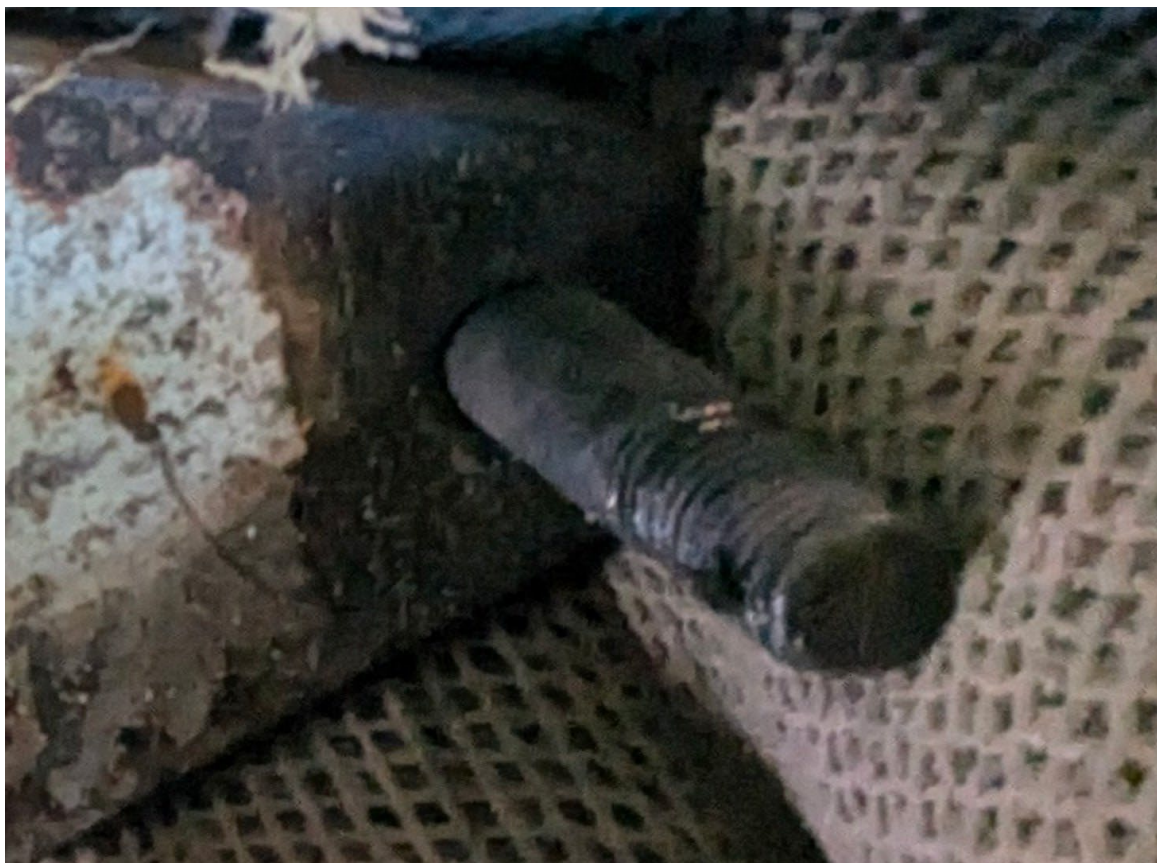
**Photograph 3 - Bolt as found after accident in landing gear (Courtesy of Owner)**

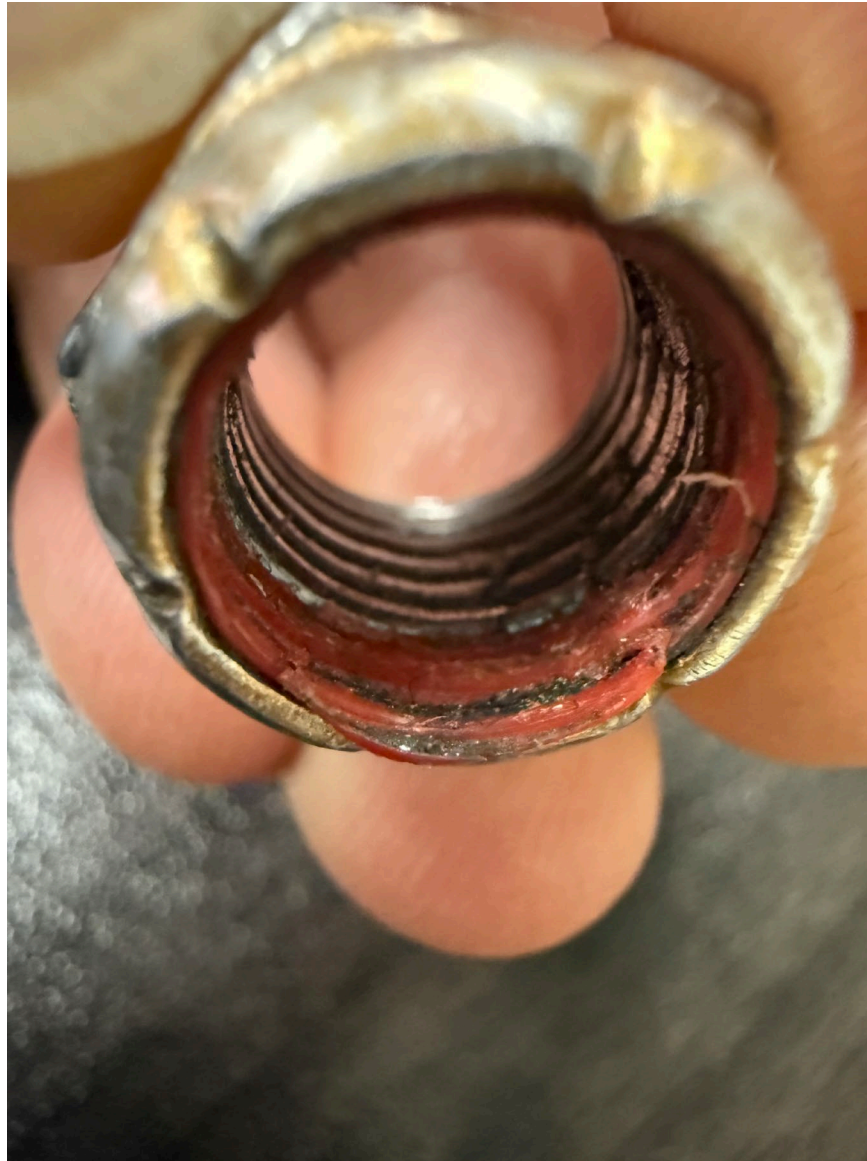
**Photograph 4 - Fiber locking nut from landing gear assembly (Courtesy of NTSB)**

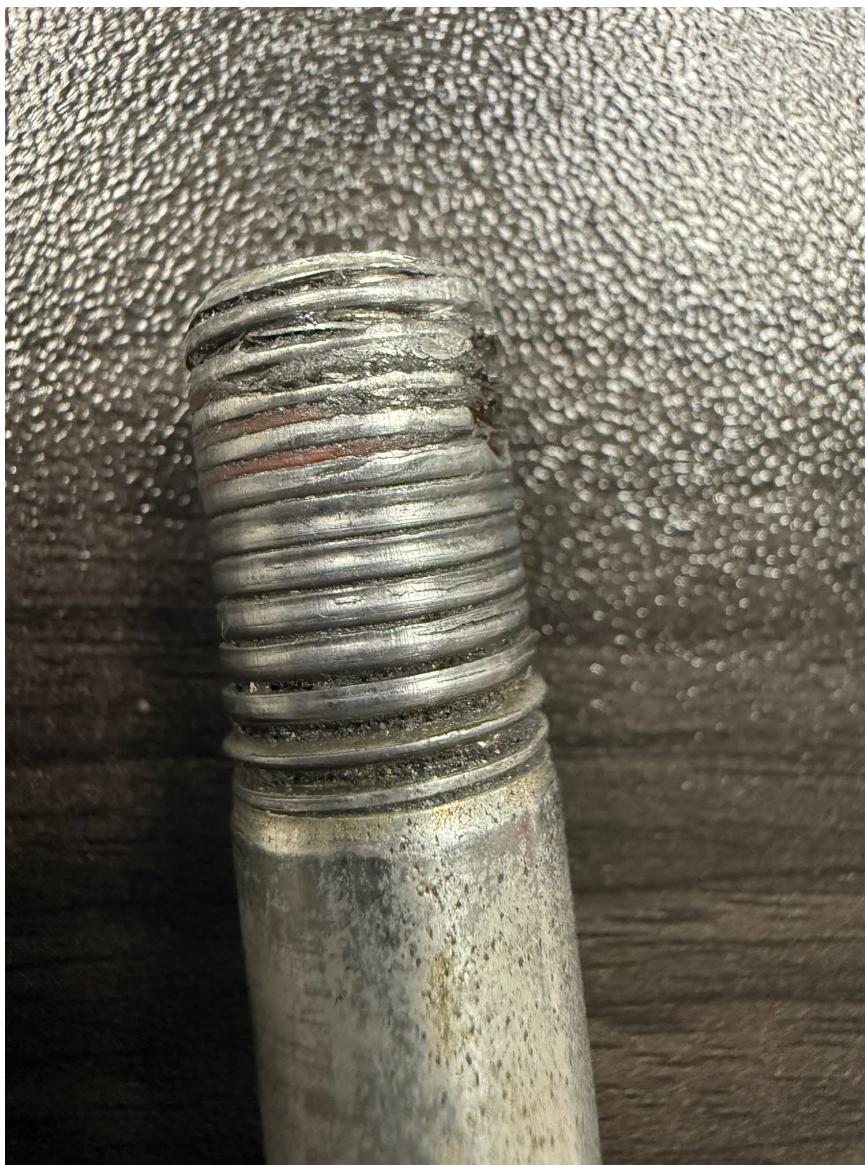
**Photograph 5 - Bolt from landing gear assembly (Courtesy of NTSB)**
