ANC25LA036

## INVESTIGATION PHOTOGRAPHS

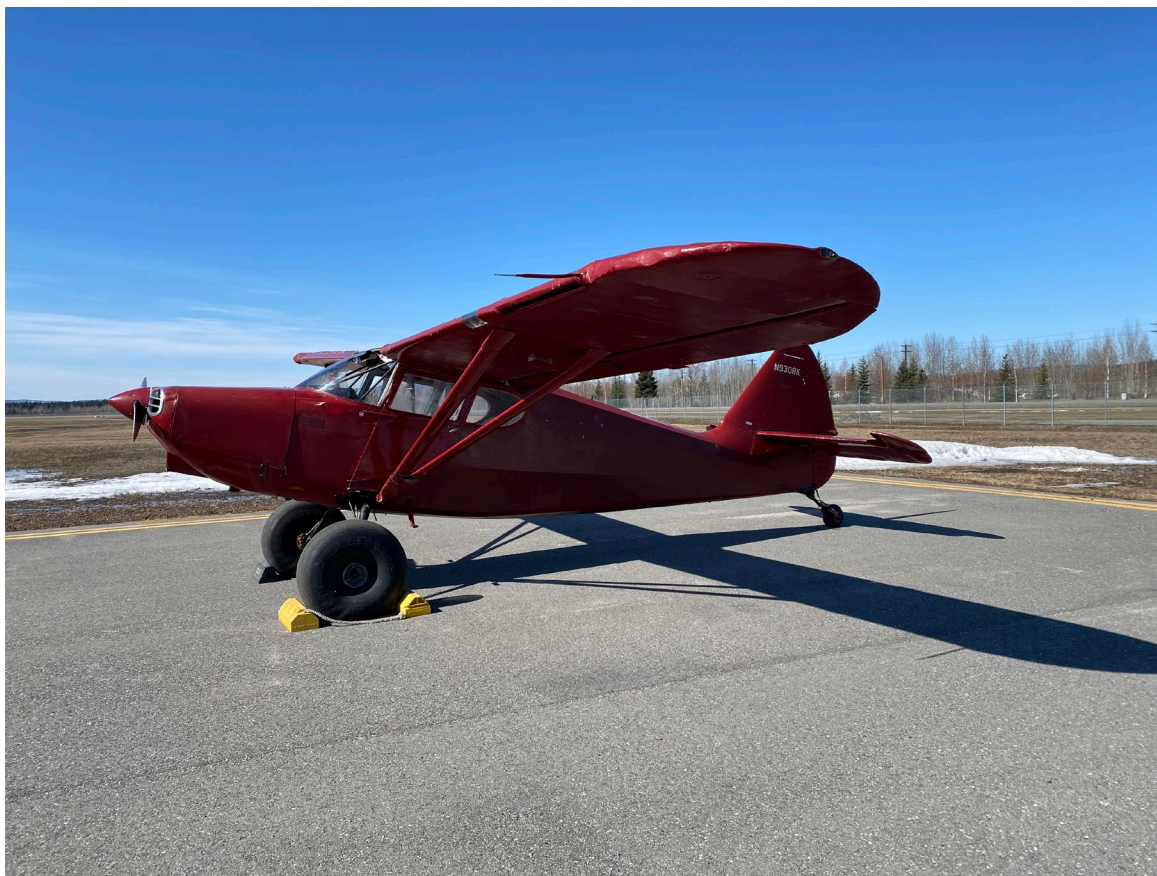
**Photograph 1 - View of the airplane and damage to left wingtip (Courtesy of airfield manager)**

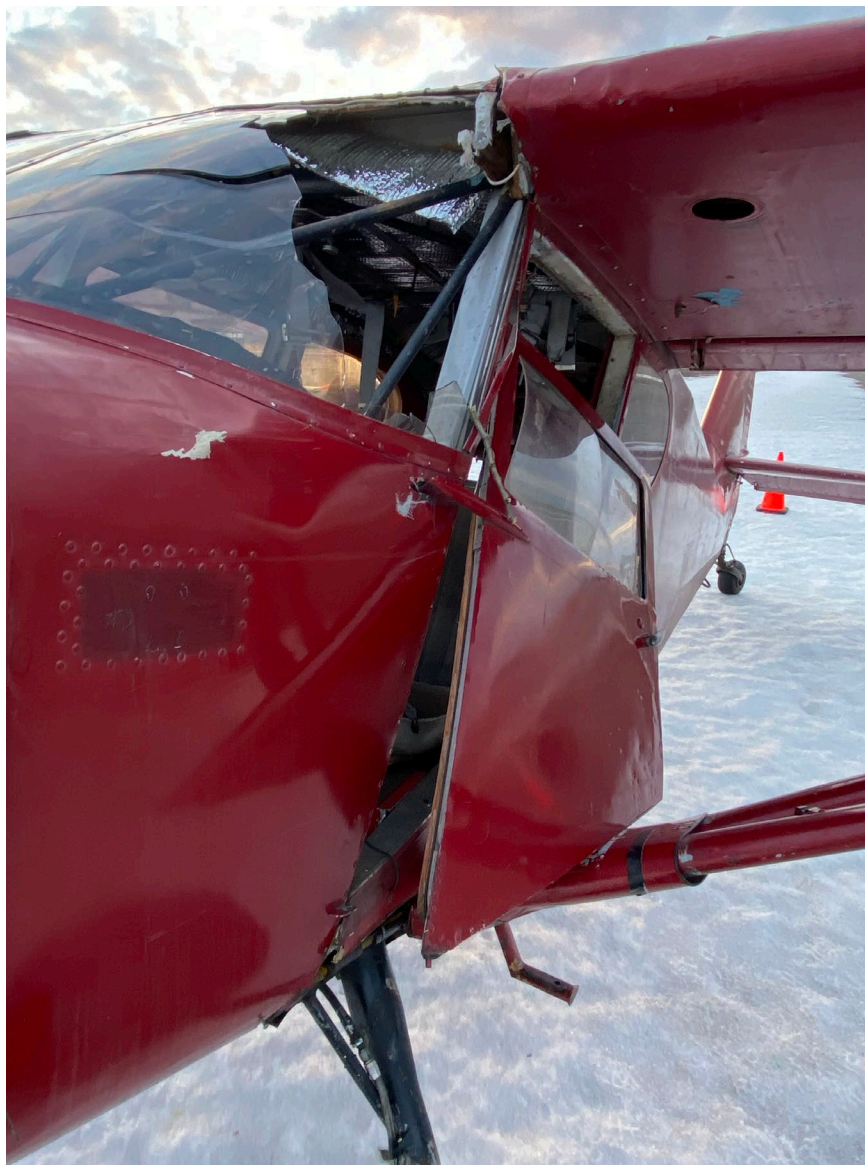
**Photograph 2 - Damage to windscreen and left side of fuselage (Courtesy of airfield manager)**

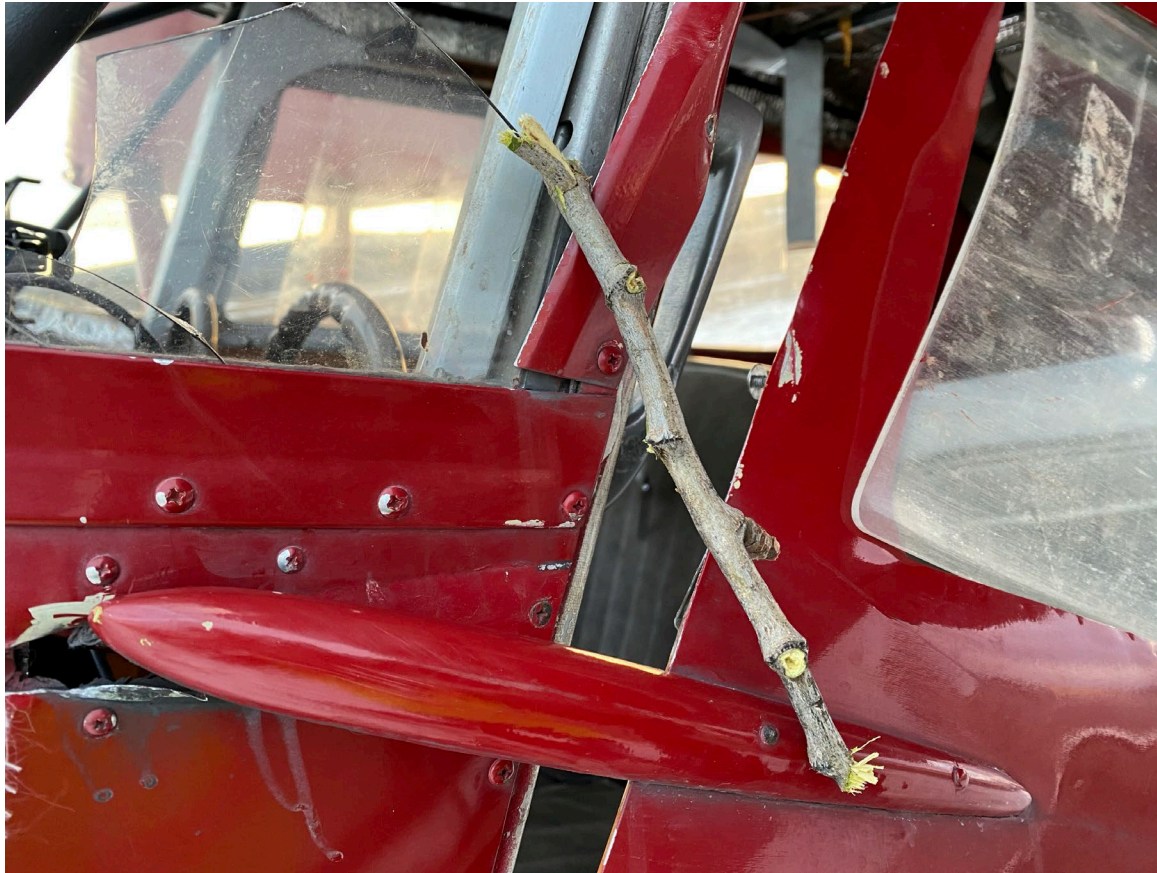
**Photograph 3 - View of a stick lodged in the airframe around the windscreen (Courtesy of airfield manager)**

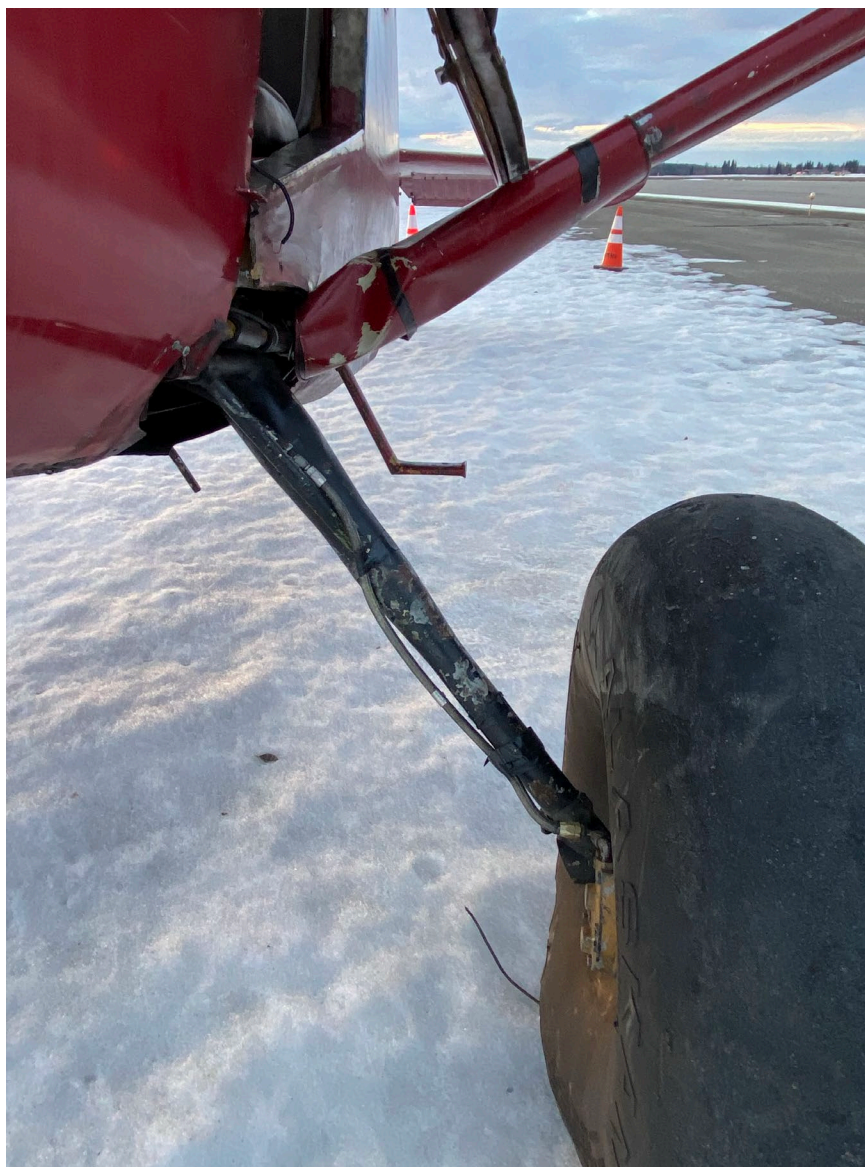
**Photograph 4 - View of damage to left strut. (Courtesy of airfield manager)**
