ANC25LA041

## INVESTIGATION PHOTOGRAPHS

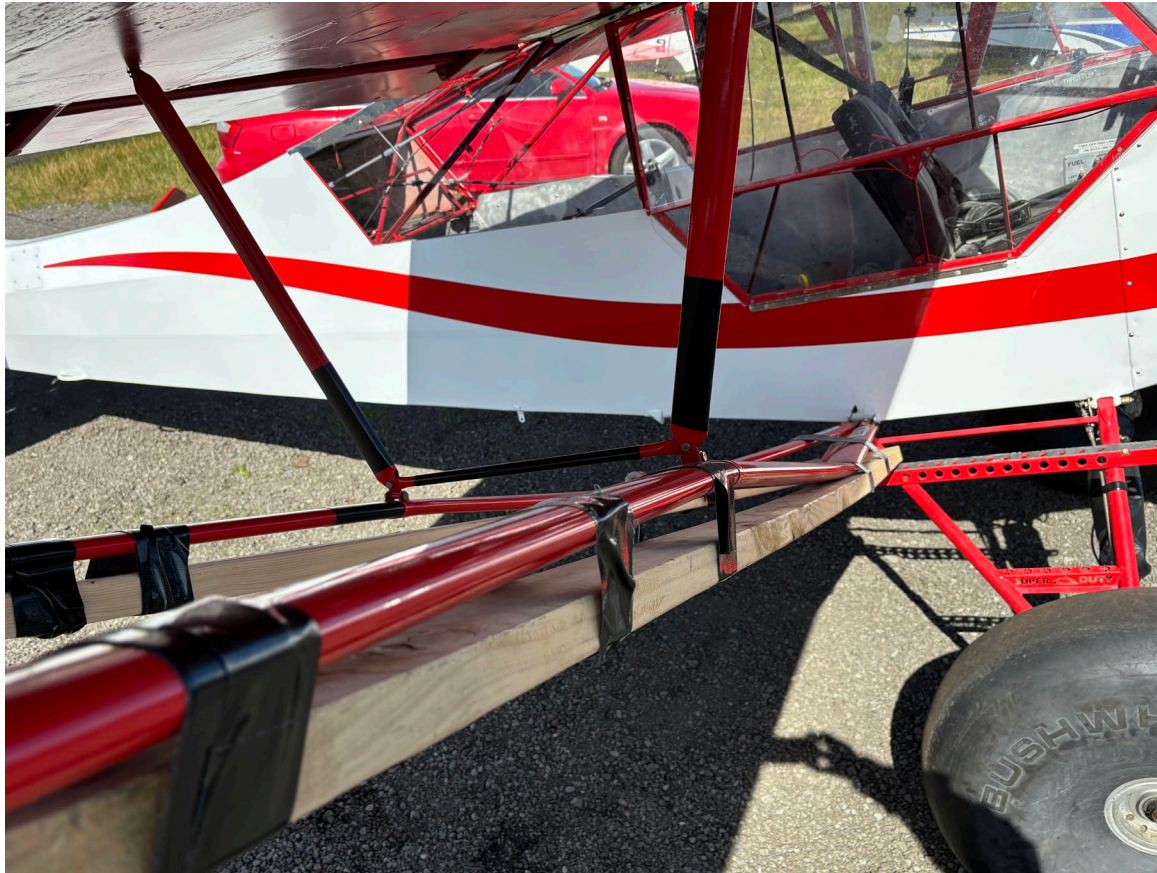
**Photograph 1 - View of damage to right strut. (Courtesy of FAA)**

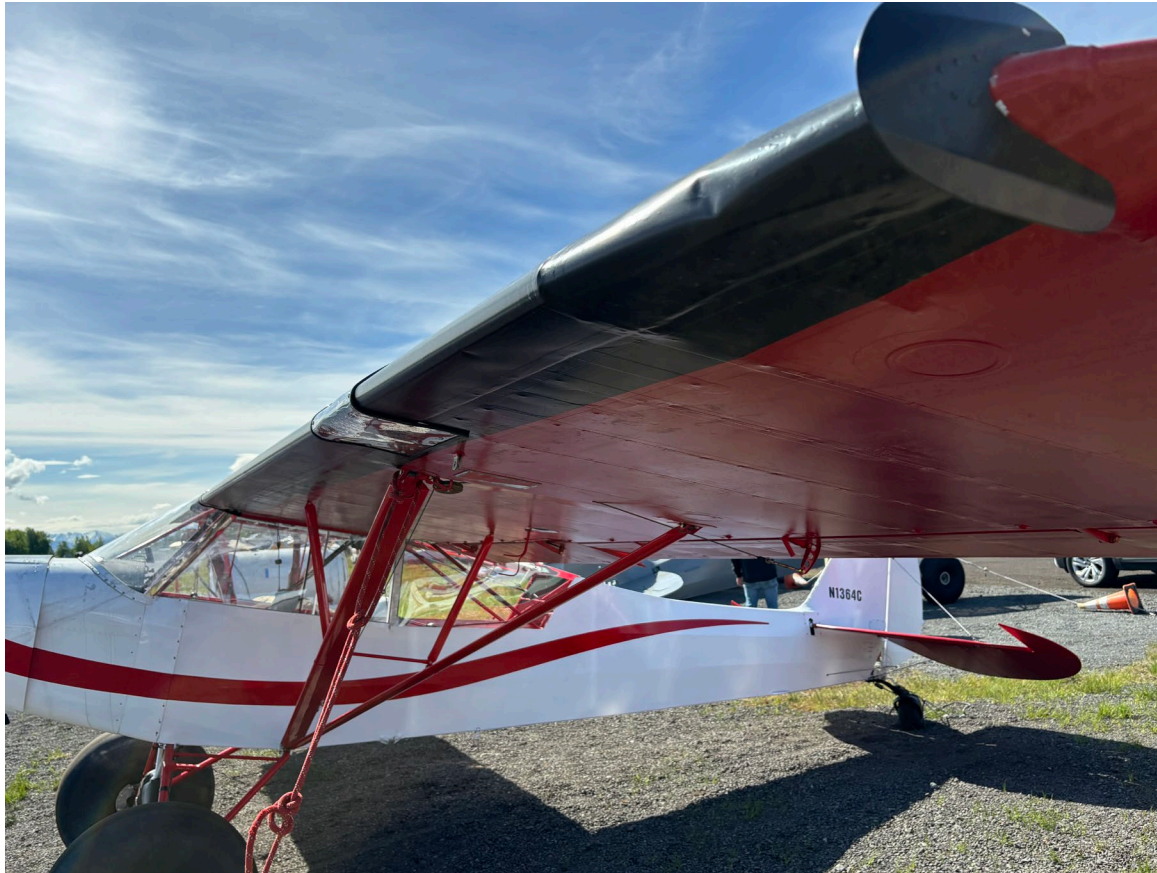
**Photograph 2 - View of damage to left leading edge. (Courtesy of FAA)**
