ANC25LA049

## INVESTIGATION PHOTOGRAPHS

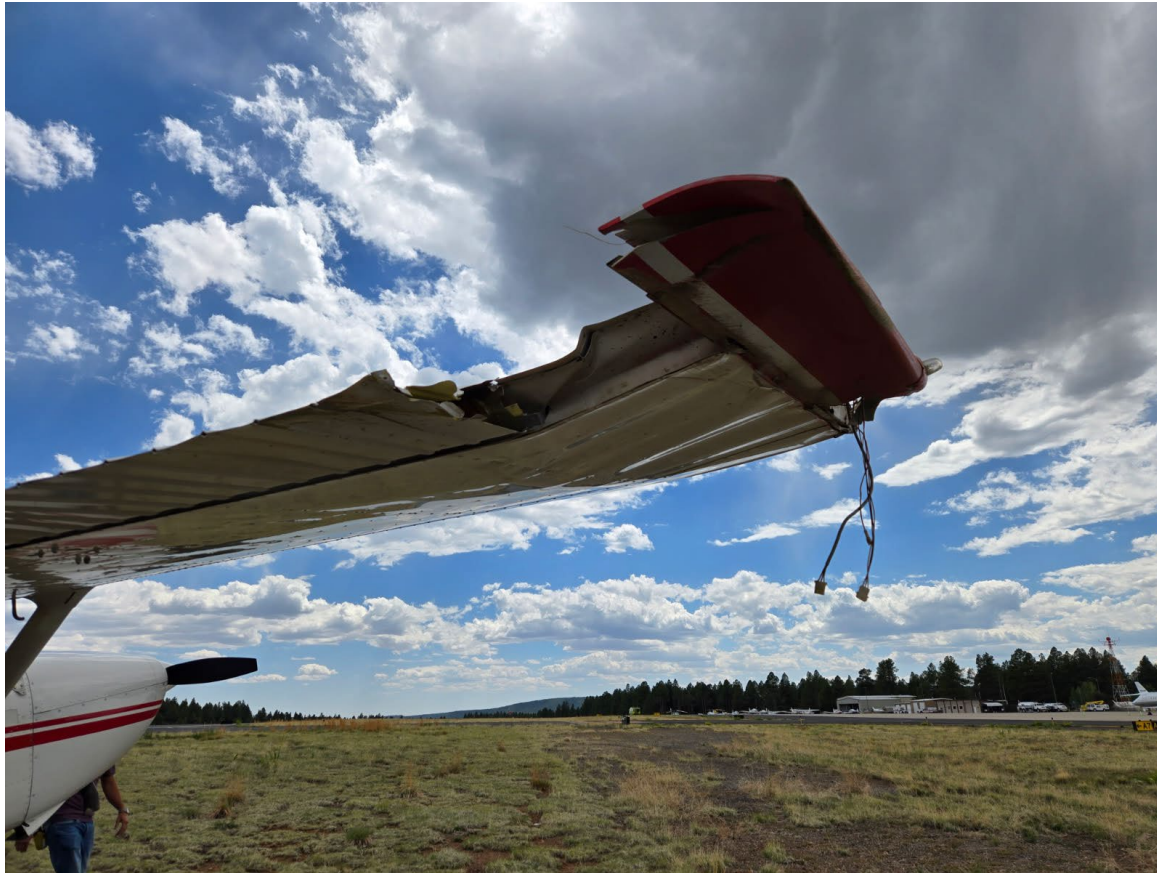
**Photograph 1 - Image of damage to right wing (Courtesy of Airport Manager)**
