ANC25LA050

## INVESTIGATION PHOTOGRAPHS

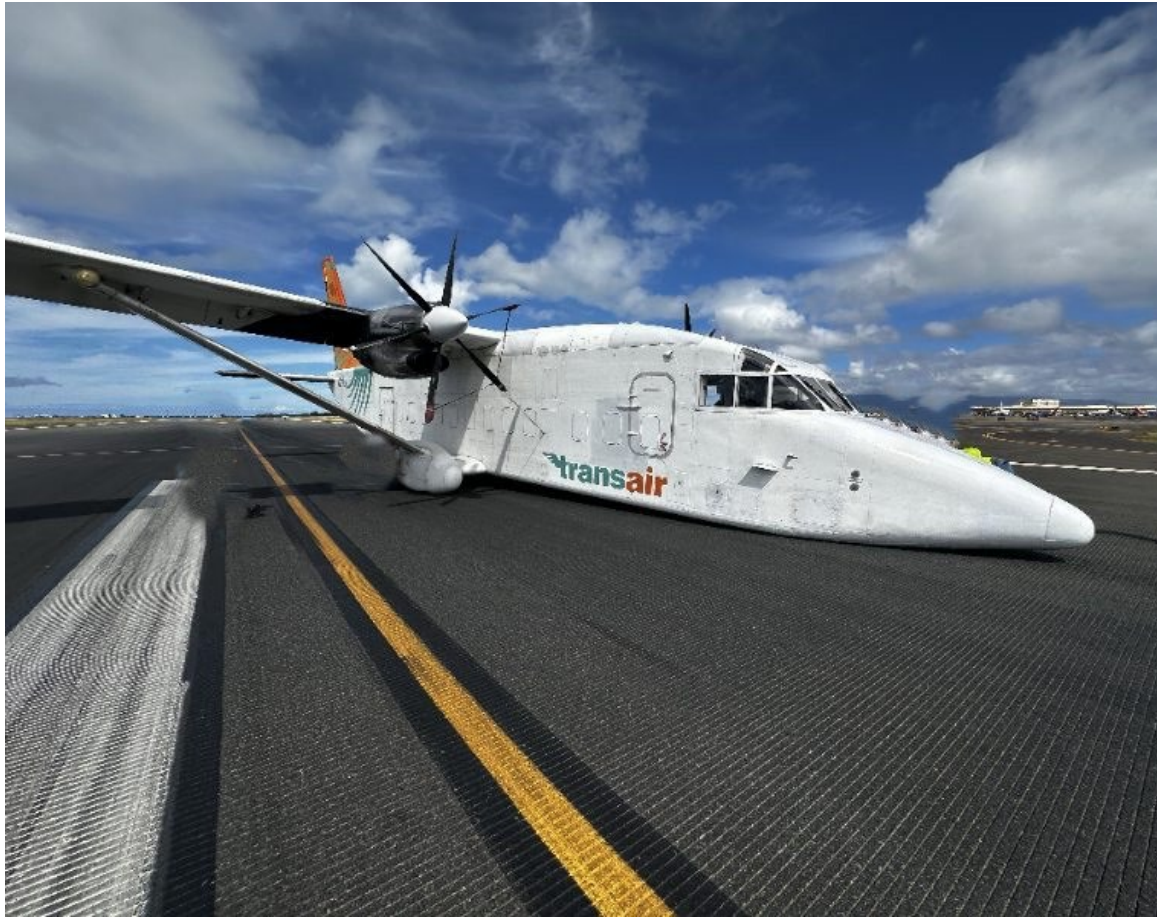
**Photograph 1 - Image of airplane after gear up landing (Courtesy of airport operations)**

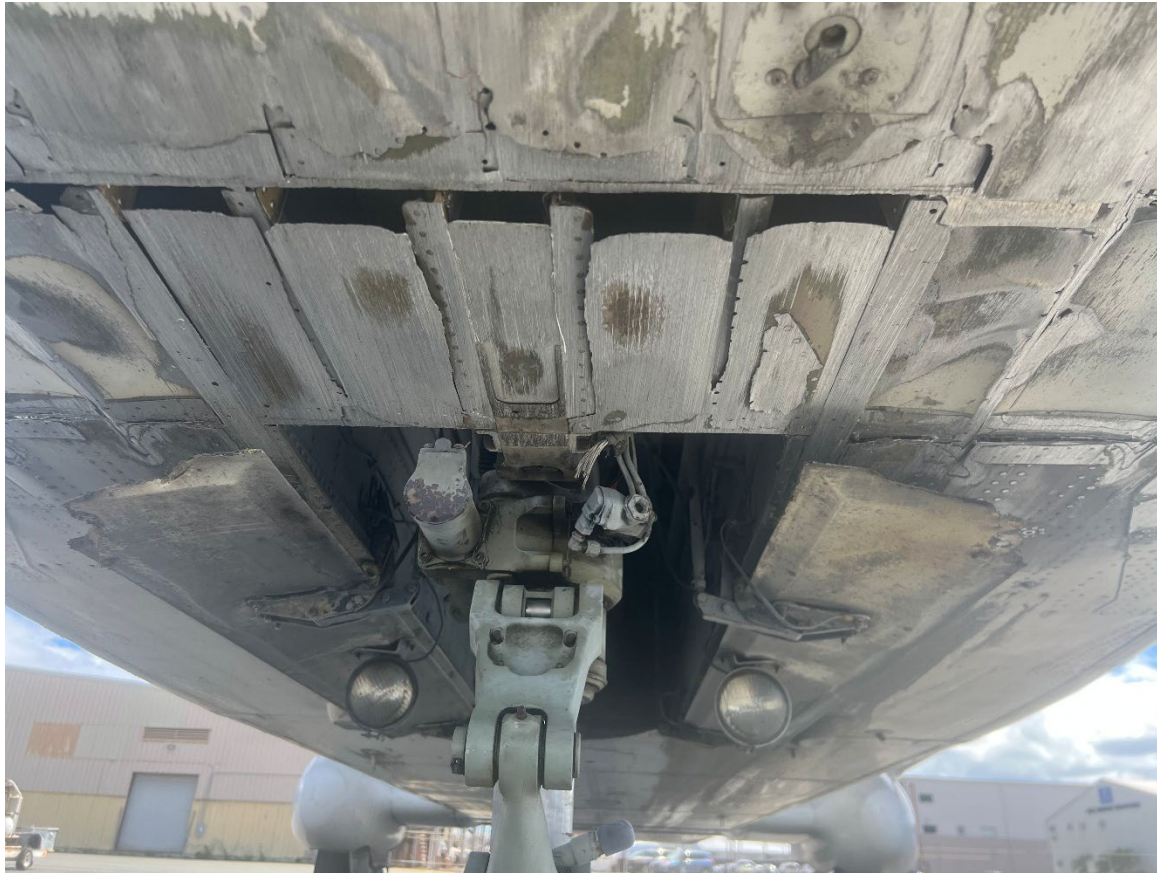
**Photograph 2 - Image of damage to belly of airplane (Courtesy of operator)**
