ANC25LA057

## INVESTIGATION PHOTOGRAPHS

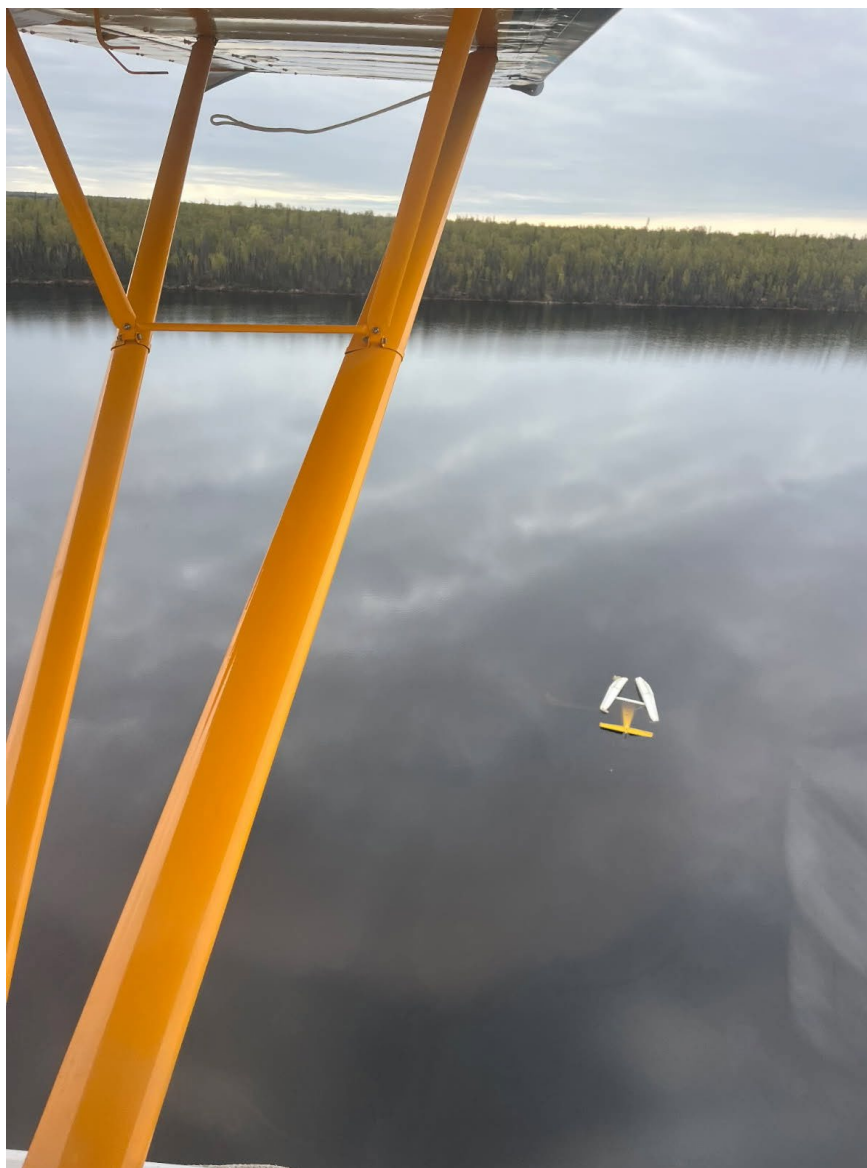
**Photograph 1 - View of airplane where it came to rest (Courtesy of FAA)**

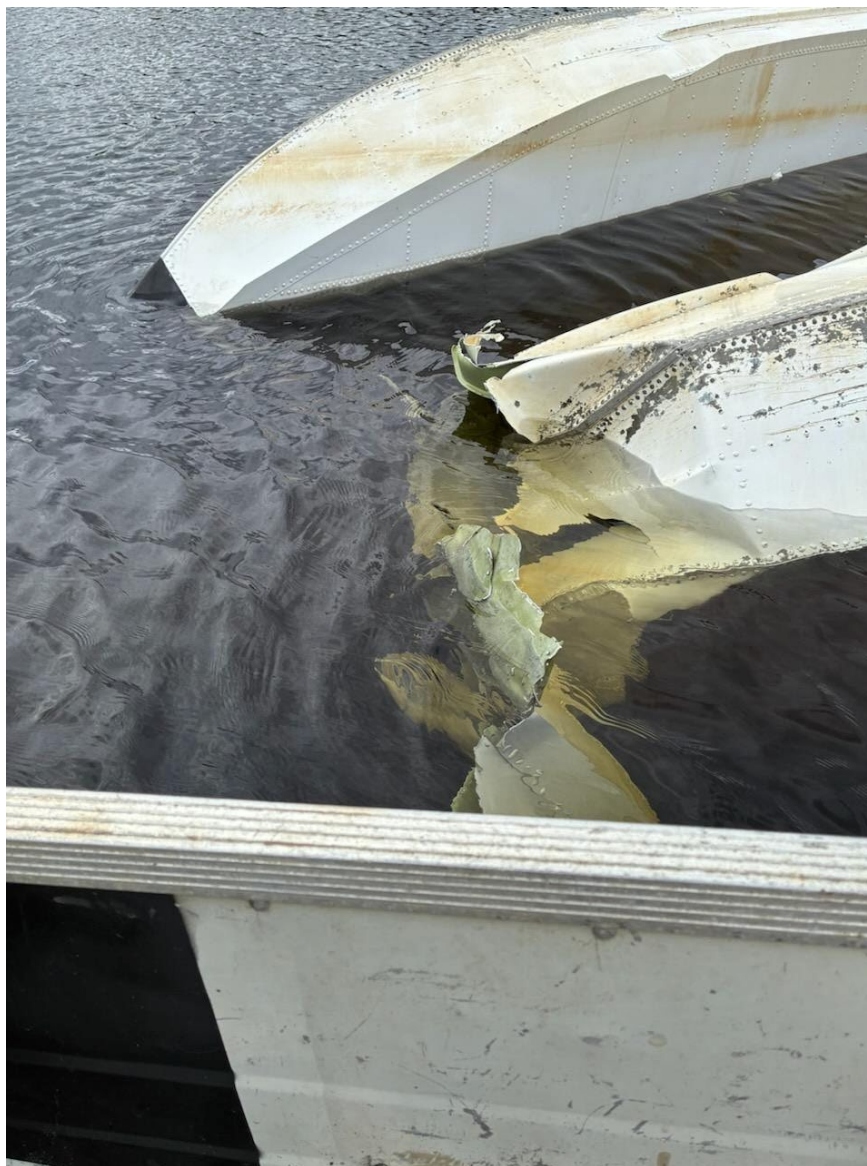
**Photograph 2 - View of damage to the floats (Courtesy of FAA)**

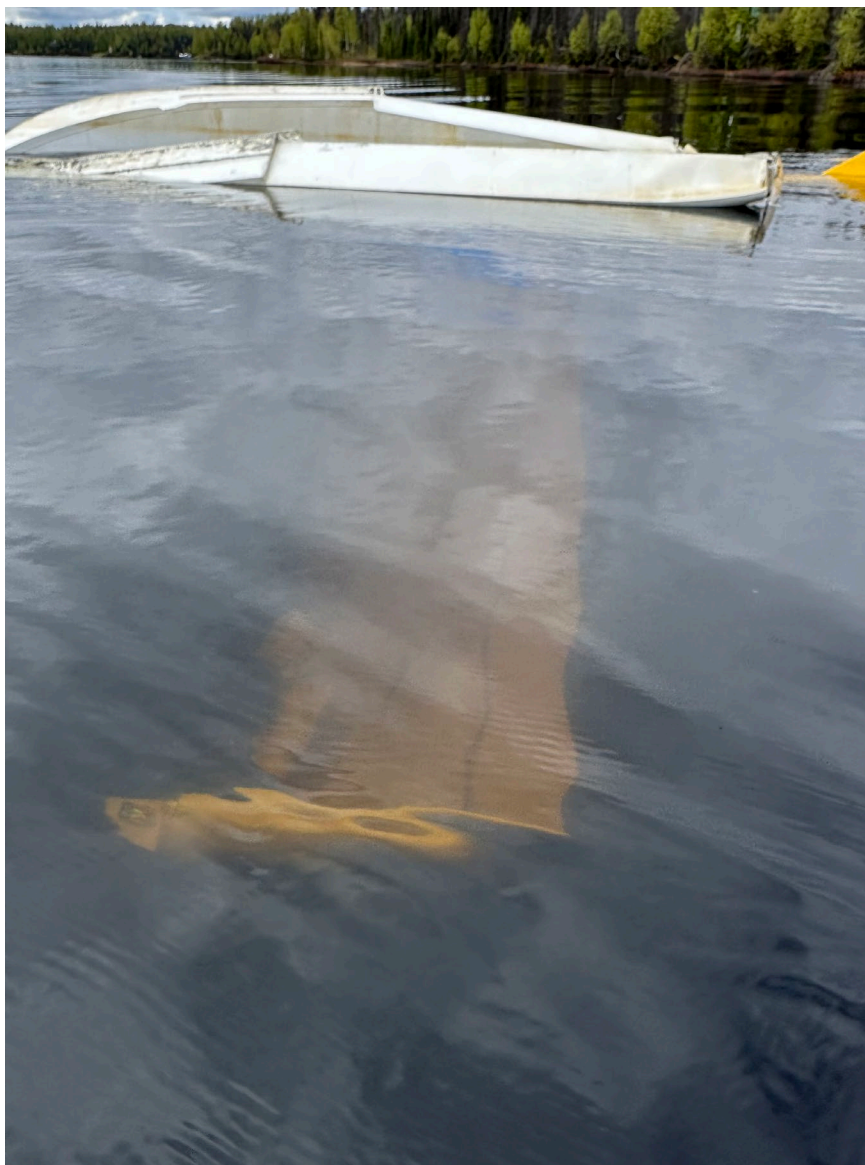
**Photograph 3 - View of the wing underwater (Courtesy of FAA)**
