**From:** [Matthew Fox](#)  
**To:** [Mitchell Rasmussen](#)  
**Subject:** ANC25LA059 - Denali Park, AK - Materials Laboratory Assessment  
**Date:** Monday, July 21, 2025 4:11:21 AM  
**Attachments:** [Fracture assessment.pdf](#)  
[image003.png](#)

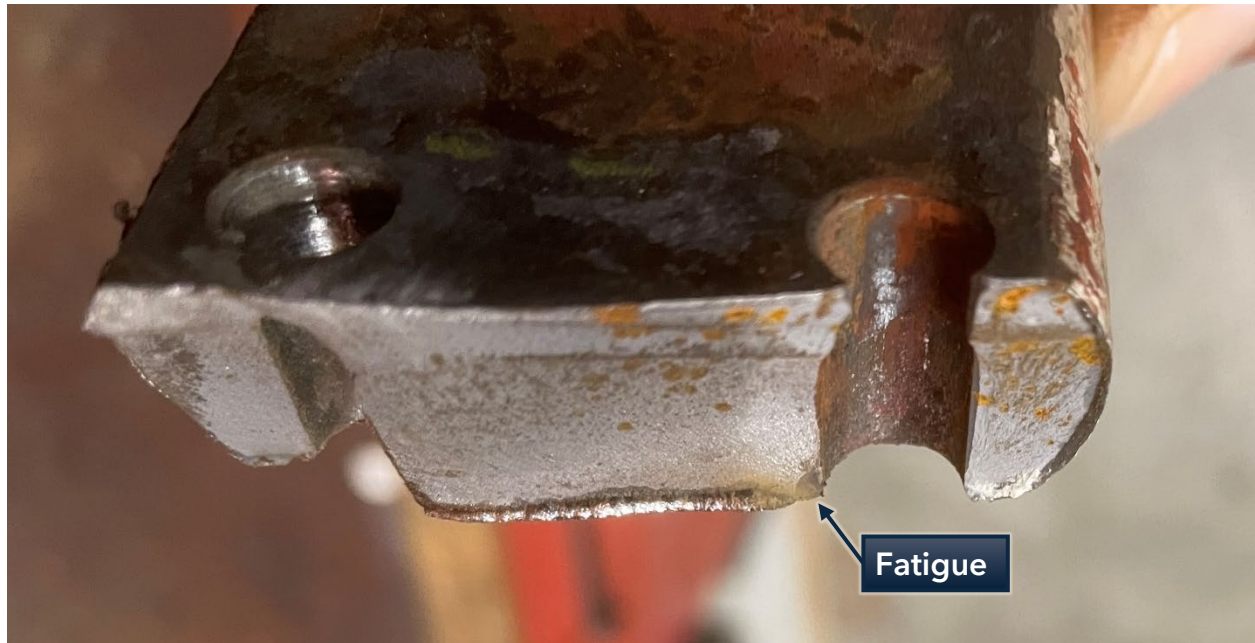
The submitted photos of the fractured left main landing gear (MLG) spring from the subject investigation were reviewed. As indicated in the attached document that contains two of those images, a small black region with a curving boundary was observed, features consistent with fatigue fracture of an MLG spring. The fatigue initiated at the aft side of the upper forward axle attachment hole where the hole intersected the inboard surface. The hole bore and inboard surface were covered in red and orange oxides. It is likely that fatigue initiated due to corrosion damage to the MLG spring surfaces.

**Figure 1.** Fatigue crack at the inboard corner of the forward hole (Photo by owner).

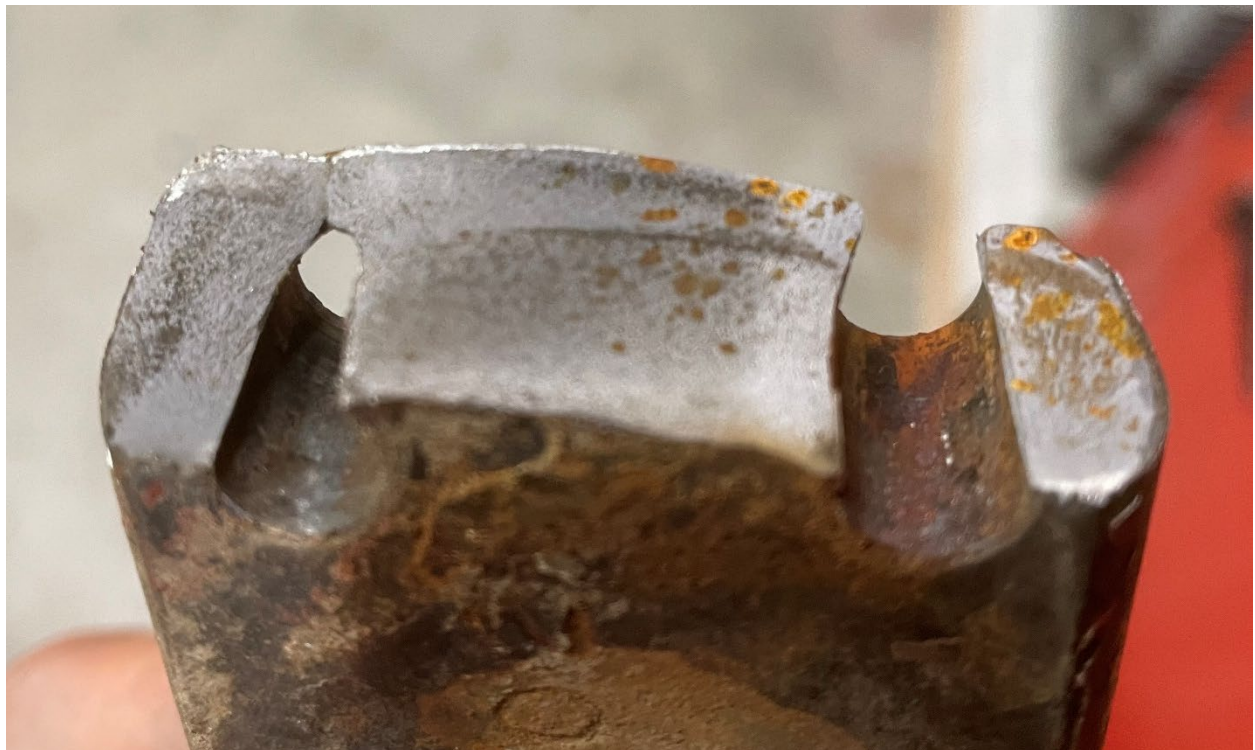
**Figure 2.** Corrosion on the inboard surface and in the forward hole (Photo by owner).
