ANC25LA059

## INVESTIGATION PHOTOGRAPHS

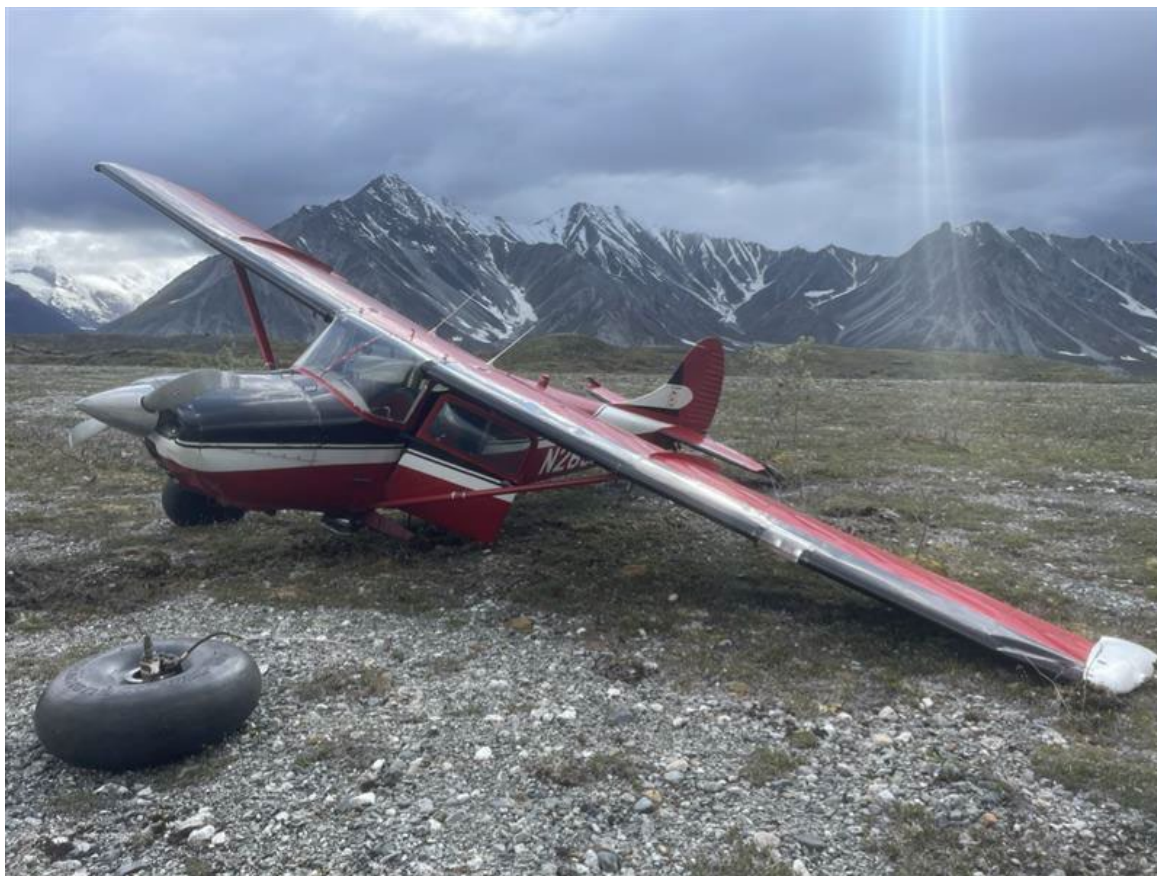
**Photograph 1 - Image of wings, fuselage, and empennage (Courtesy of Owner)**

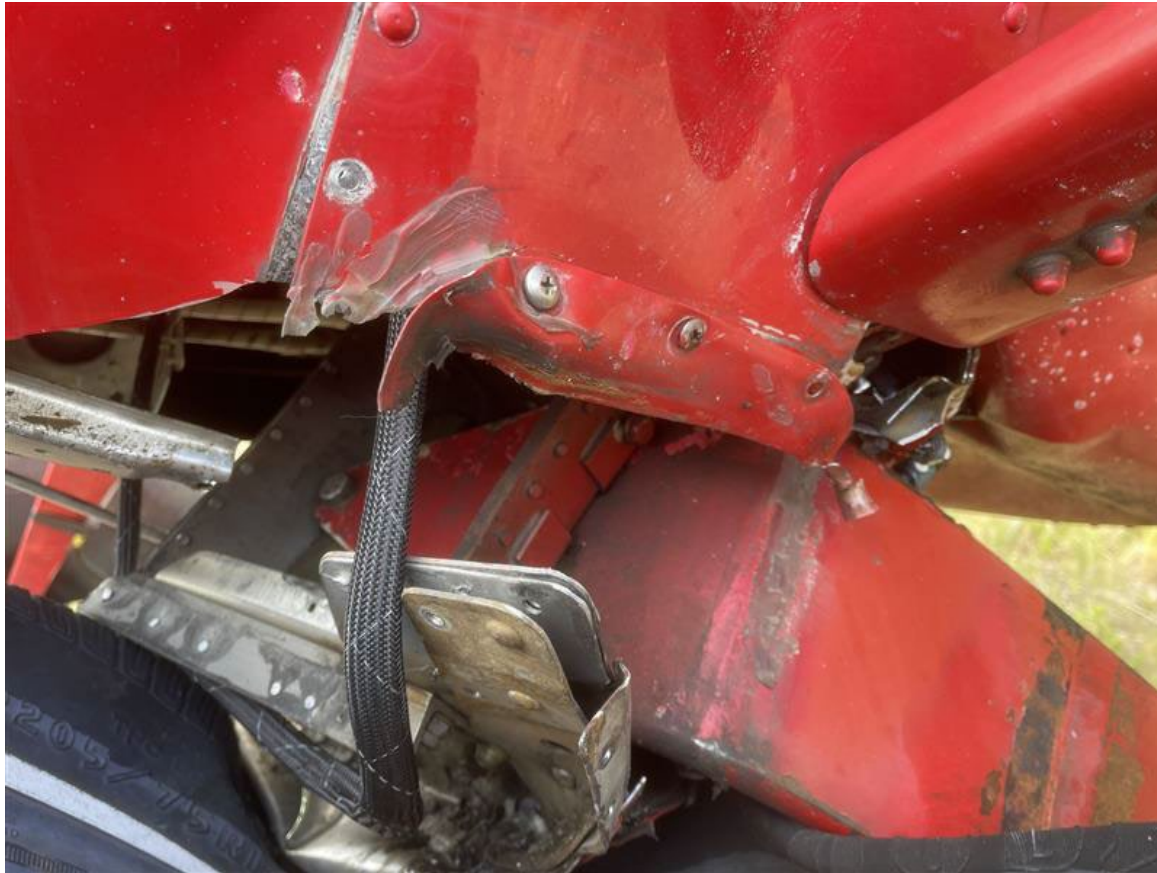
**Photograph 2 - Main landing gear spring to fuselage attach point (Courtesy of Owner)**

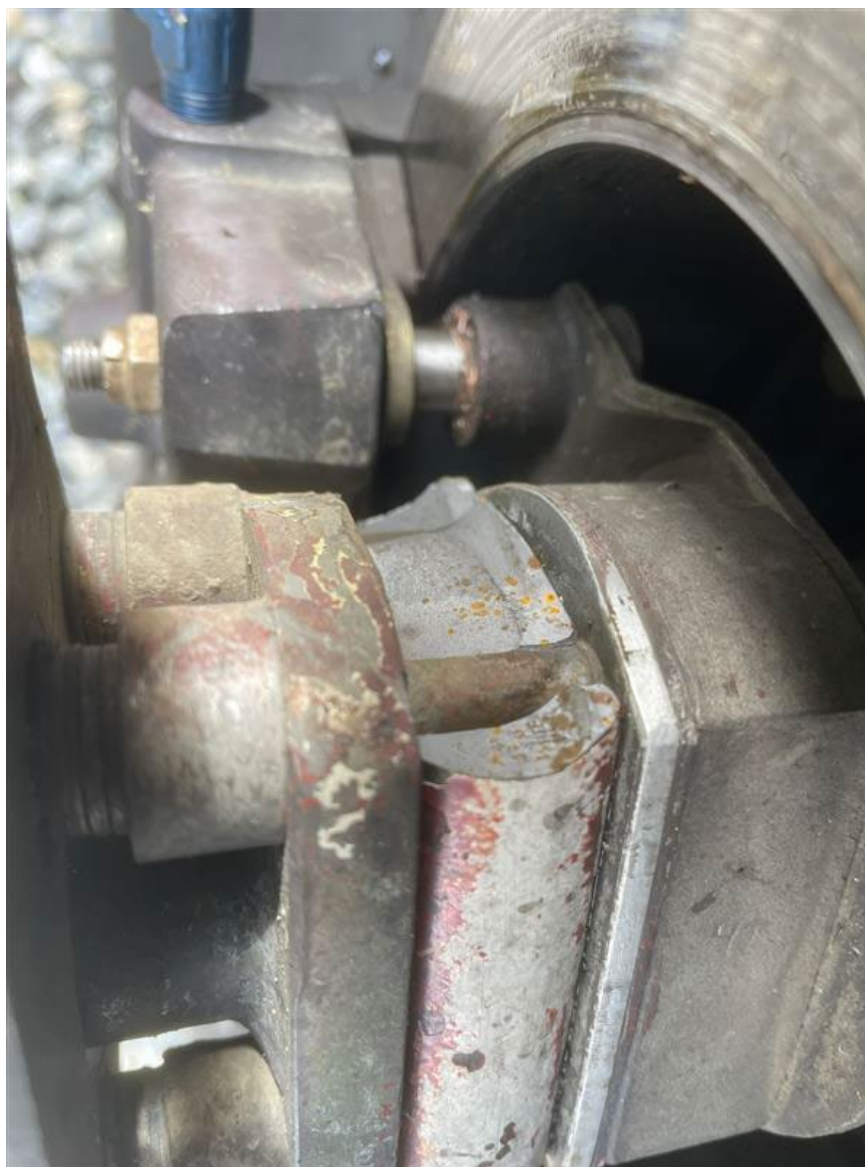
**Photograph 3 - Fractured main landing gear spring attached to wheel axle (Courtesy of Owner)**
