ANC25LA068

## INVESTIGATION PHOTOGRAPHS

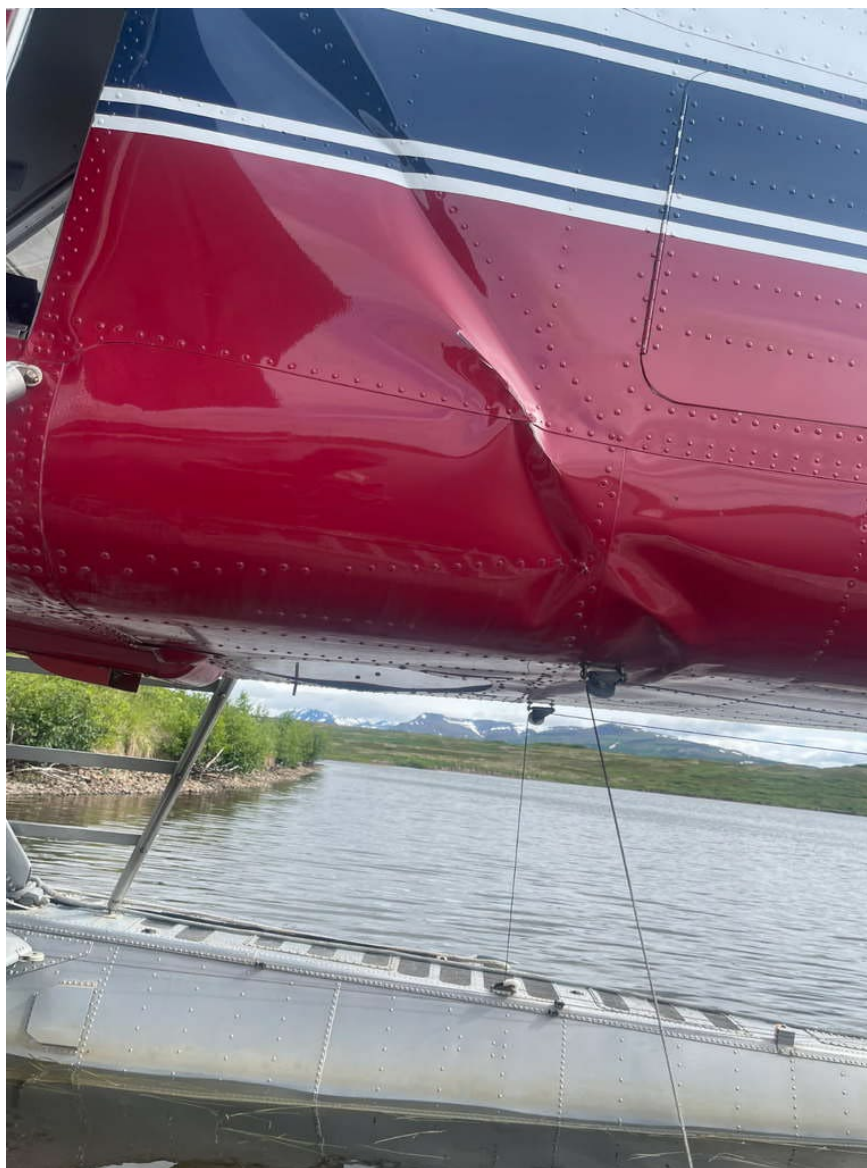
**Photograph 1 - Image of damage to fuselage (Courtesy of Owner)**

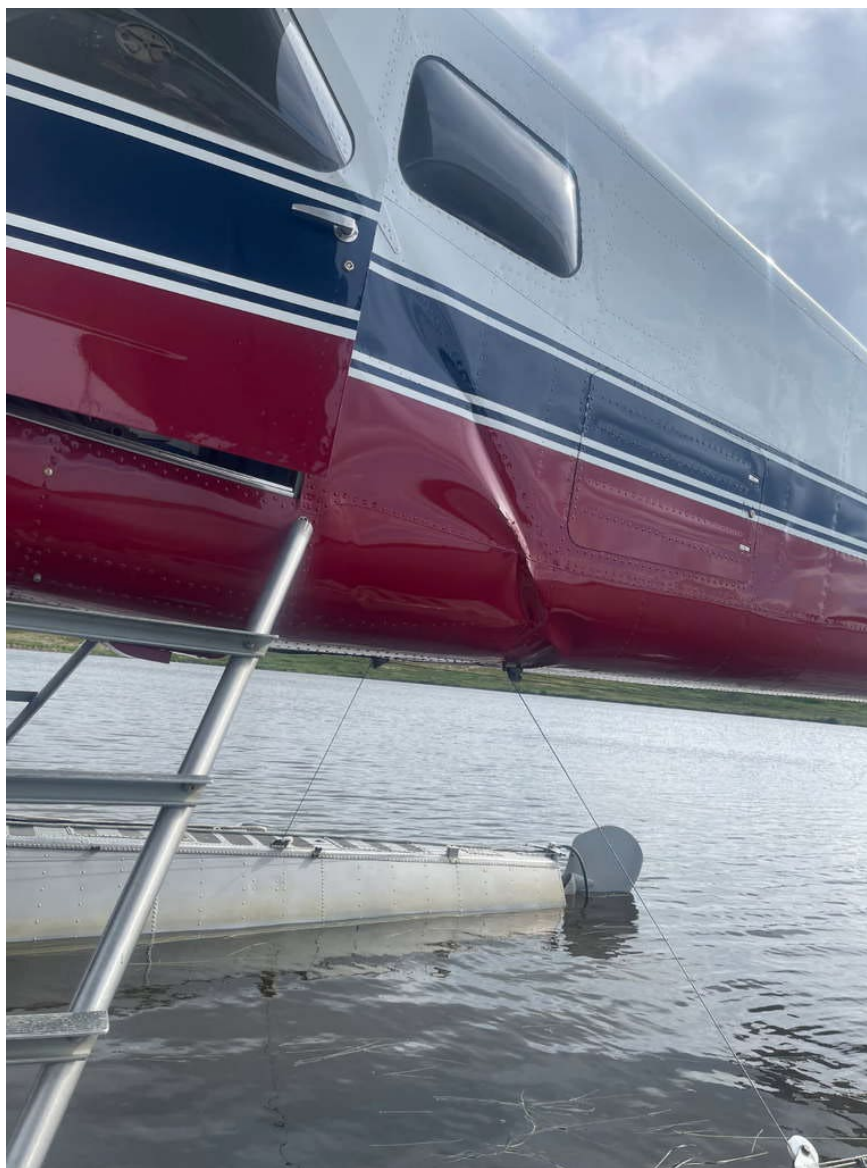
**Photograph 2 - Image of damage to airplane fuselage (Courtesy of Owner)**
