ANC25LA070

## INVESTIGATION PHOTOGRAPHS

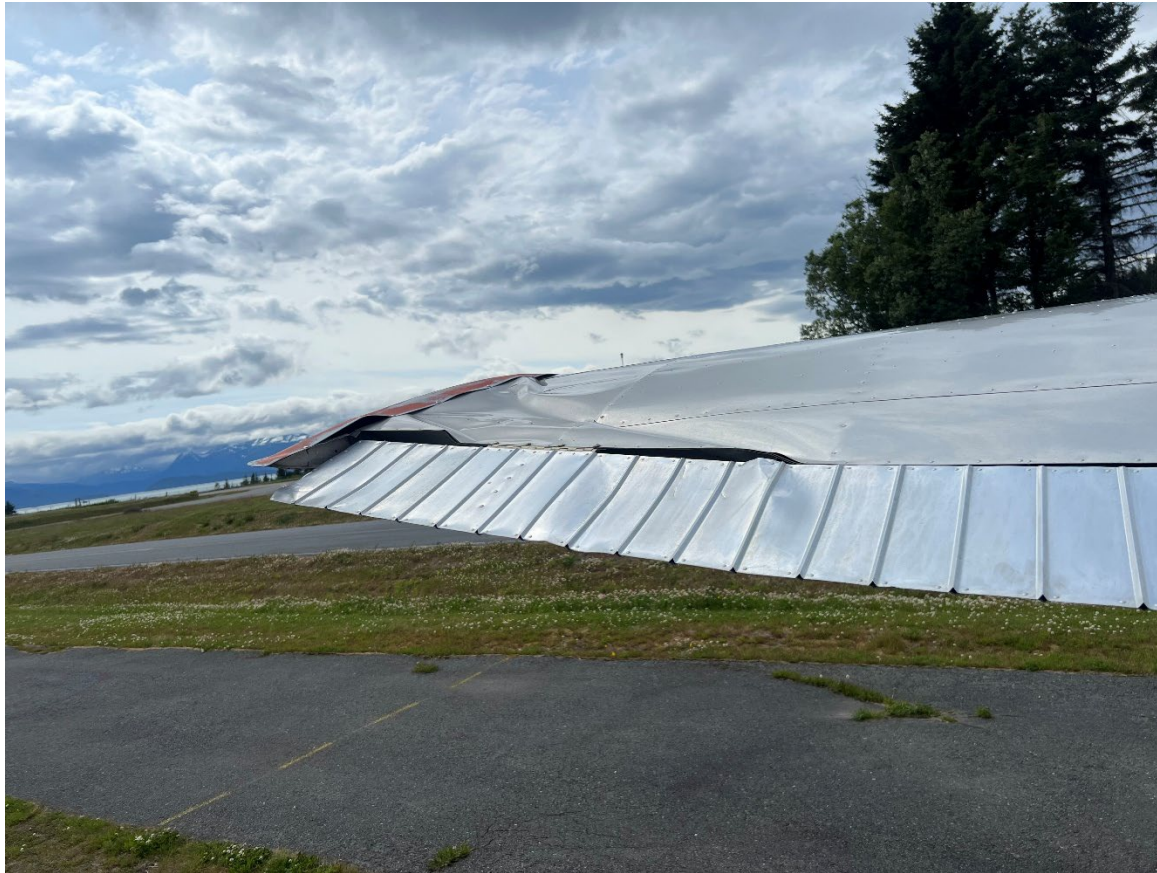
**Photograph 1 - Image of damage to left wing (Courtesy of Owner)**

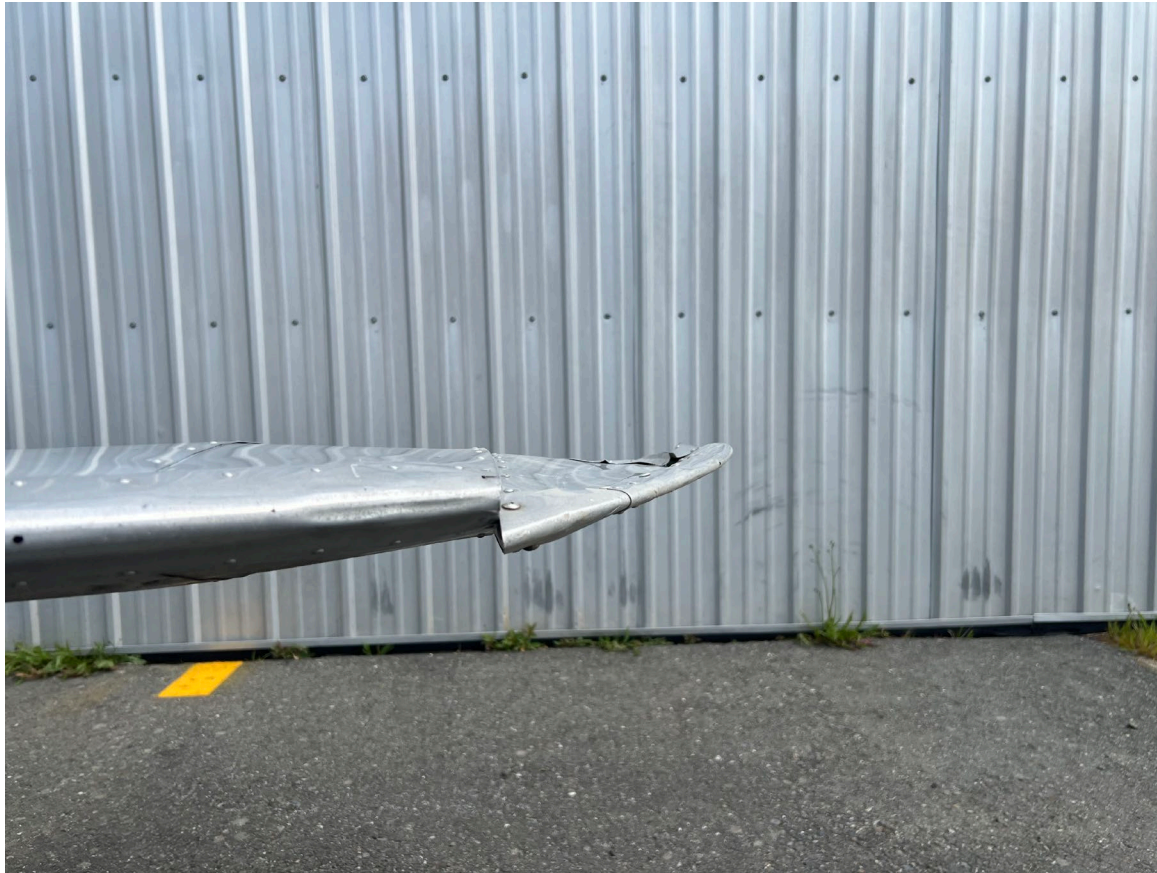
**Photograph 2 - Image of damage to right wing tip (Courtesy of Owner)**

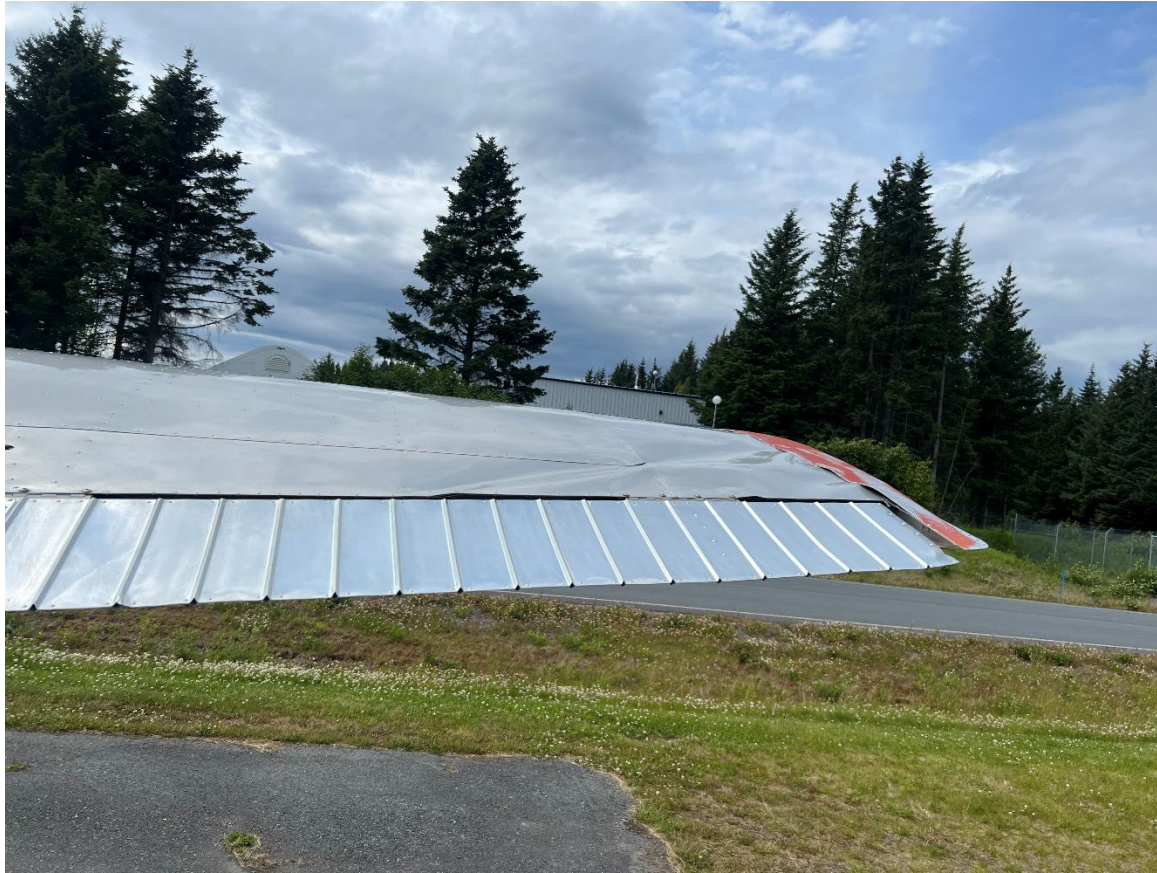
**Photograph 3 - Image of damage to right wing (Courtesy of Owner)**
