ANC25LA071

## INVESTIGATION PHOTOGRAPHS

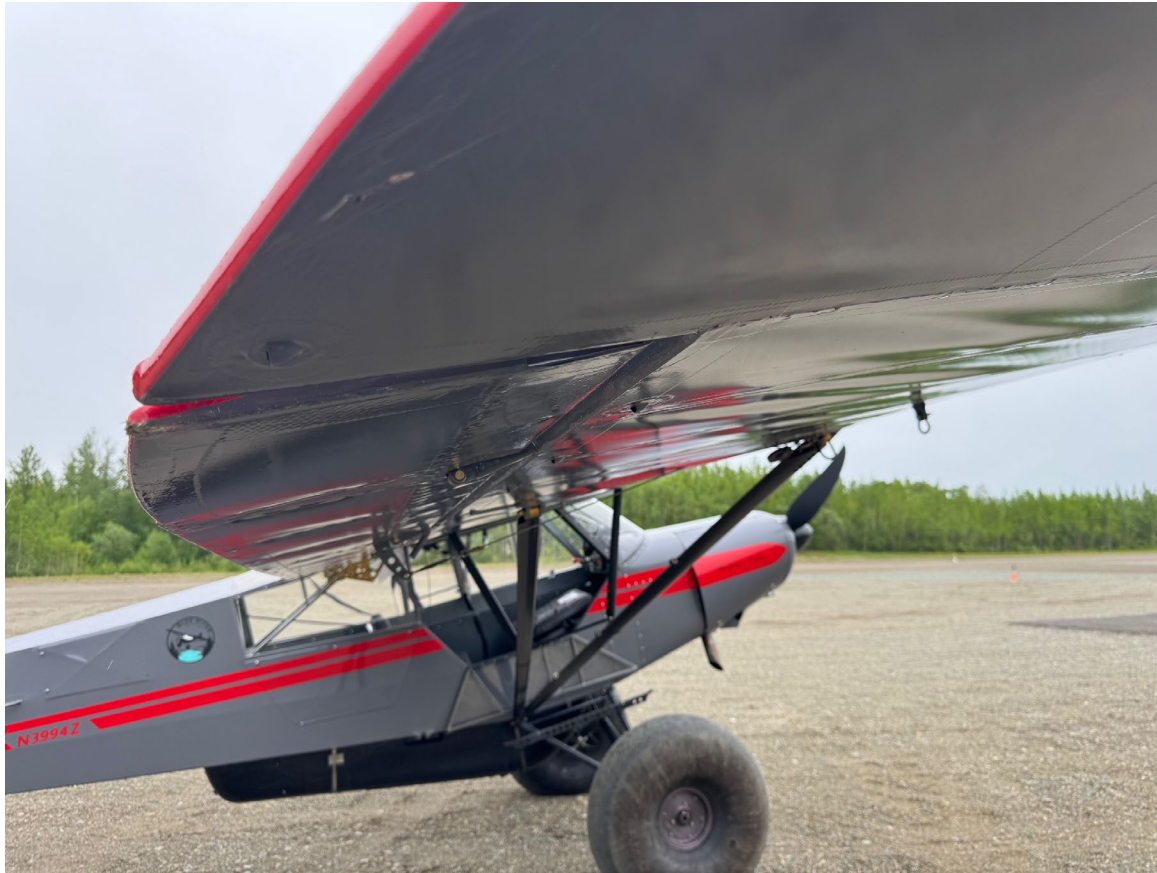
**Photograph 1 - View of bottom of right wing and right side of fuselage (Courtesy of pilot)**

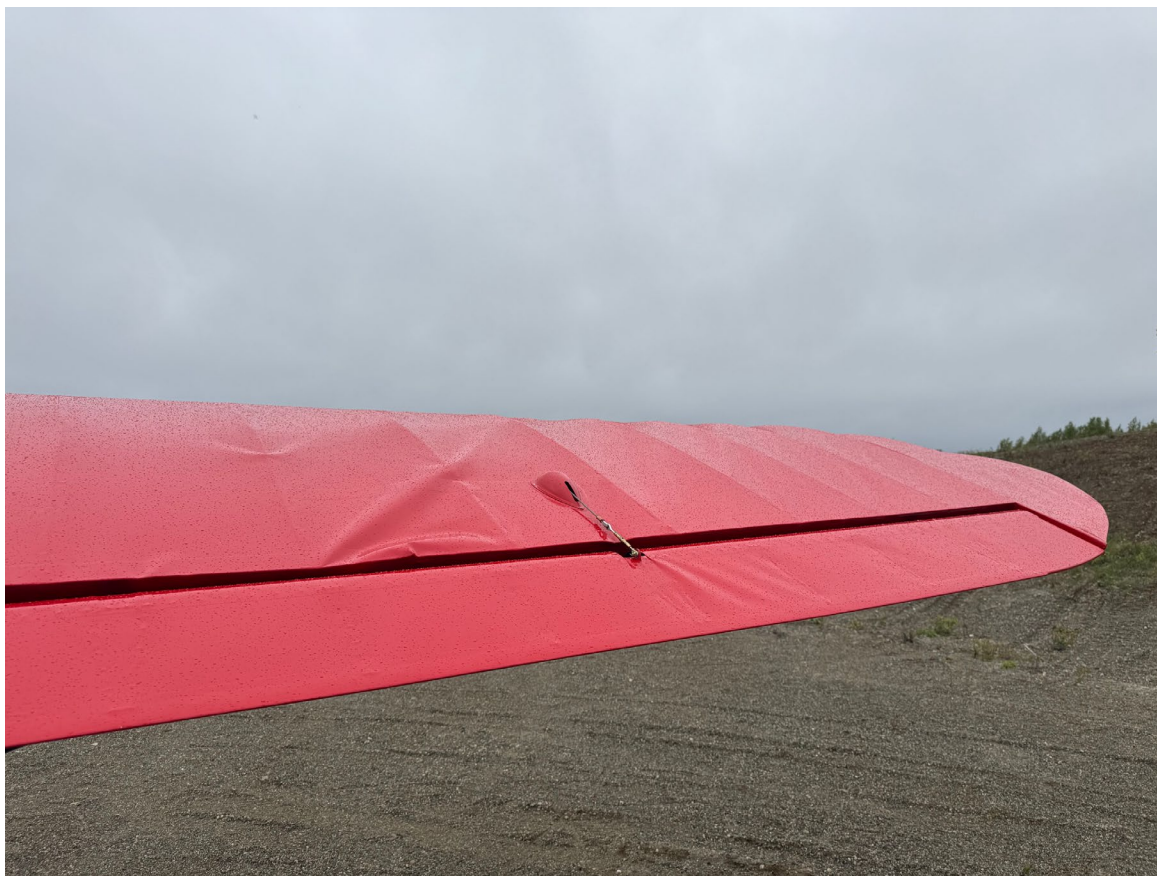
**Photograph 2 - View of damage to the top of the right wing. (Courtesy of pilot)**
