ANC25LA076

## INVESTIGATION PHOTOGRAPHS

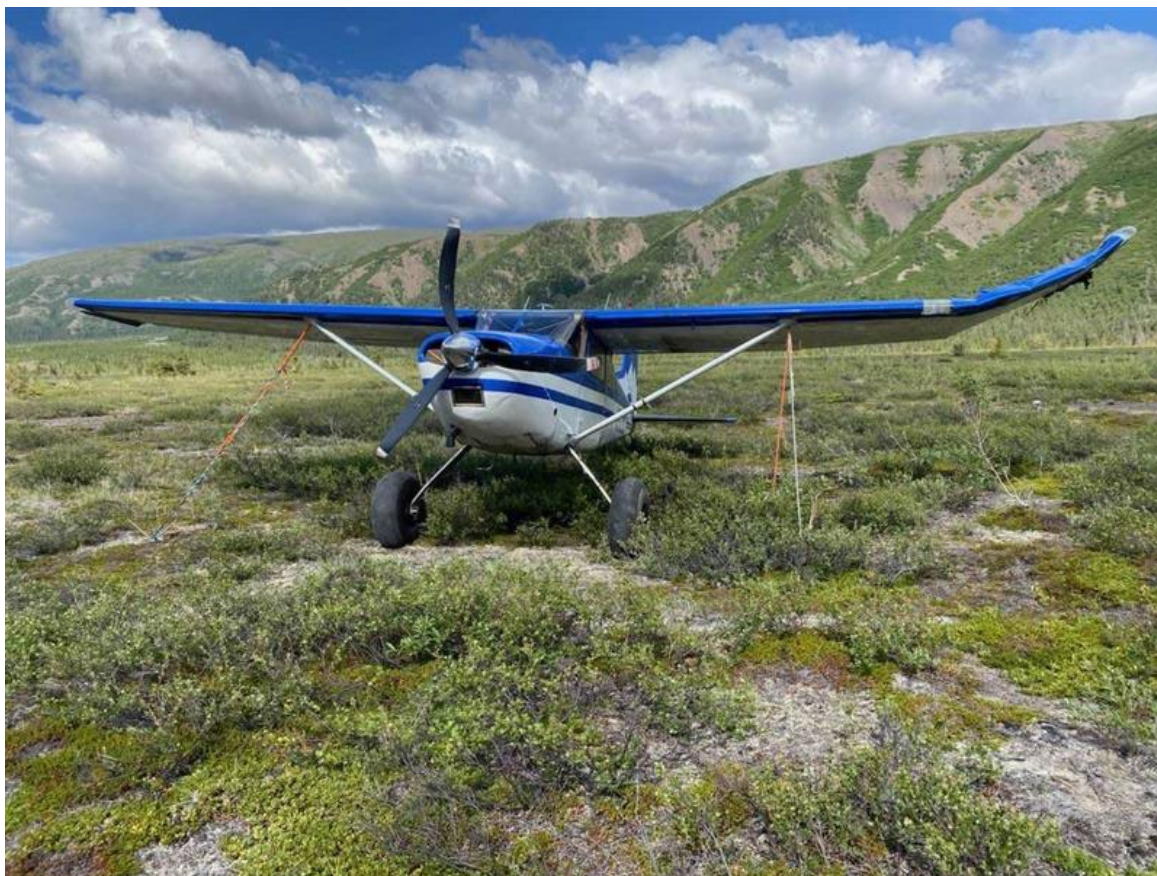
**Photograph 1 - View of the airplane and damage to left wing. (Courtesy of operator)**

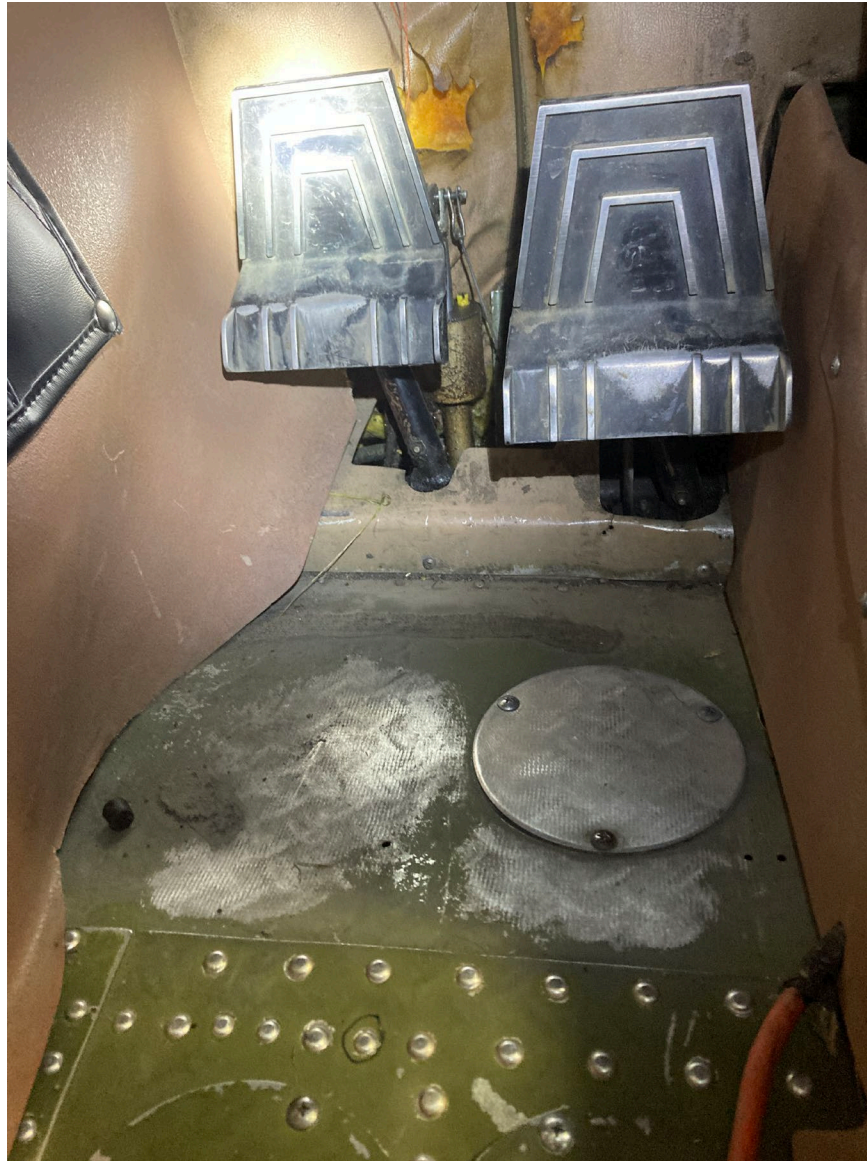
**Photograph 2 - View of left and right rudder pedals. (Courtesy of FAA)**

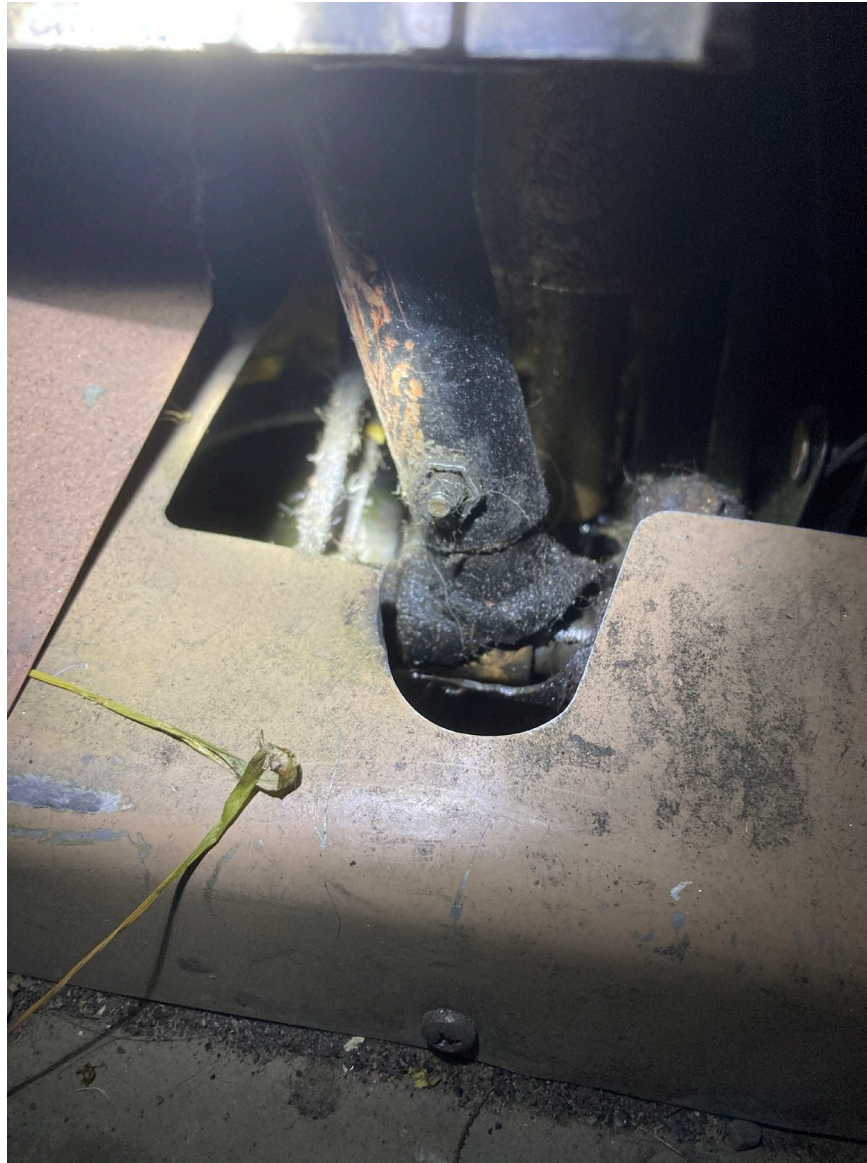
**Photograph 3 - View of the failure of the left rudder assembly (Courtesy of FAA)**
