ANC25LA083

## INVESTIGATION PHOTOGRAPHS

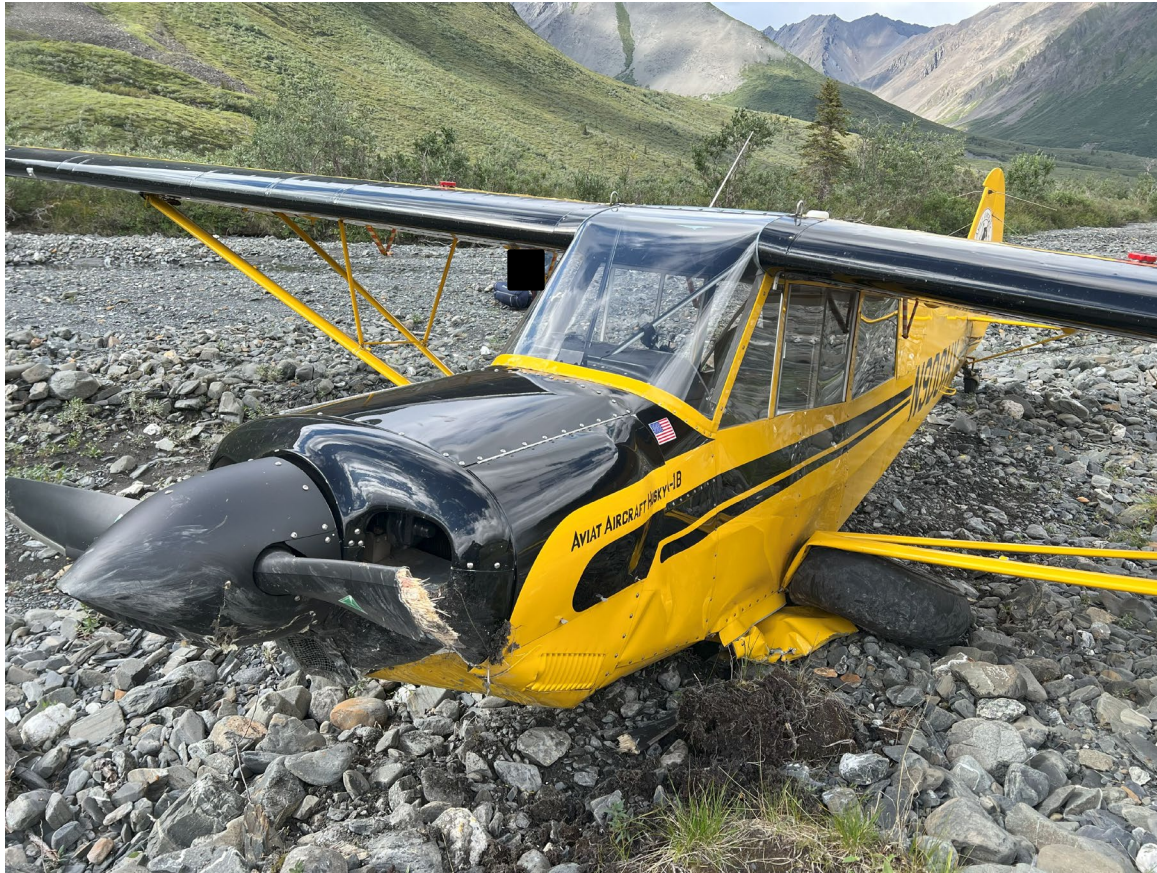
**Photograph 1 - View of accident airplane at accident site (Courtesy of the owner)**

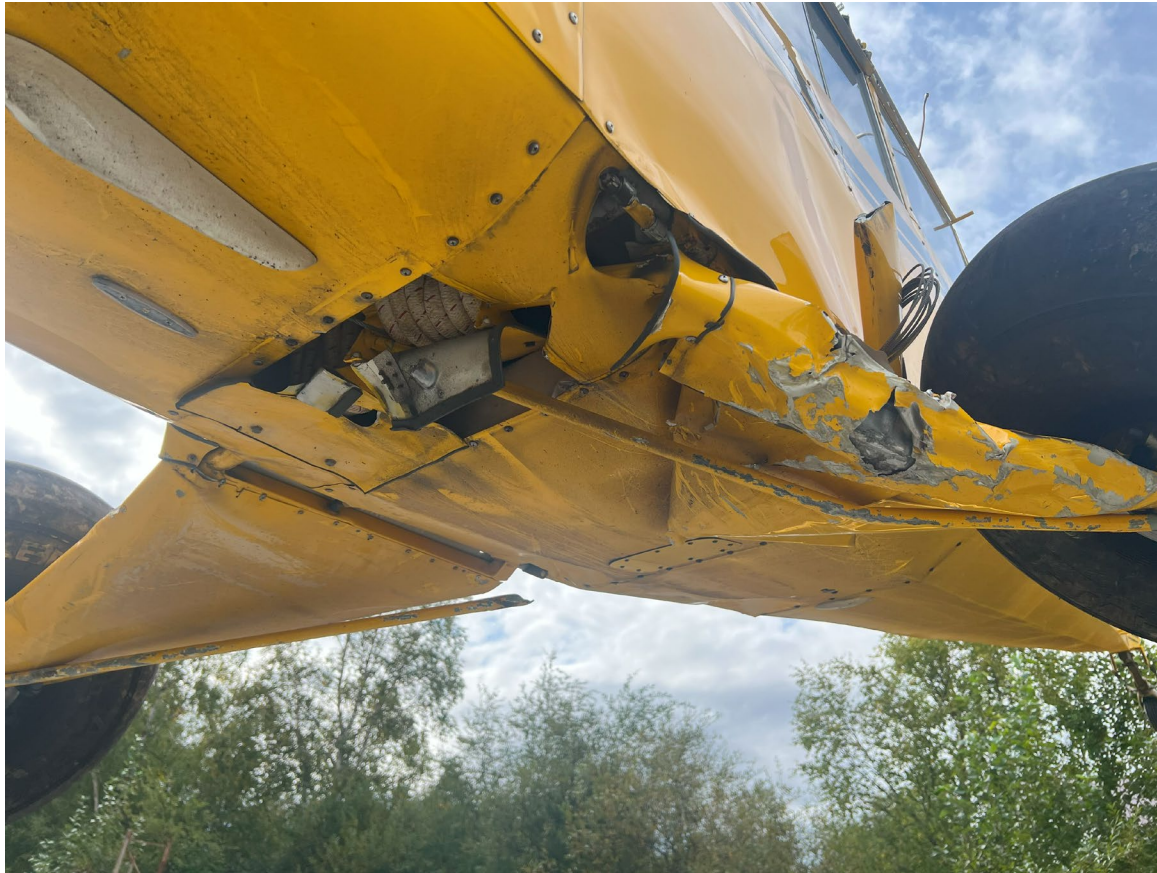
**Photograph 2 - View of landing gear. Bungees still attached, fractures from overload from hard landing.**
