ANC25LA088

## INVESTIGATION PHOTOGRAPHS

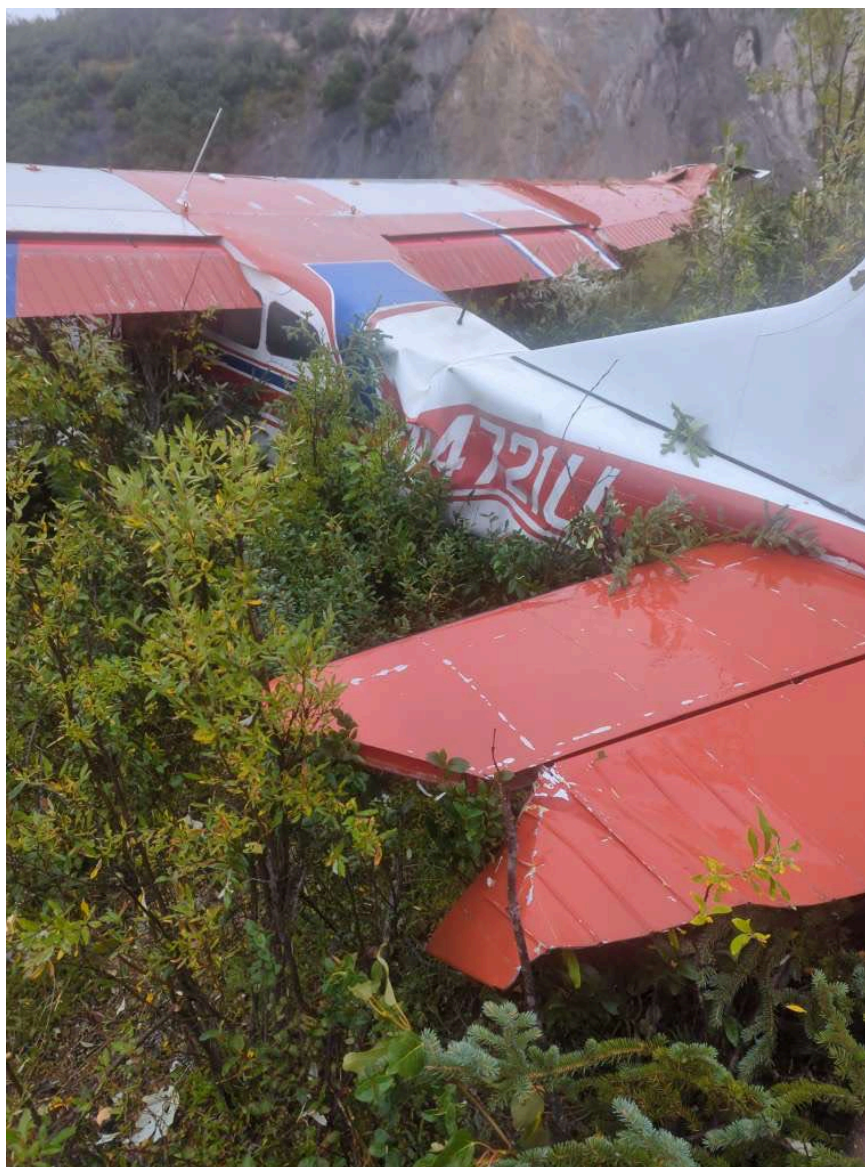
**Photograph 1 - Image of horizontal stabilizer, wings, and fuselage (Courtesy of Owner)**

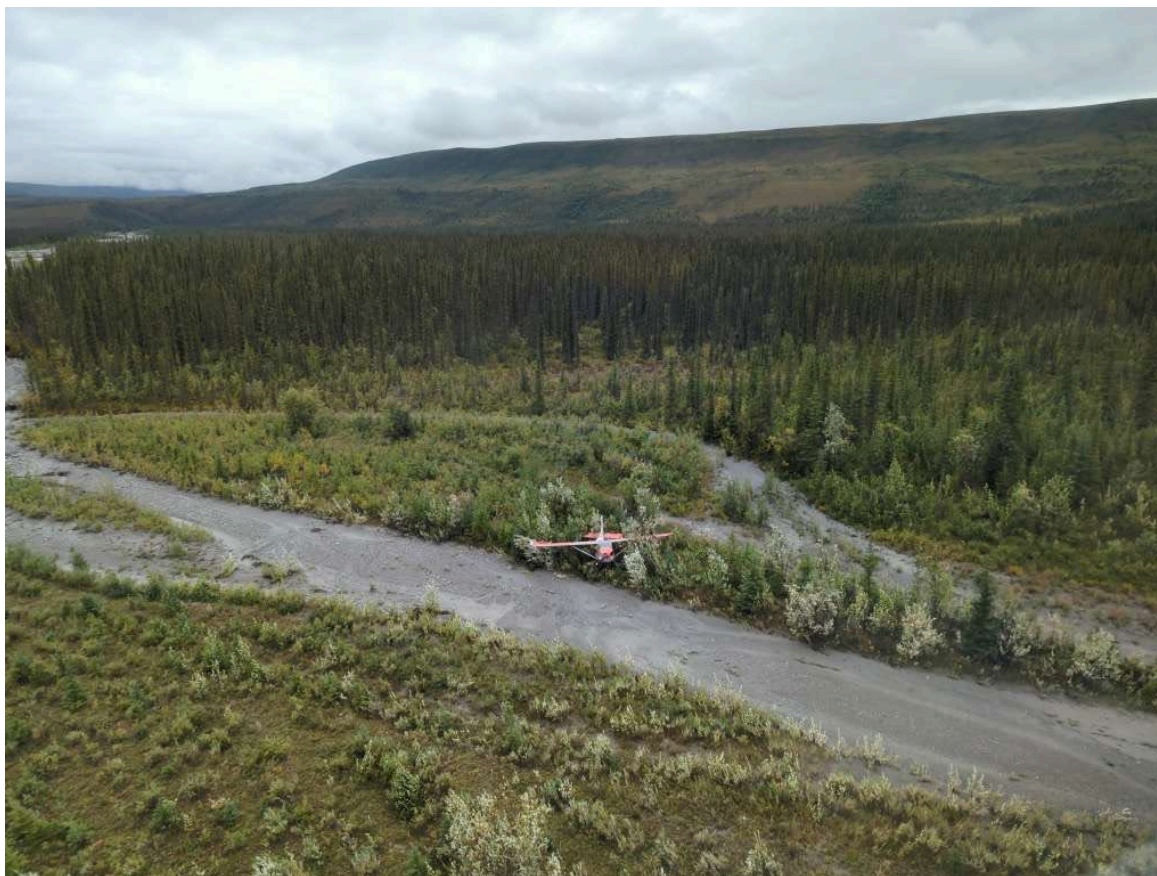
**Photograph 2 - Aerial view of accident airplane (Courtesy of Owner)**

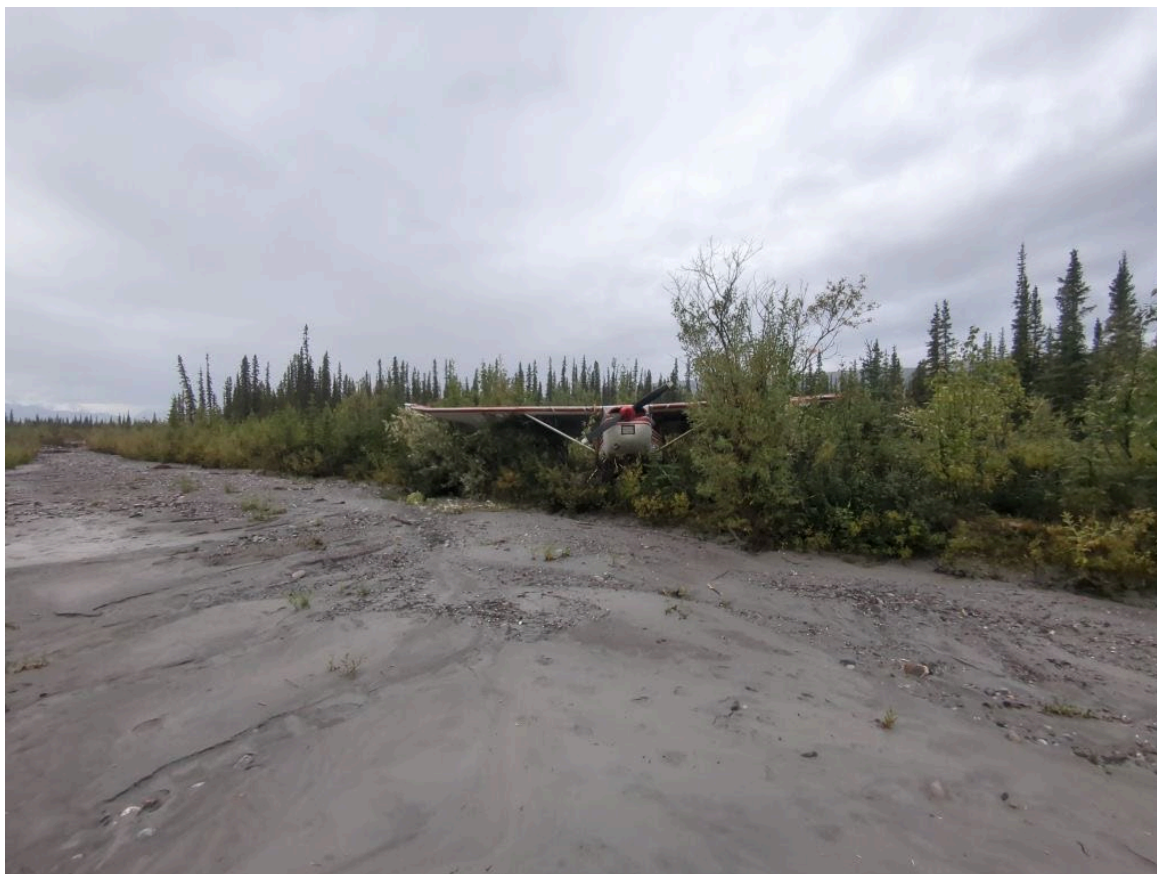
**Photograph 3 - Image of accident airplane at accident site (Courtesy of Owner)**
