ANC25LA101

## INVESTIGATION PHOTOGRAPHS

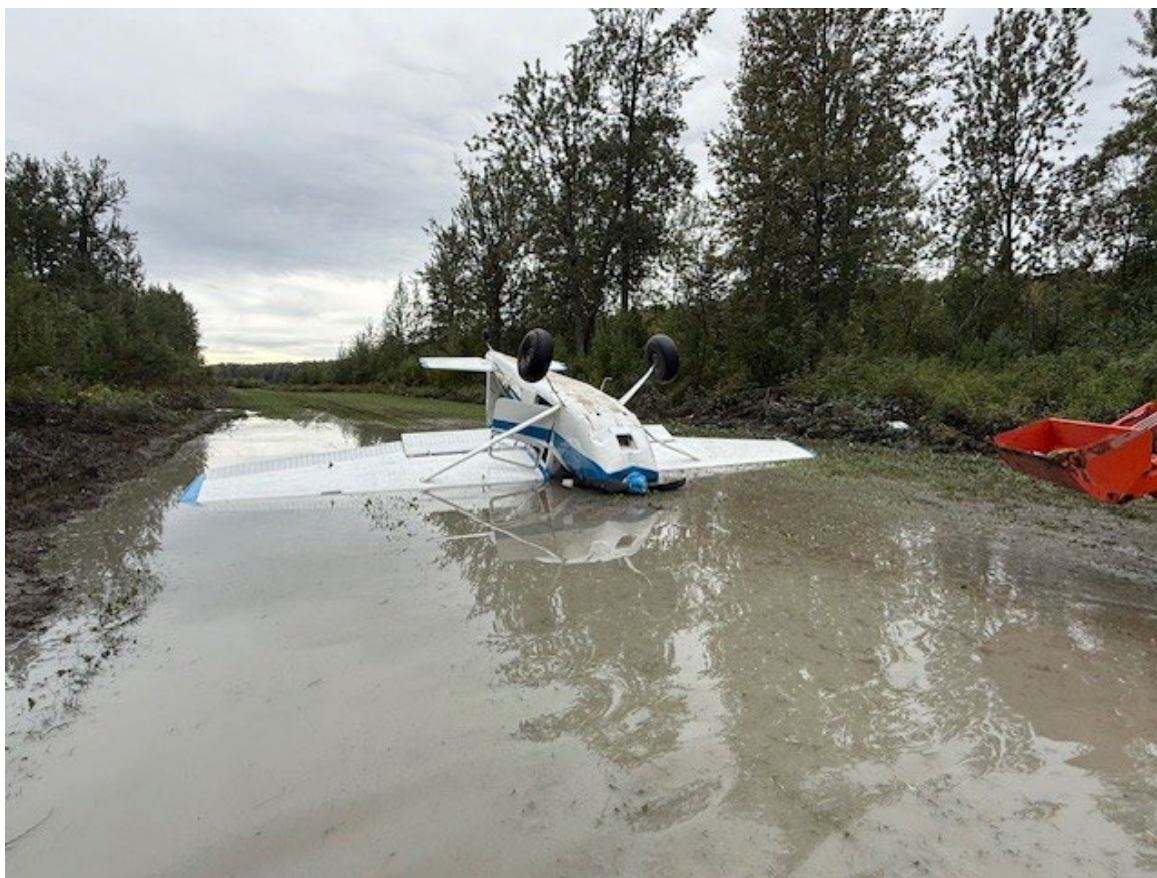
**Photograph 1 - Front view of the accident airplane and condition of the runway (Courtesy of the pilot)**

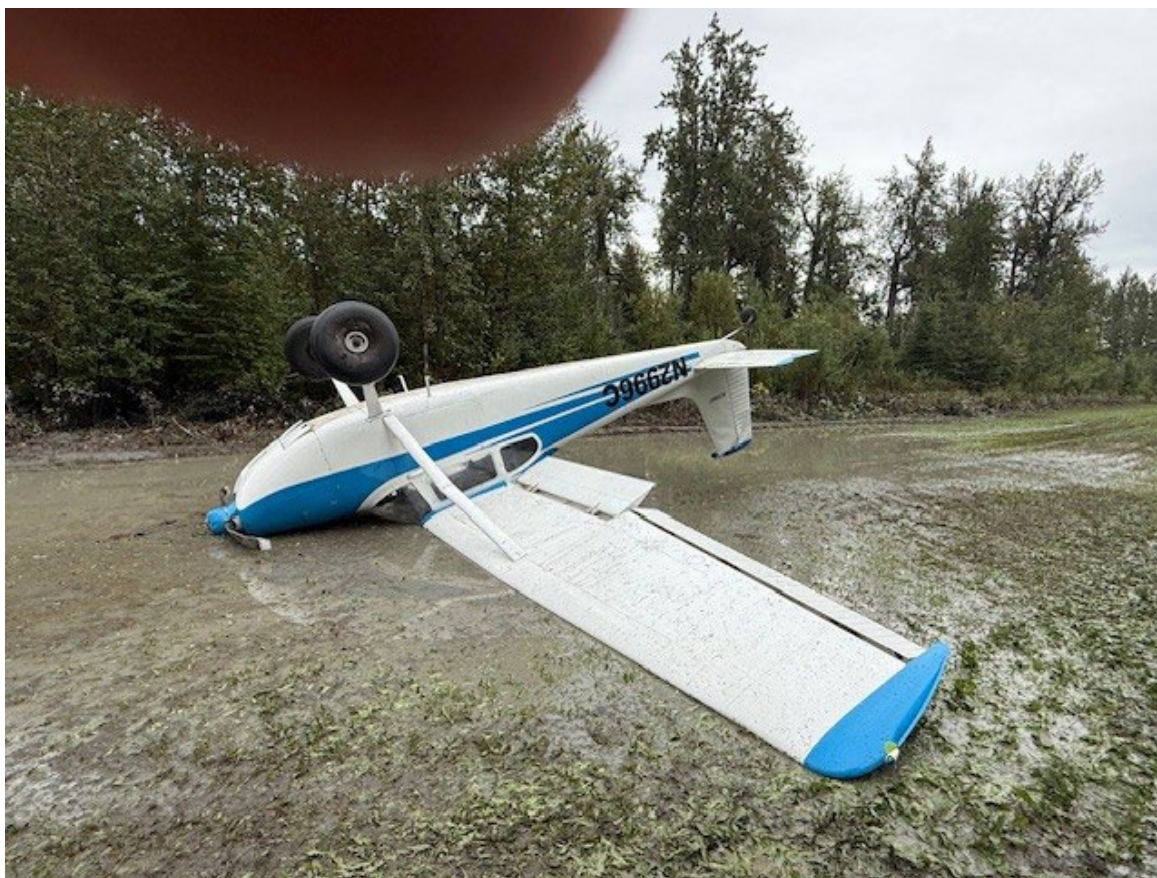
**Photograph 2 - Side view of the accident airplane (Courtesy of the pilot)**

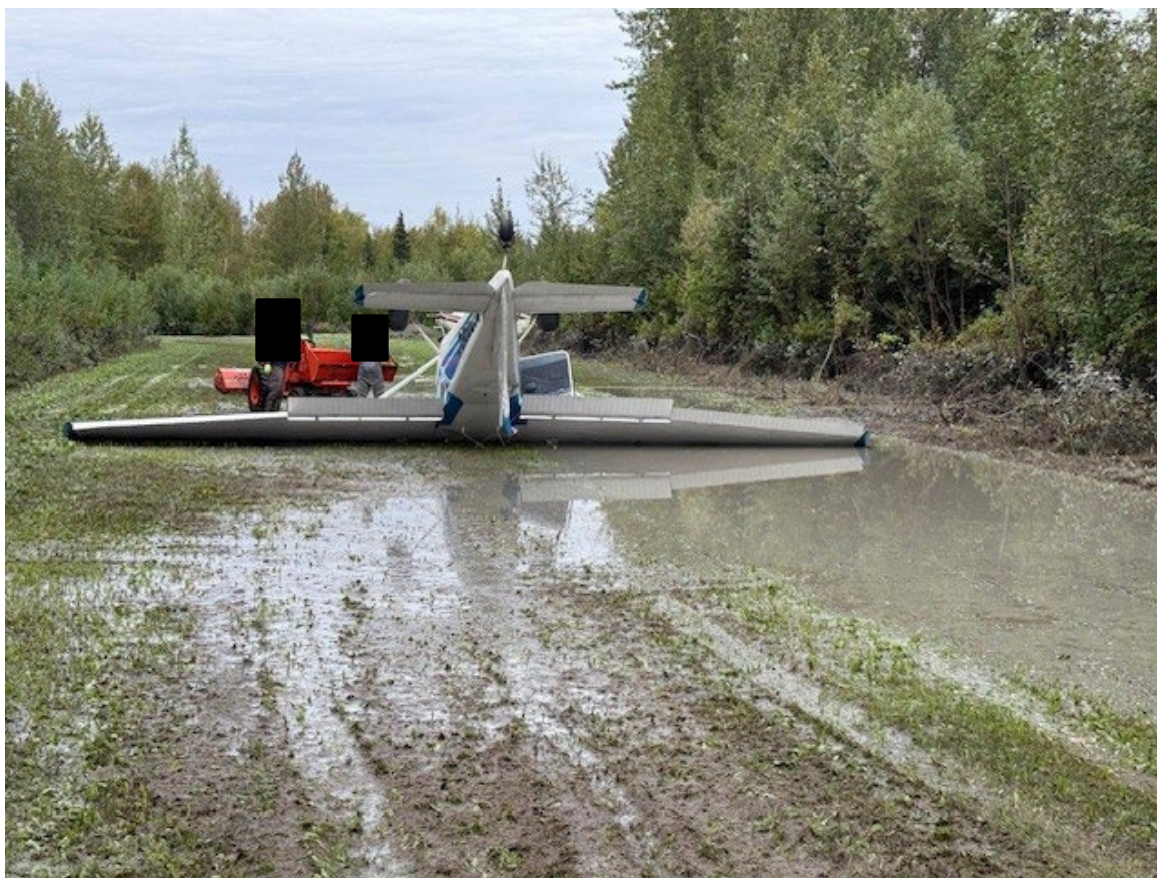
**Photograph 3 - Aft view of the accident airplane (Courtesy of the pilot)**

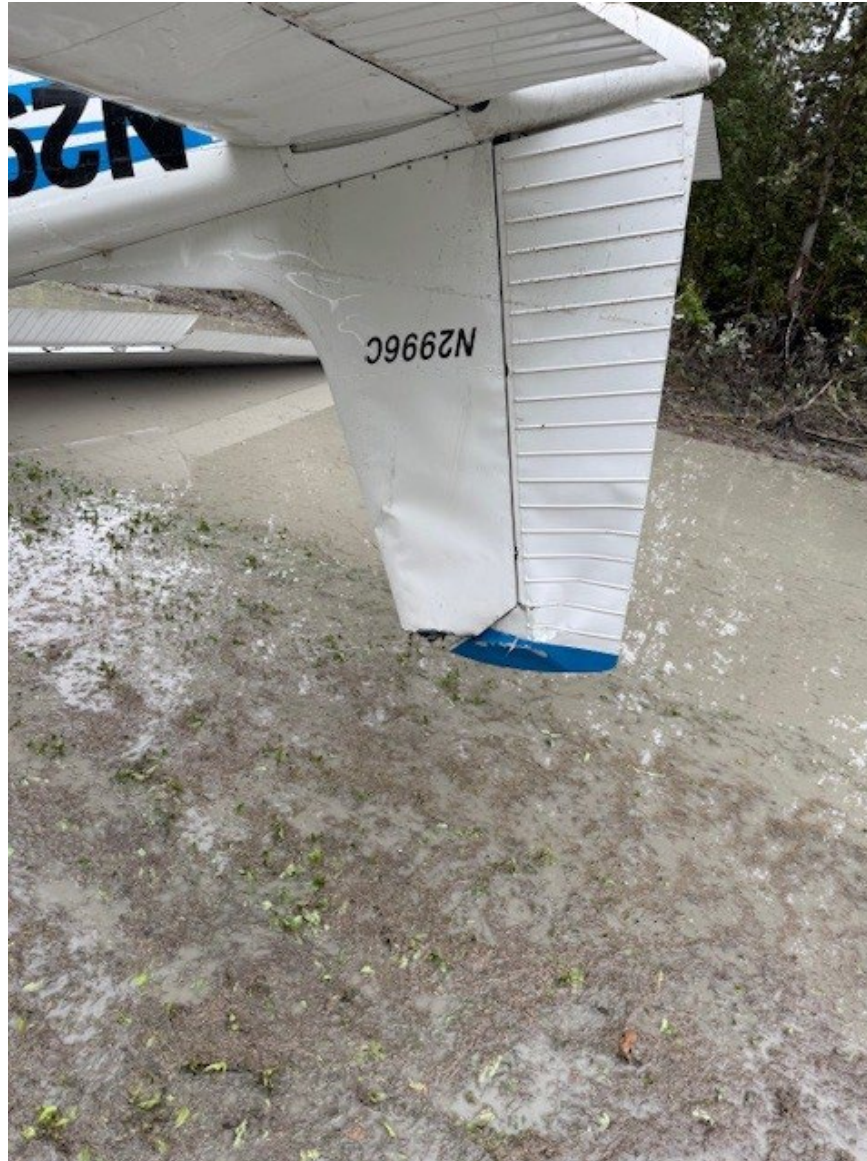
**Photograph 4 - Damage to the vertical stabilizer and rudder (Courtesy of the pilot)**
