ANC25LA108

## INVESTIGATION PHOTOGRAPHS

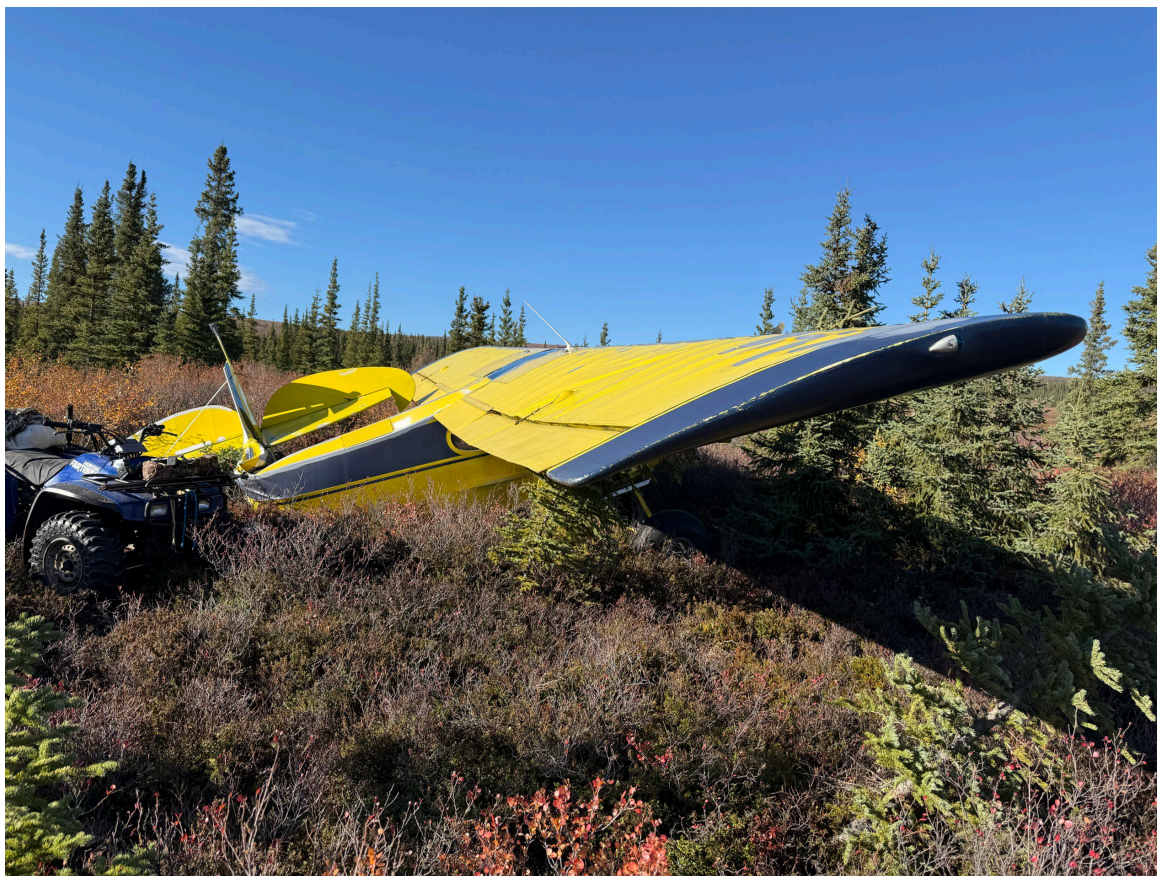
**Photograph 1 - Accident airplane at accident site (Courtesy of Owner)**

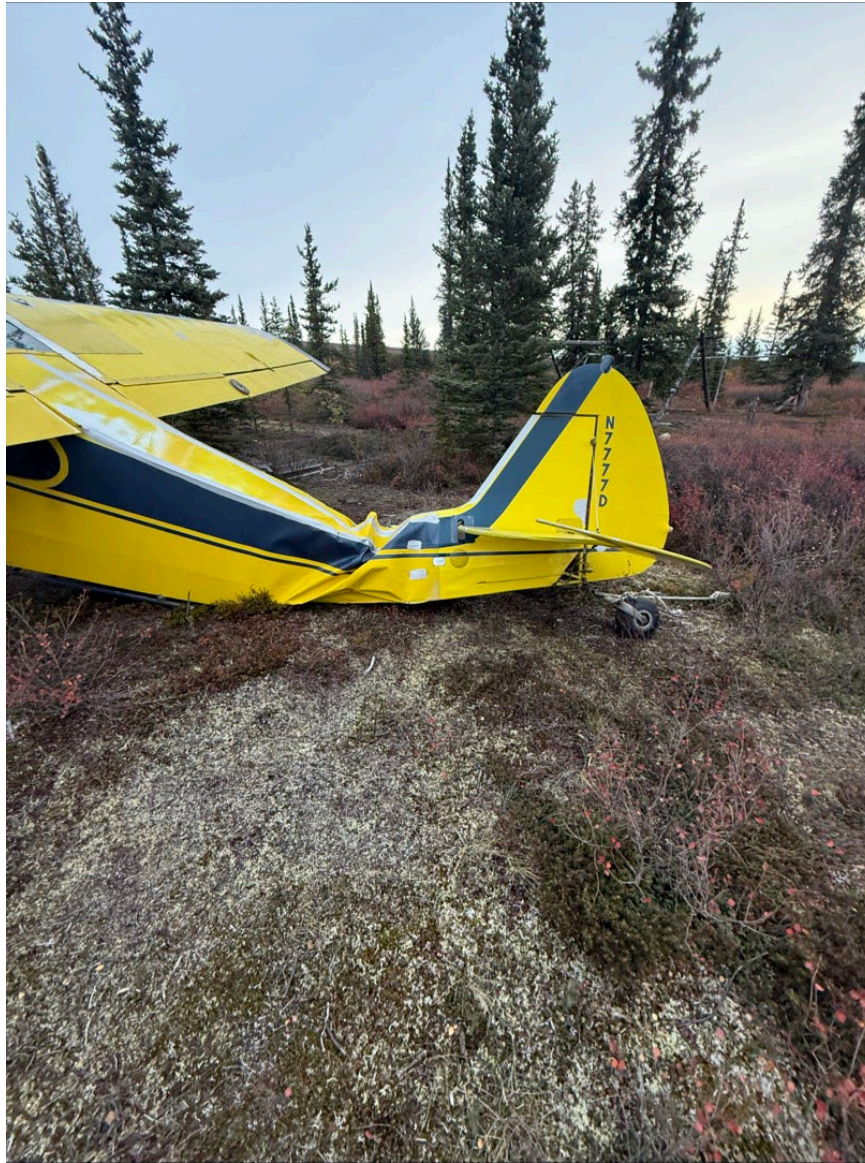
**Photograph 2 - Image of fuselage and empennage (Courtesy of Owner)**
