ANC25LA110

## INVESTIGATION PHOTOGRAPHS

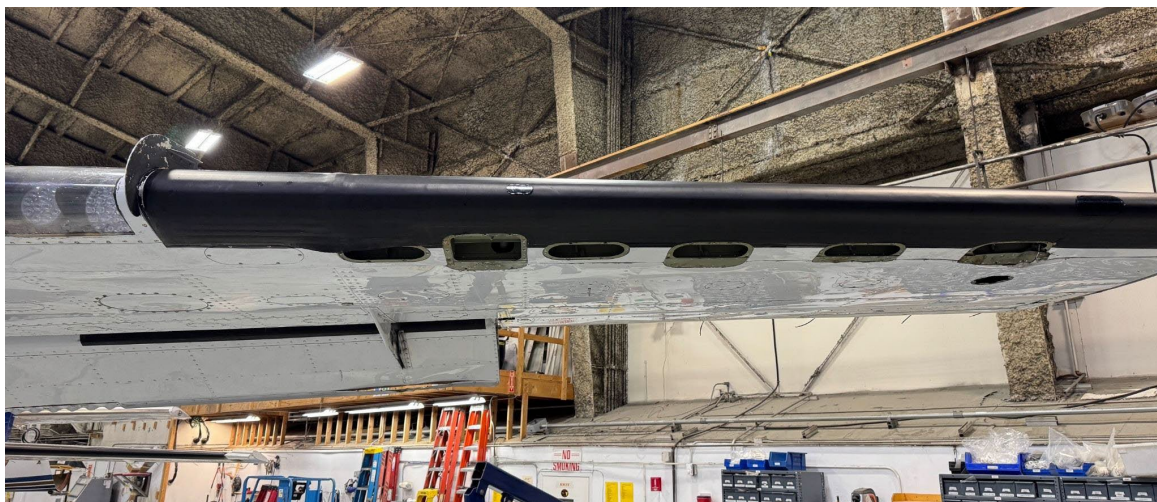
**Photograph 1 - Left wing of accident airplane (Courtesy of operator)**

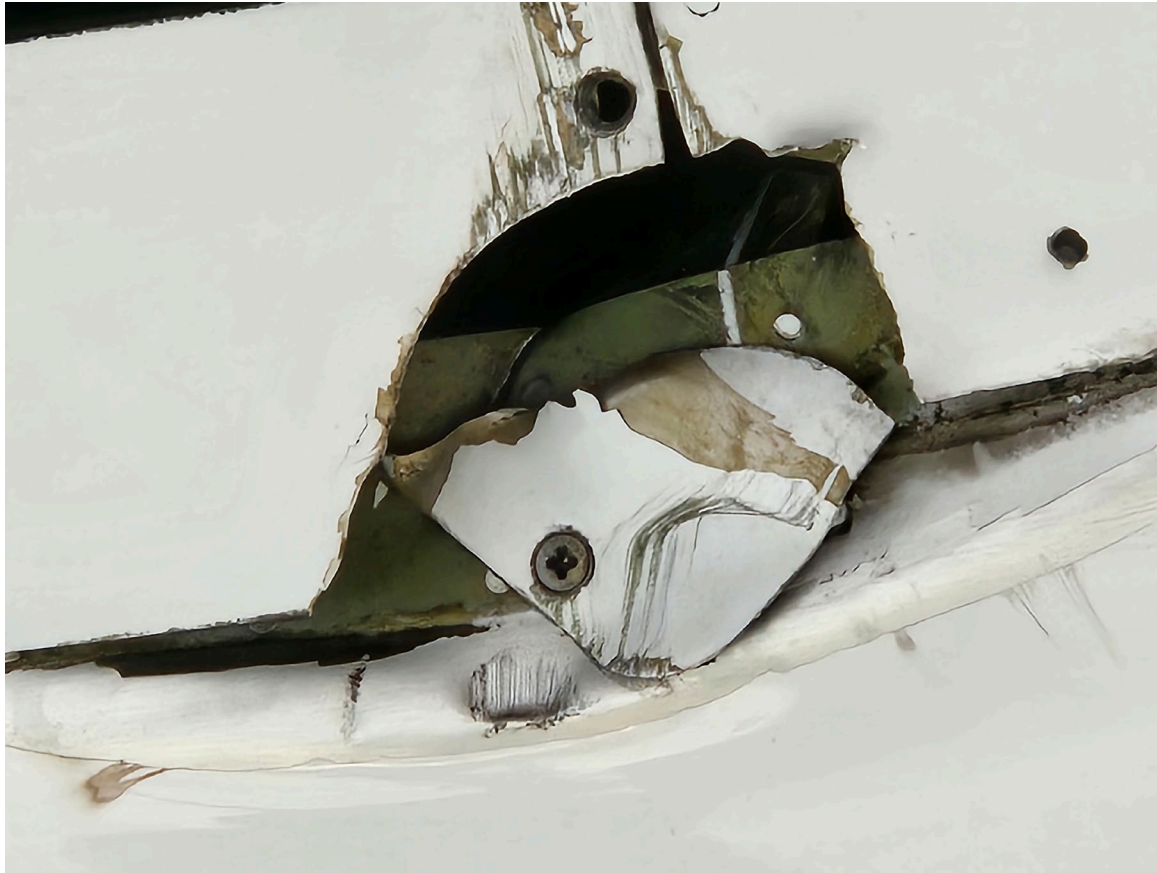
**Photograph 2 - Damage to lower spar cap in the left wing(Courtesy of Operator)**
