# Carburetor Icing Probability Graph – ANC25LA112

Airplane: Cessna 172

Accident Date: 09/21/2025

Accident Location: Yakataga, AK

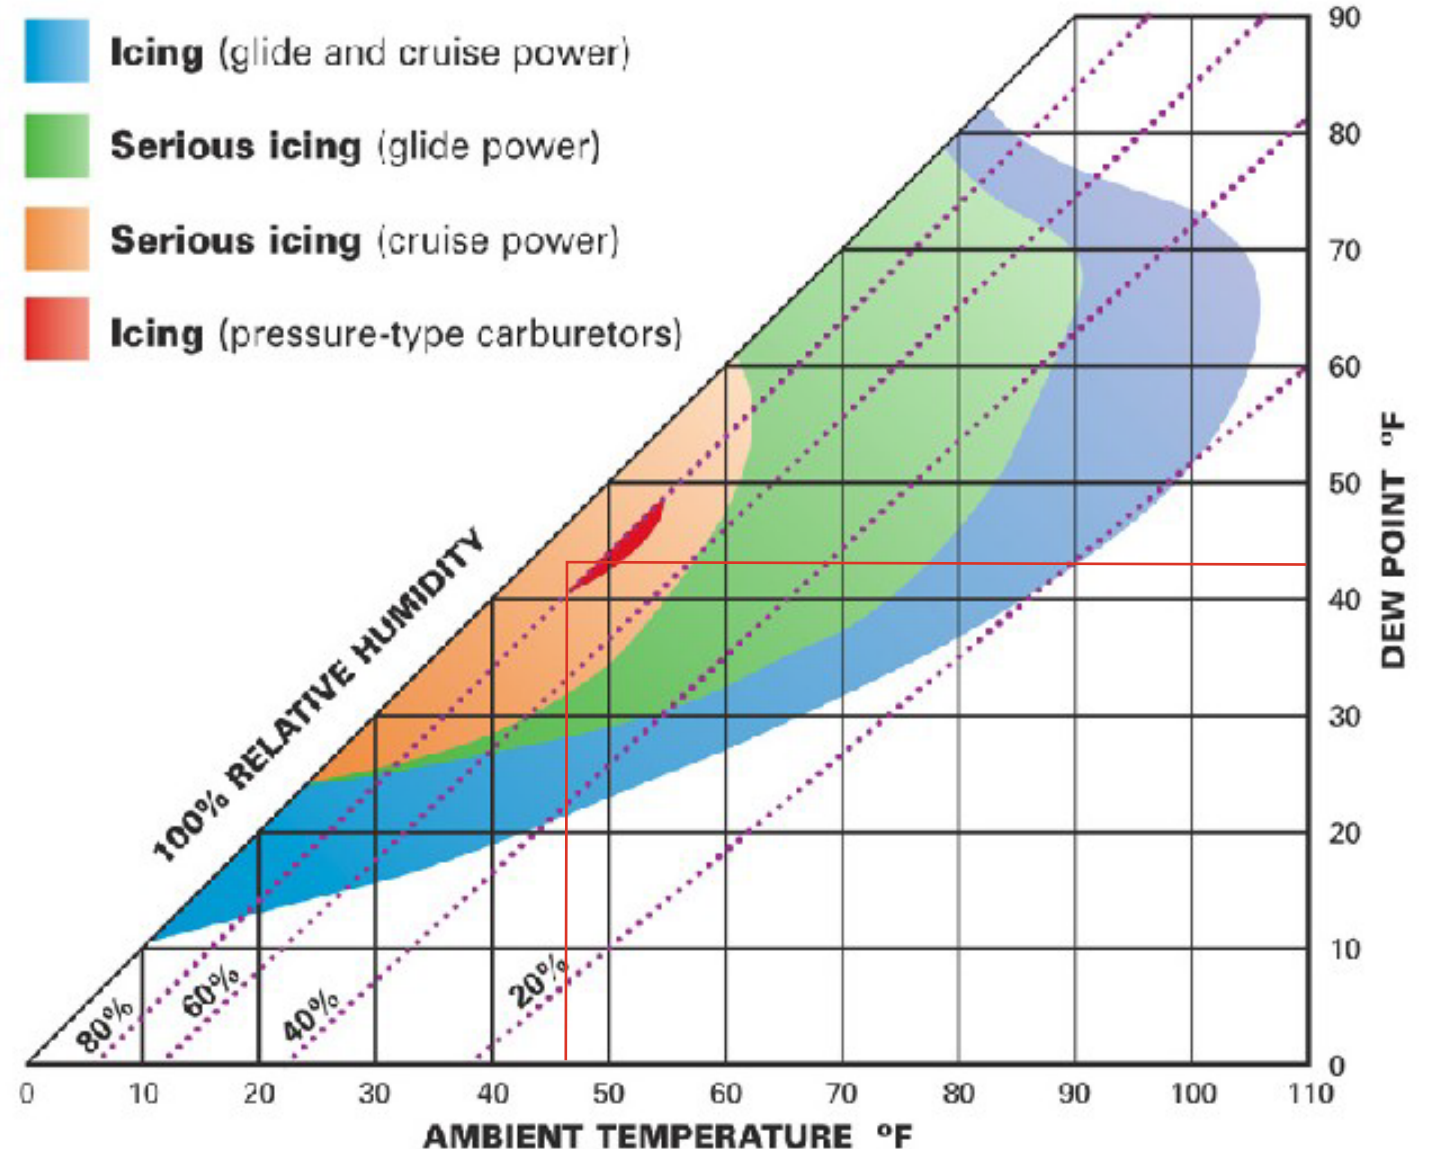
Weather: Observation Facility (YAK) reported temperature 46° F; dew point 43° F

Observation Facility (CDV) reported temperature 46° F; dew point 37° F
