ANC25LA119

## INVESTIGATION PHOTOGRAPHS

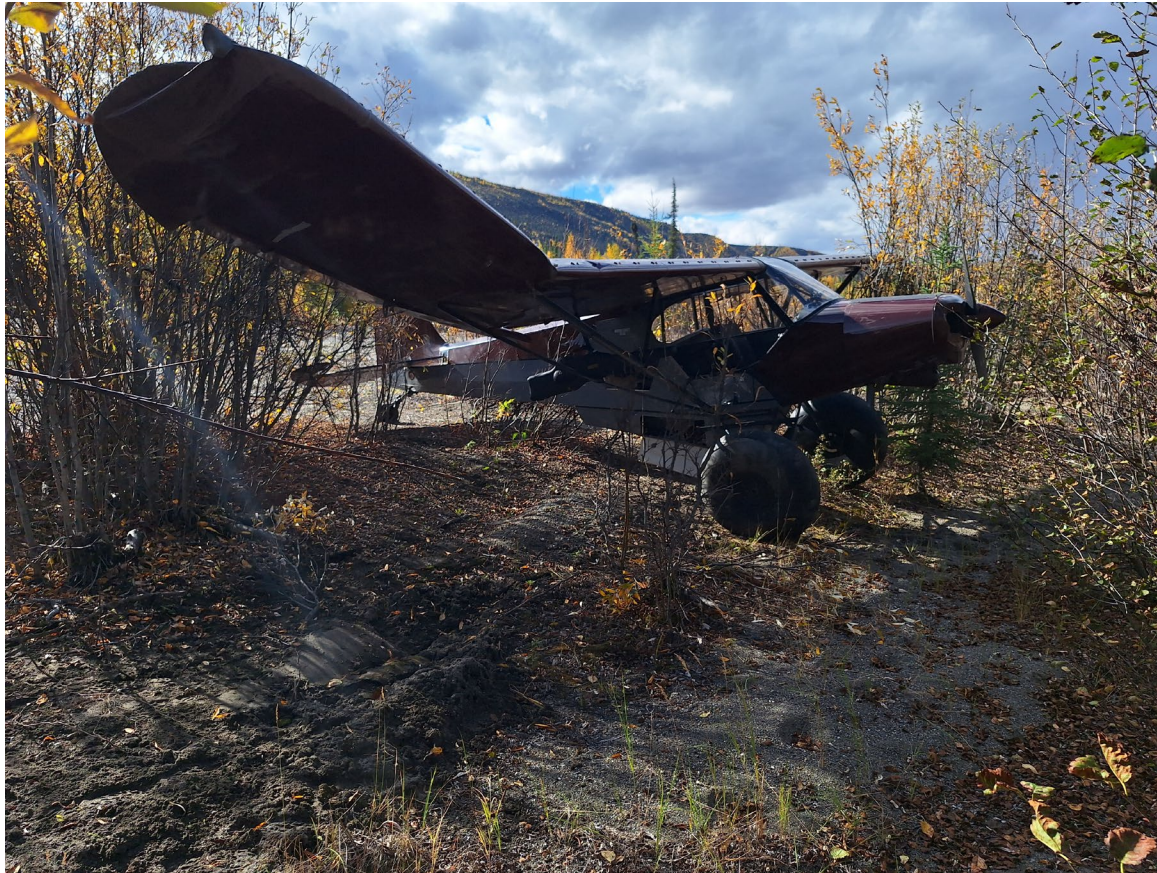
**Photograph 1 - View of damage to the right wing (Courtesy of FAA)**

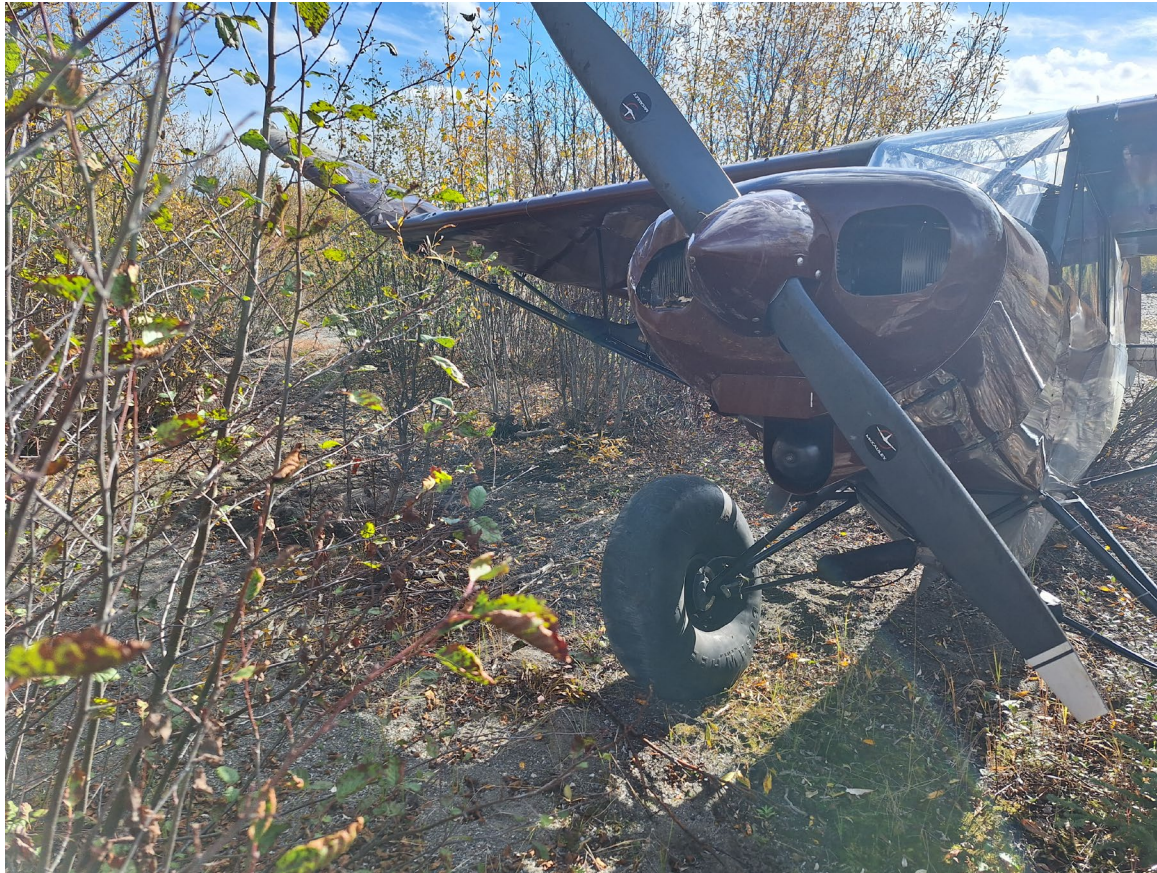
**Photograph 2 - View of the airplane where it came to rest (Courtesy of FAA)**
