# National Transportation Safety Board

ANC25MA018

## **POWERPLANT FACTUAL REPORT**

Location: Nome, Alaska  
Date: February 6, 2025  
Time: 15:20 local time  
Airplane: Textron Aviation 208B, Registration Number N321BA

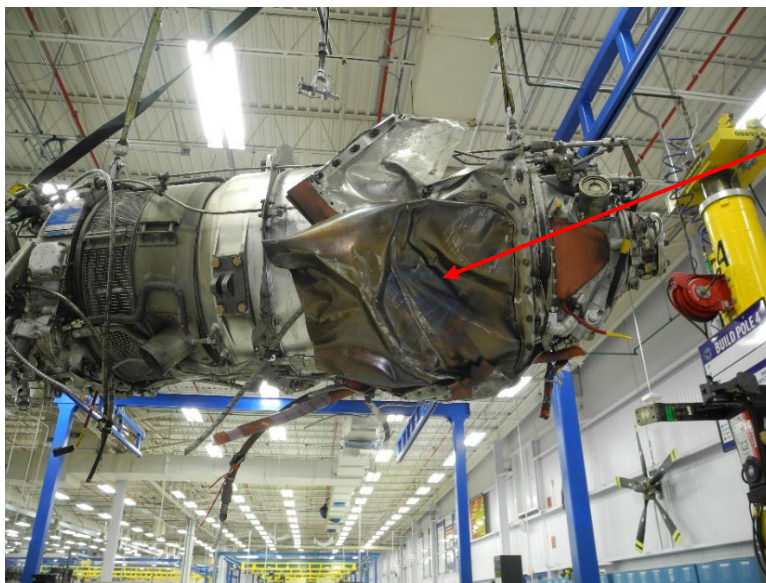
The airframe exhaust duct was deformed and folded backwards, almost completely covering the engine exhaust opening (**Photo 4**).

Airframe  
Exhaust -  
Deformed

**Photo 4** - Airframe Exhaust Duct - Blocking Engine Exhaust Port

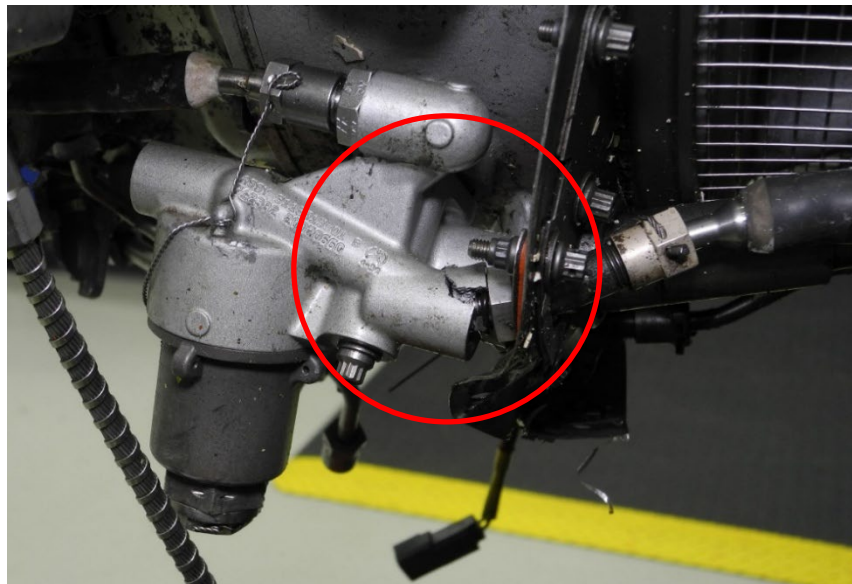
The P3<sup>1</sup> system was present; however, the P3 filter housing was fractured at the fitting (**Photo 7**) so a pressure test could not be performed. The P3 B-nuts on the compressor housing and the FCU were tight. The P3 filter and filter bowl were free of debris (**Photo 8**). The B-nut of the Py fitting was secure and was removed using 50 inch-pounds in-lbs of torque, however, the safety cable of the B-nut was missing one ferrule. The B-nuts on the bulkhead fittings on the firewall and the torque limiter were tight.

**Photo 7** - P3 Filter Housing and Filter - Fractured

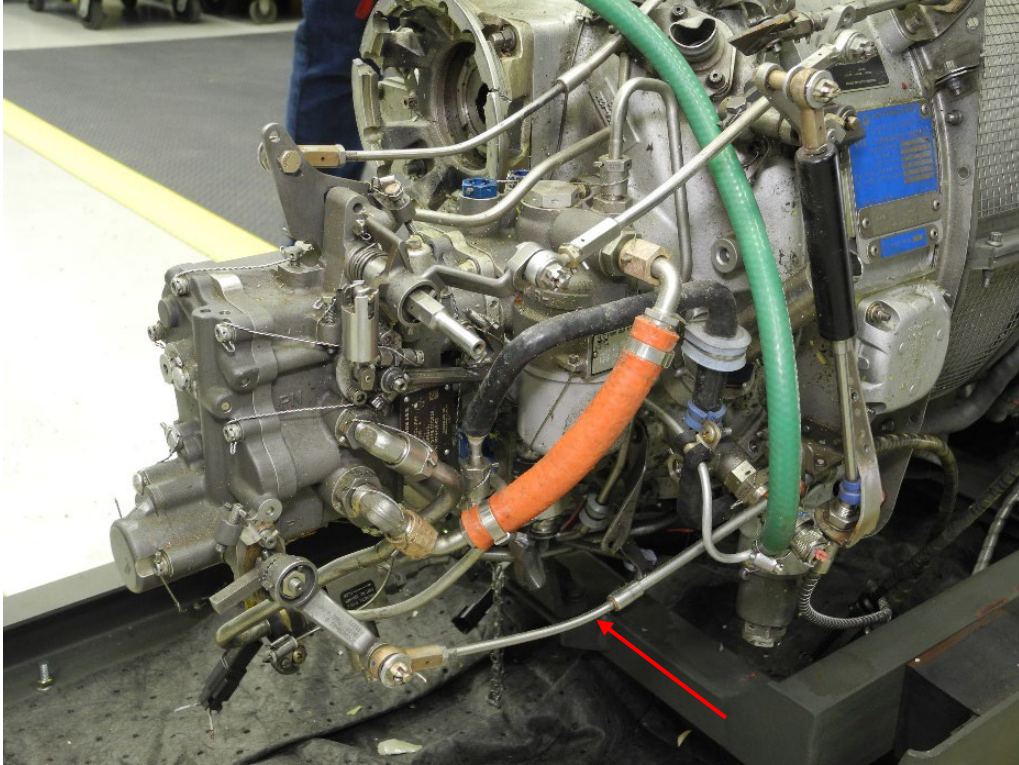
The FCU power lever shaft was bent (**Photo 9**), and the lever was in an over extended position (**Photo 10**). The manual override (MOR) lever shaft was bent but it could still be turned with moderate effort. The MOR was in the non-engaged position. All the push-pull cables were intact; however, most were bent.

**Photo 9** - Control rods - Intact; however, bent.

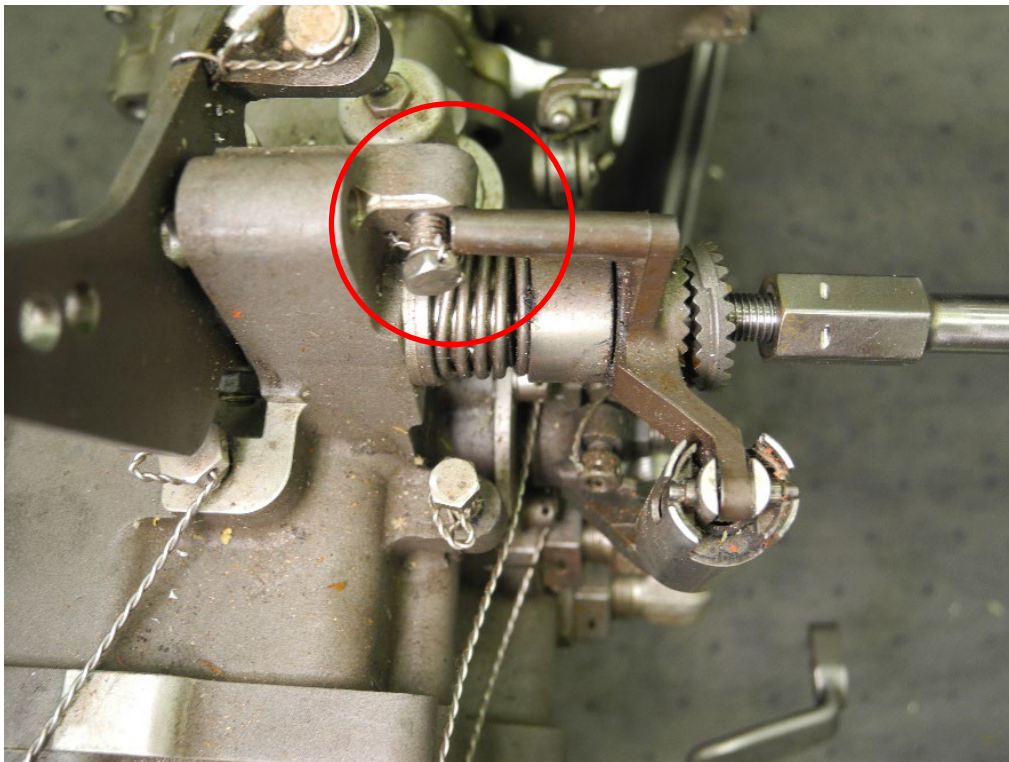
**Photo 10** - Power Lever Shaft - Bent and in Over-Extended Position Beyond the Stop

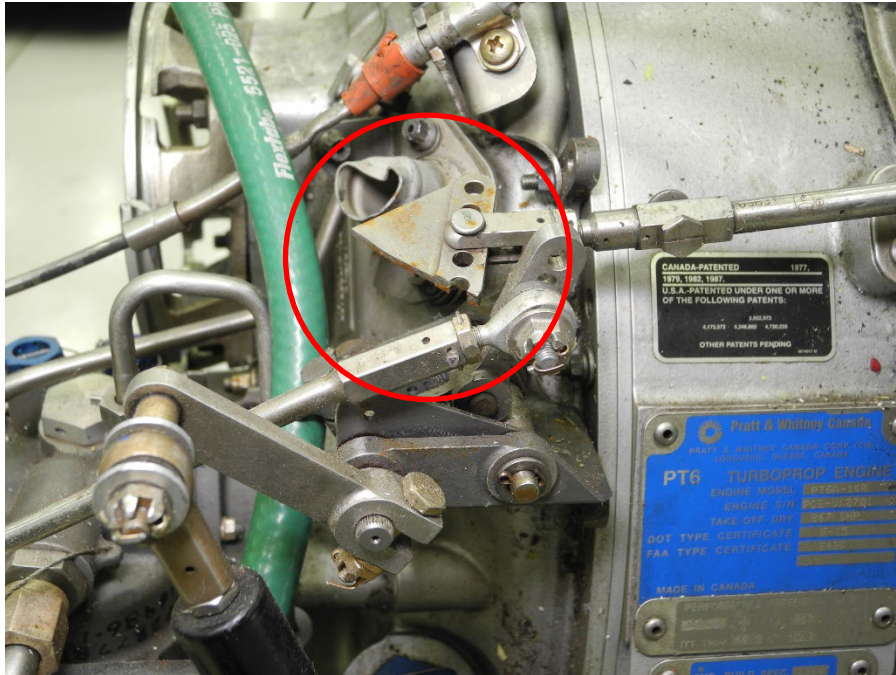
The propeller reverser cam was present; however, it was impact fractured (**Photo 11**).

**Photo 11** - Reverser Cam - Fractured

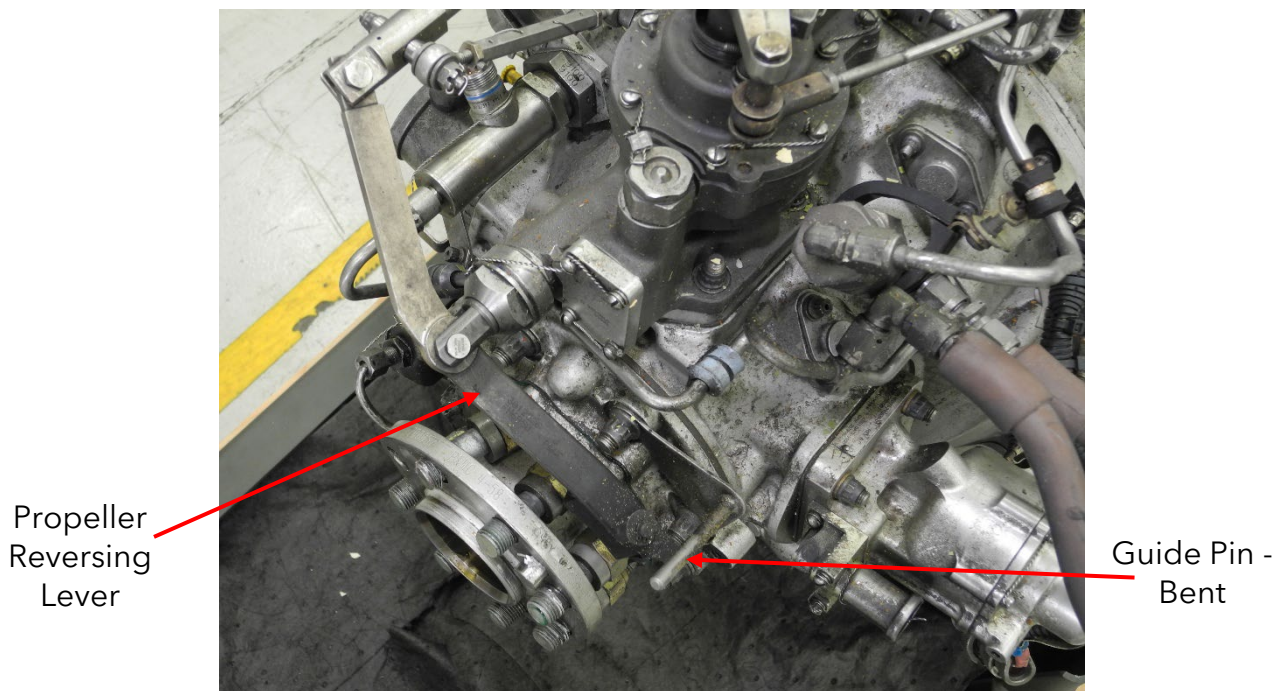
The propeller reversing lever was intact and under the reversing lever guide pin (Photo 13). The guide pin was bent. The carbon block was impact damaged.

**Photo 13** – Propeller Reversing Lever

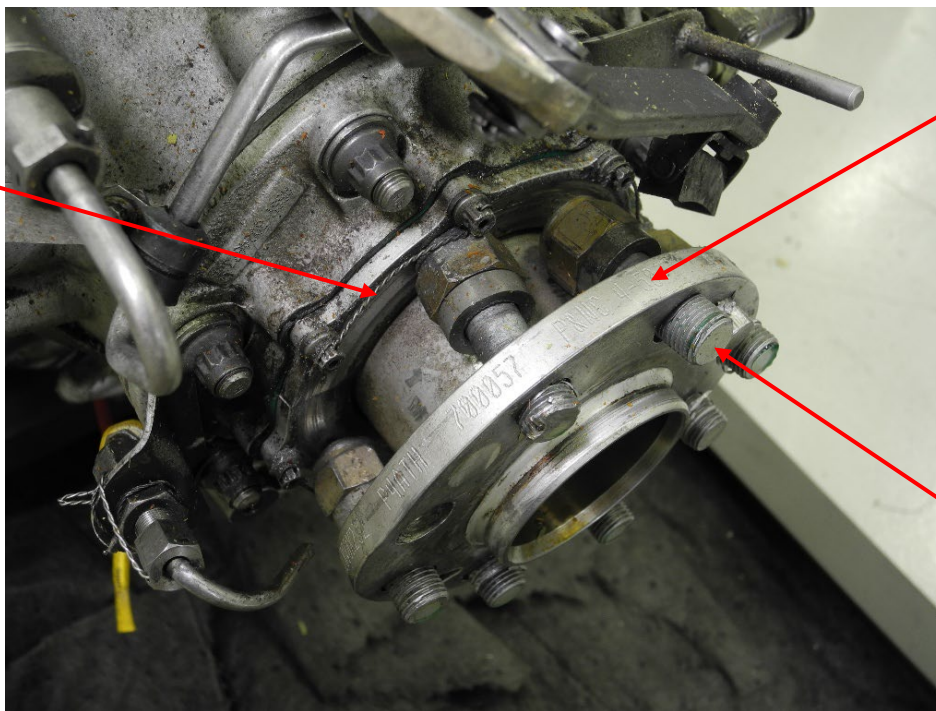
The propeller shaft flange was bent (Photo 14). One of the two dowel pins was missing. Seven of the eight propeller mounting studs were pulled out of the propeller hub and captured at the aft side of the flange with the nuts still present. The nuts had contacted the RGB propeller top and bottom oil seal retaining rings and attachment hardware (Photo 15), consistent with propeller shaft rotation after the loss of the propeller.

Propeller  
Mounting  
Studs - Pulled

**Photo 14** - Propeller Shaft - Bent Propeller Mounting Flange

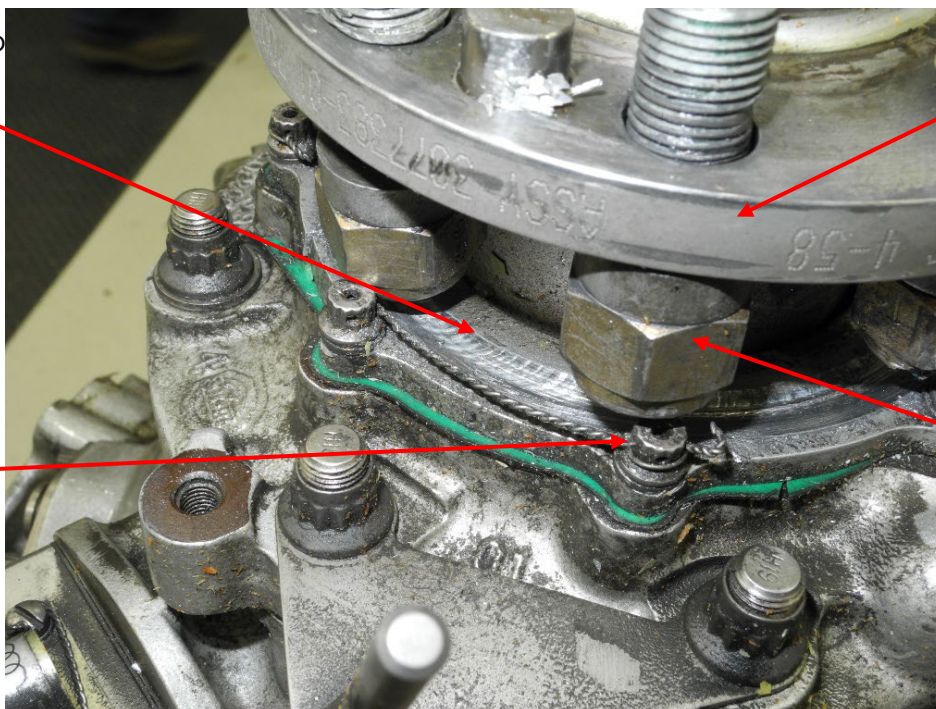
Propeller Top  
and Bottom  
Oil Seal  
Retaining  
Rings -  
Rotationally  
Scored

Securing Nuts  
of Propeller  
Top and  
Bottom Oil  
Seal Retaining  
Rings - Impact  
Damaged

**Photo 15** - Propeller Oil Seal Retaining Rings - Scored by Propeller Mount Nuts

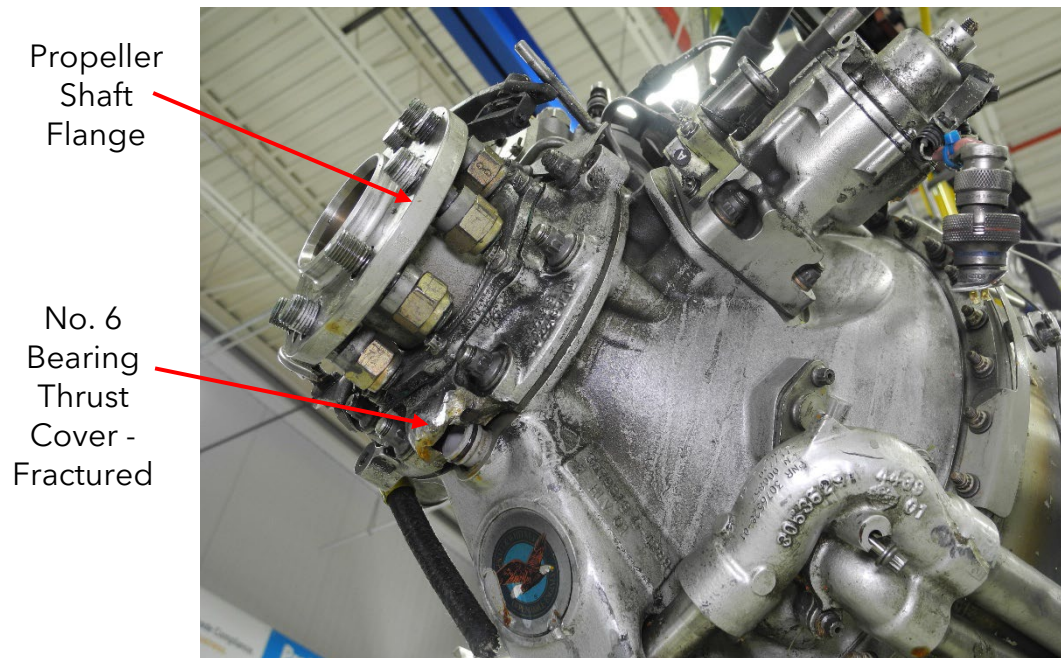
The No. 6 bearing thrust cover was fractured at the 6 o'clock location, exposing an oil transfer tube (**Photo 16**).

**Photo 16** - RGB Housing - View from Bottom

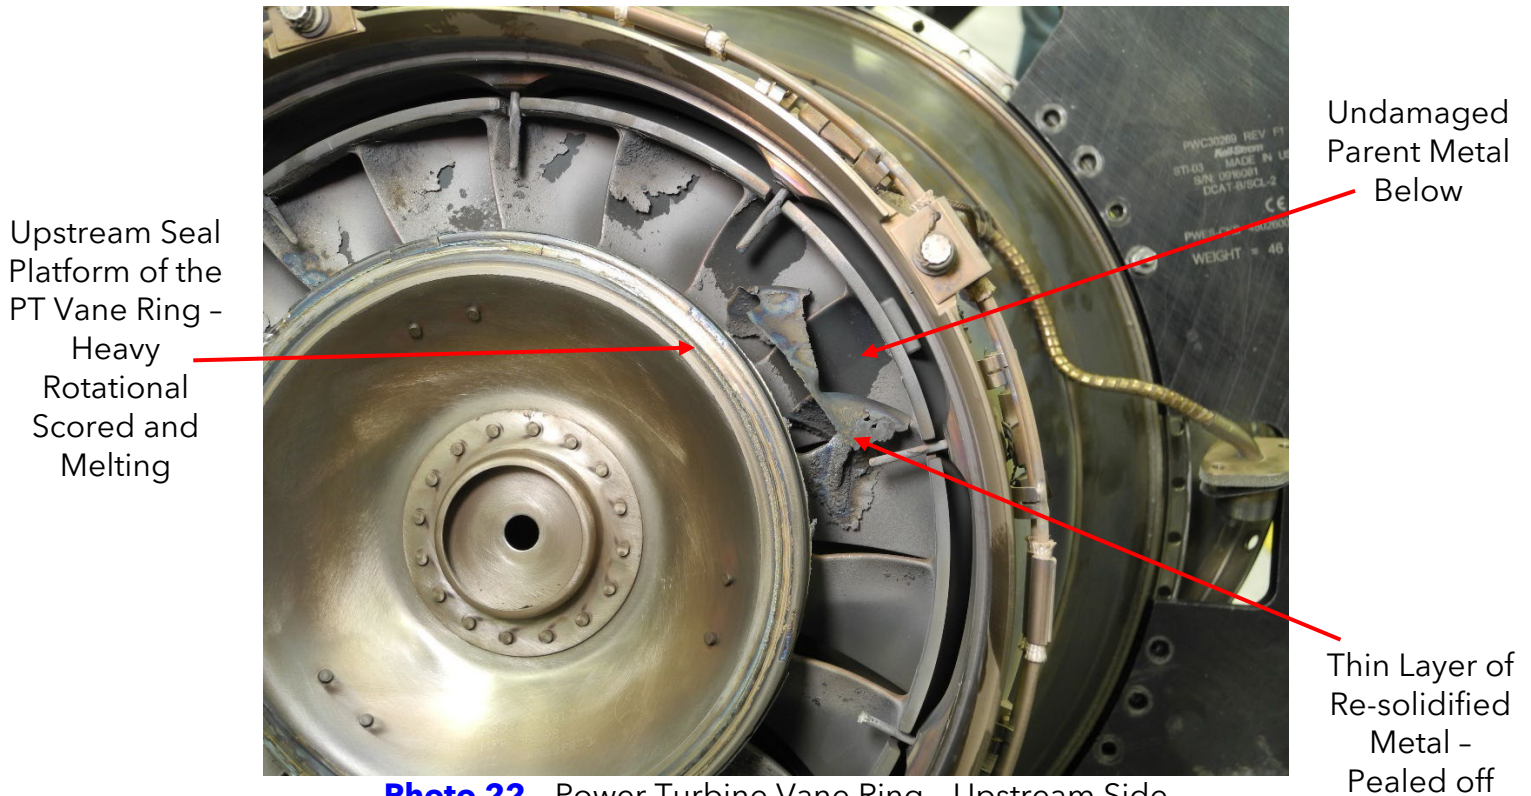
The PT vane ring (**Photo 22**) was intact; however, the upstream<sup>2</sup> side of some of the vanes of the PT vane ring had an uneven splatter of re-solidified metal consistent with metal being melted from contact between the stationary upstream vane platform of the PT and the rotating downstream blade platforms of the CT wheel (**Photo 23**). The splattered material was easily peeled away from the parent metal, exposing undamaged PT vane surfaces.

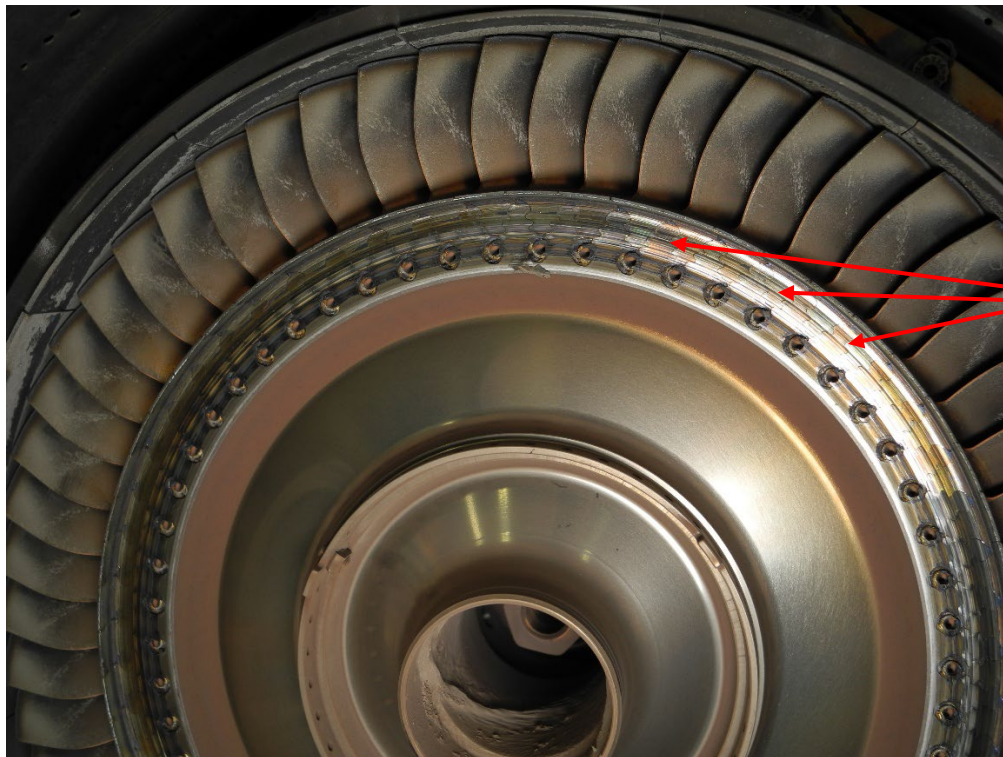
Downstream  
Blade  
Platforms of  
the CT Wheel  
- Heavy  
Rotational  
Scored and  
Melting

**Photo 23** - CT Wheel - Downstream Side

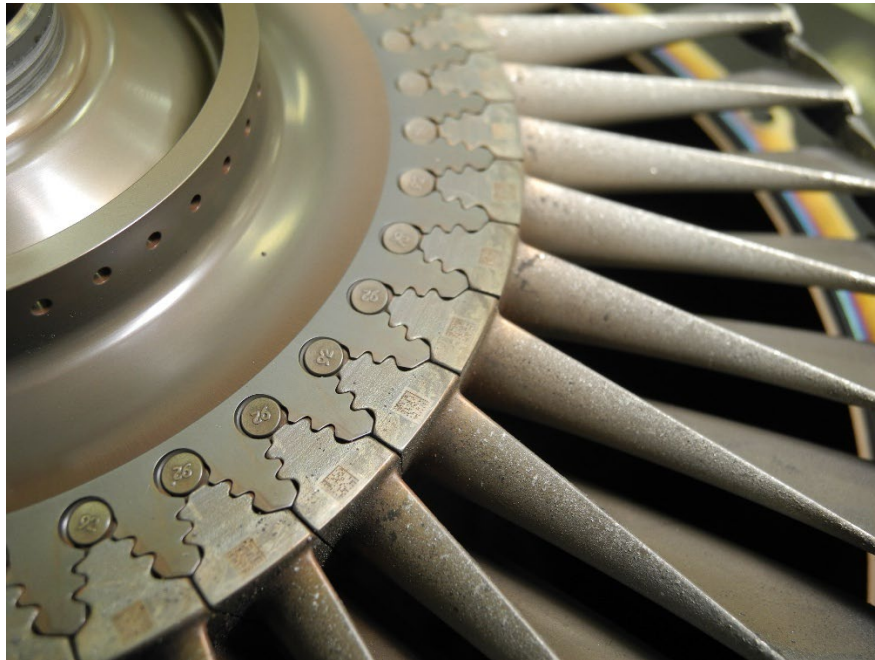
The leading edges of the PT blades had a rough finish, consistent with erosion and metal splatter from upstream.

**Photo 25** - PT Blades - Leading Edges Eroded

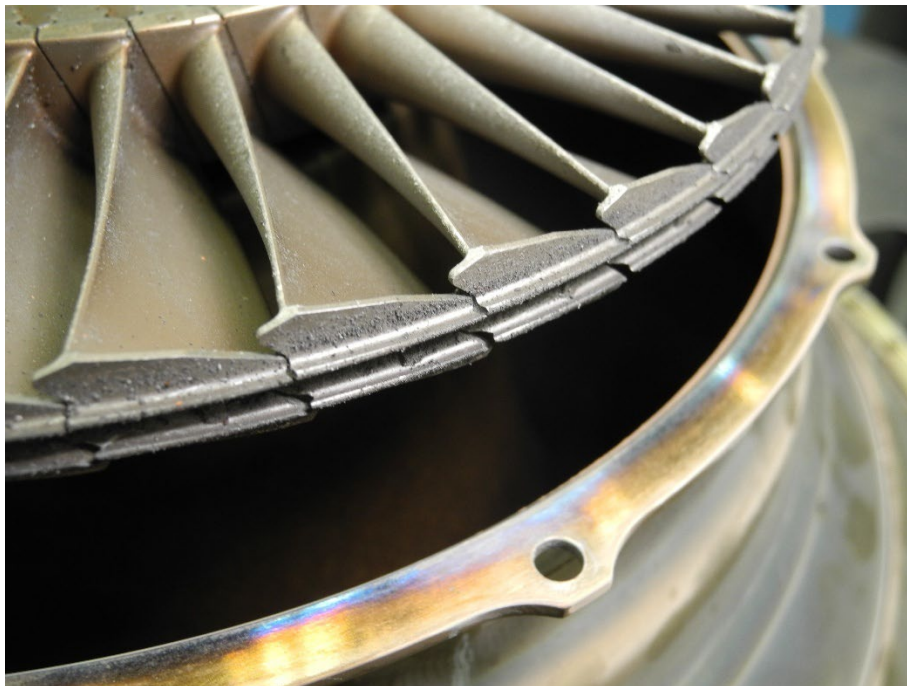
The outer PT blade platforms were all intact but were rubbed (**Photo 26**), consistent with contact against the outer abradable seal (**Photo 27**).

**Photo 26** - Outer PT Blade Platforms - Rubbed

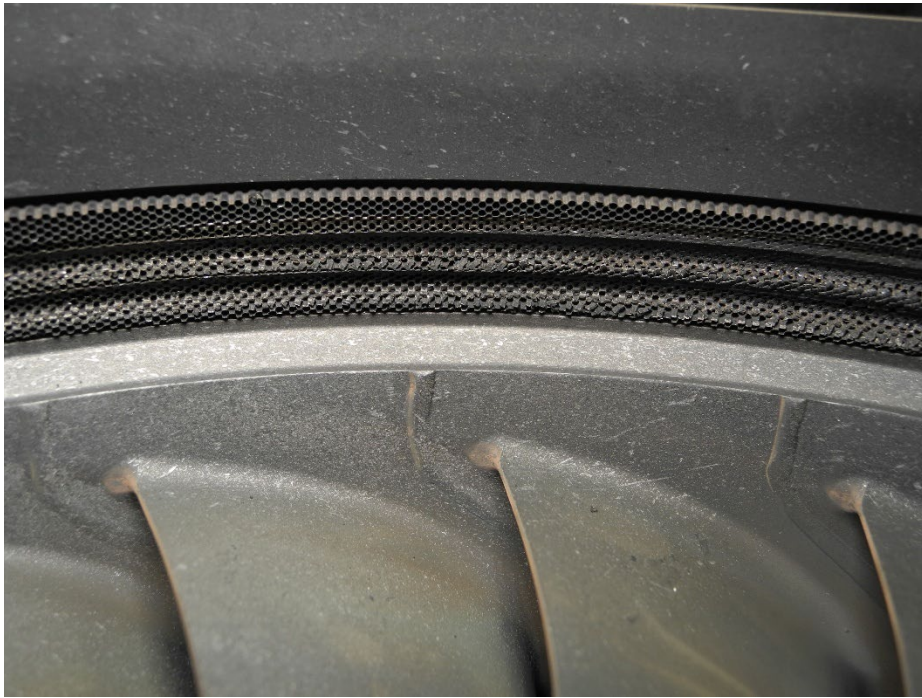
**Photo 27** - PT Honeycomb Abradable Seal - Rotationally Scored

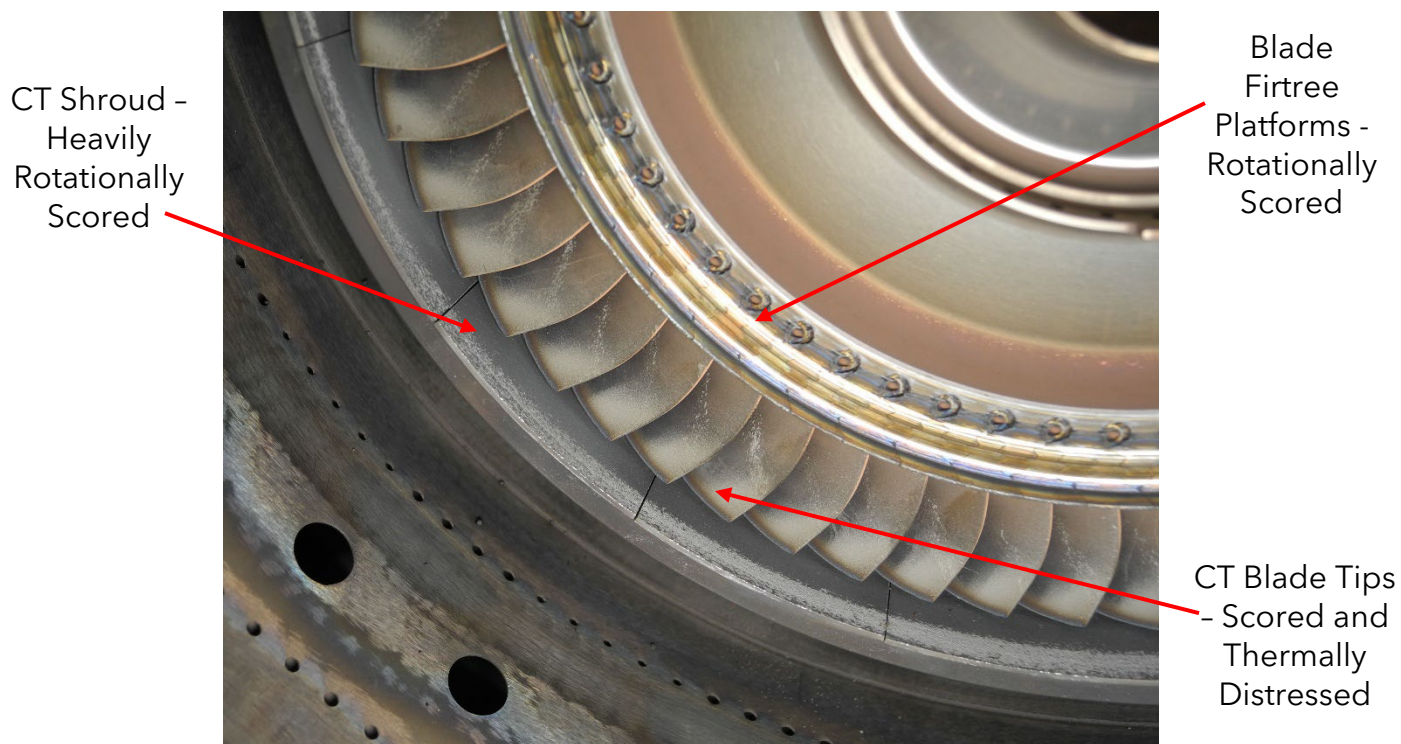
The CT wheel was intact. The blades were all present; however, the tips were rubbed and thermally distressed (**Photo 28**), consistent with contact against the shroud. The downstream platforms were rotationally scored, consistent with contact against the PT vane ring upstream platform. The leading edges of the CT blades were undamaged.

**Photo 28** - CT Blades, Hub, and Shroud

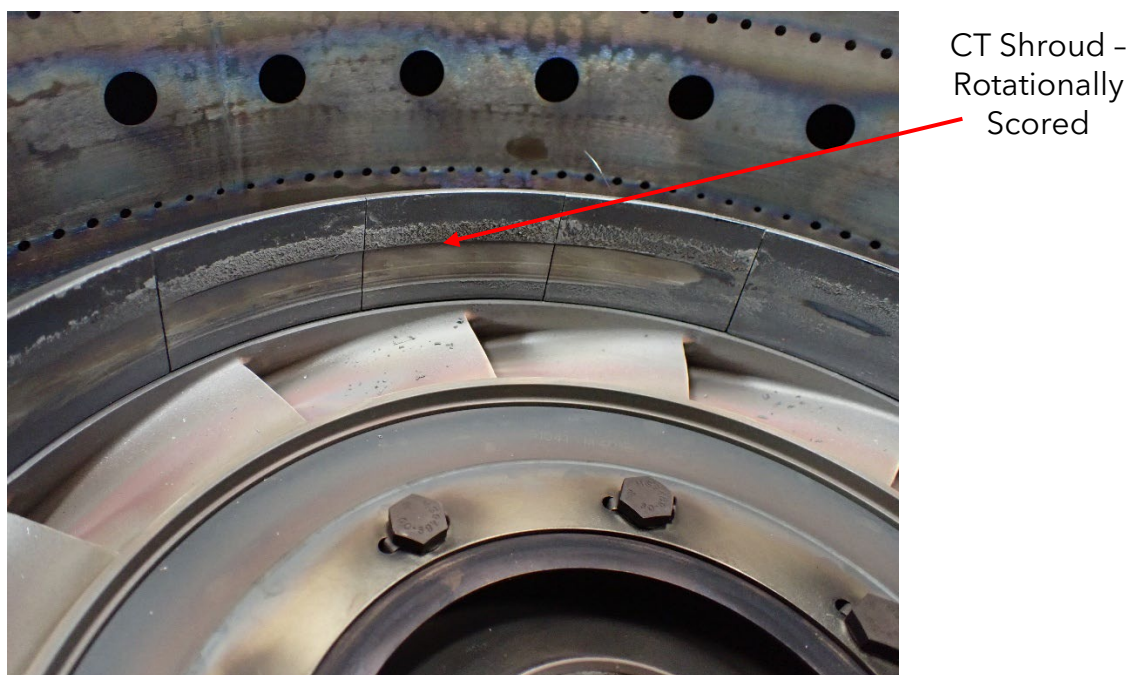
The CT shroud was heavily scored at the 3 to 6 o'clock location (**Photo 29**), consistent with contact against the CT blade tips.

**Photo 29** - CT Shroud - Heavy Rotational Scoring

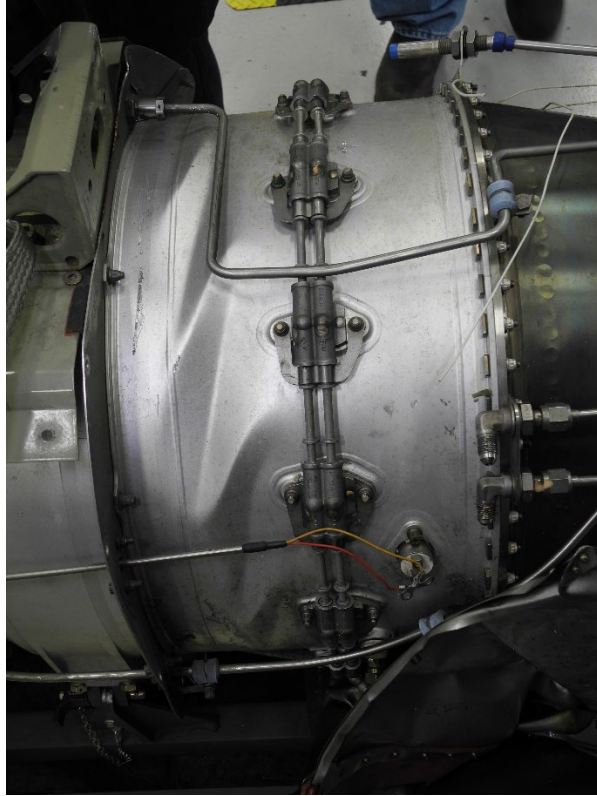
The gas generator (GG) case was intact; however, it was buckled near the 12 o'clock location (**Photo 31**). The fuel nozzle assemblies were all present and intact. Two transfer tubes were impact damaged. A visual examination of the fuel nozzles revealed clean nozzles. The diffusers were intact and undamaged (**Photo 32**).

**Photo 31** - GG case - Buckled

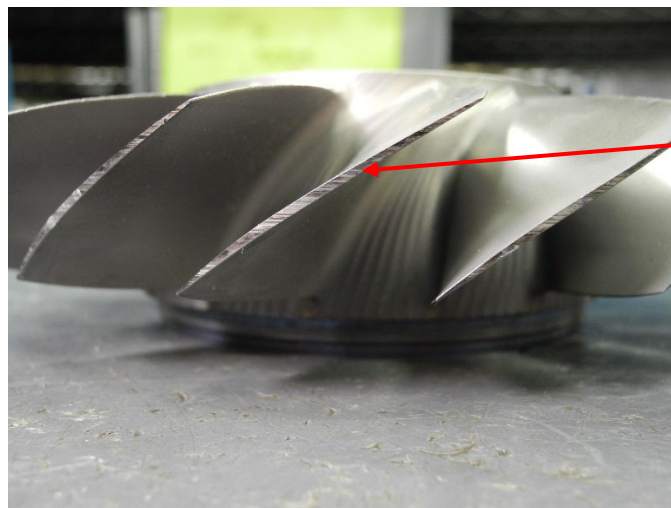
The 1<sup>st</sup> stage compressor rotor was intact; however, the blade tips were rotationally scored and thermally distressed (**Photo 34**), consistent with contact against the shroud (**Photo 35**).

1<sup>st</sup> Stage  
Compressor  
Rotor Tips  
Rotationally  
Scored

**Photo 34** - 1<sup>st</sup> Stage Compressor Rotor - Intact

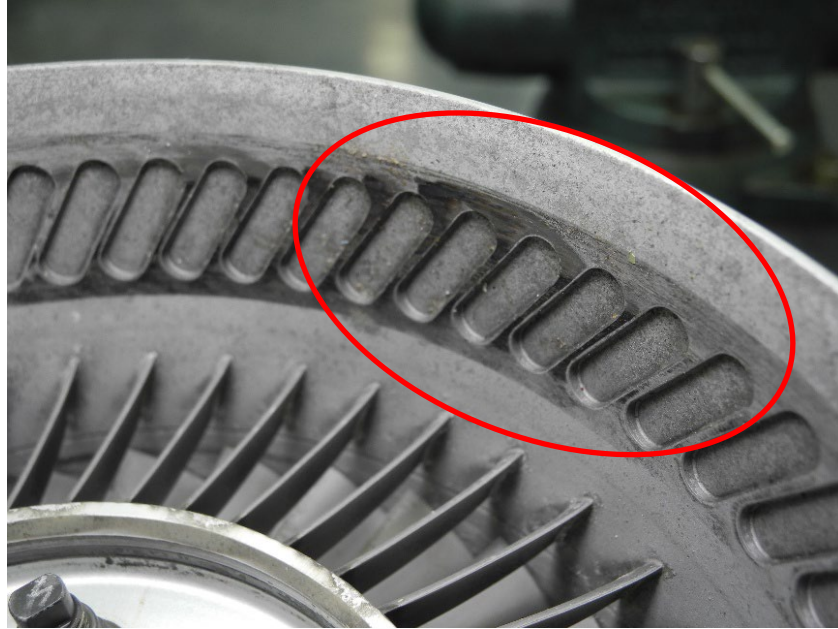
**Photo 35** - 1<sup>st</sup> Stage Compressor Shroud - Scored at 3 - 6 O'clock Position

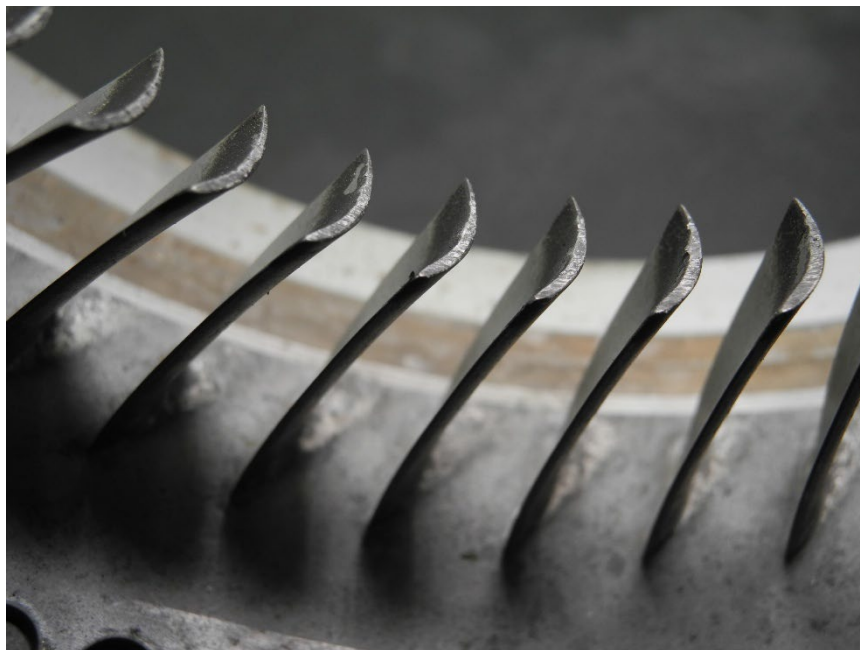
The 2<sup>nd</sup> stage stator vanes (**Photo 36**) were rubbed, consistent with contact against the 2<sup>nd</sup> stage spacer hub (**Photo 37**).

**Photo 36** - 2<sup>nd</sup> Stage Stator Vanes - Rubbing on Inner Tips

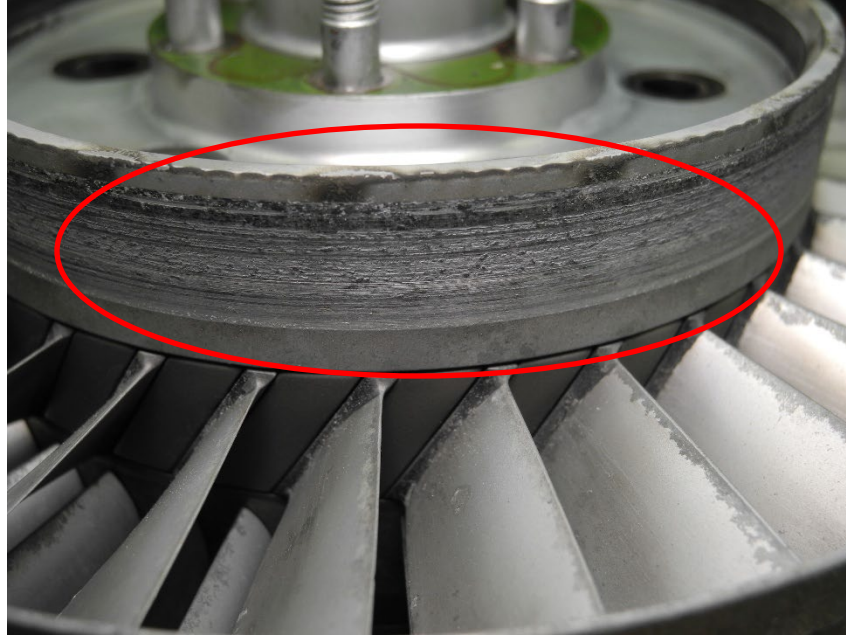
**Photo 37** - 2<sup>nd</sup> Stage Spacer Hub - Rotational Scoring

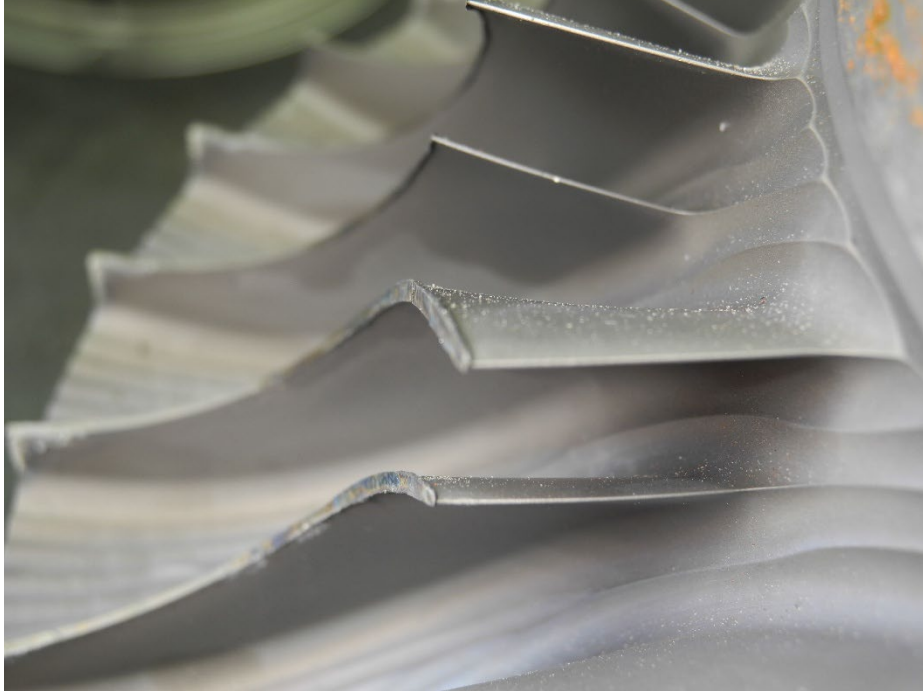
The centrifugal compressor impeller (**Photo 38**) was intact; however, the vane shroud lines were rotationally scored associated with deformed and rolled material (**Photo 39**), consistent with contact against the impeller shroud (**Photo 40**). The impeller shroud was rotationally scored, predominantly near the inducer (**Photo 41**).

**Photo 39** - Impeller Shroud Line - Rotational Scoring and Deformed, Rolled Material

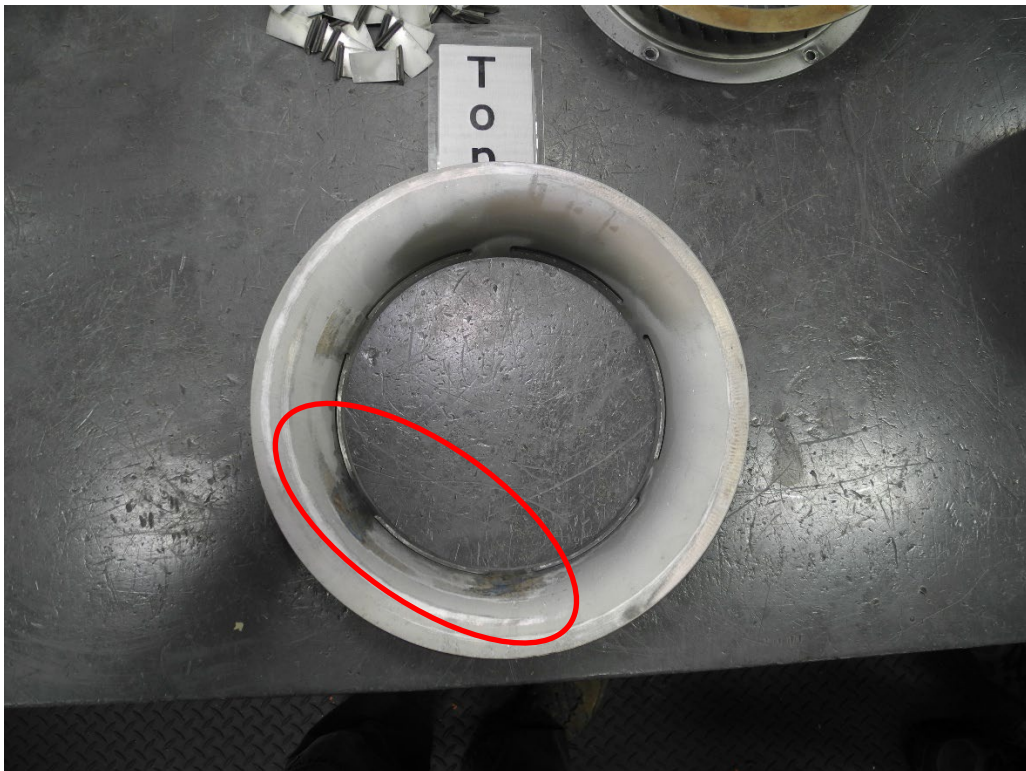
**Photo 40** - Impeller Shroud - Rotational Scoring at 4 to 6 O'clock Location

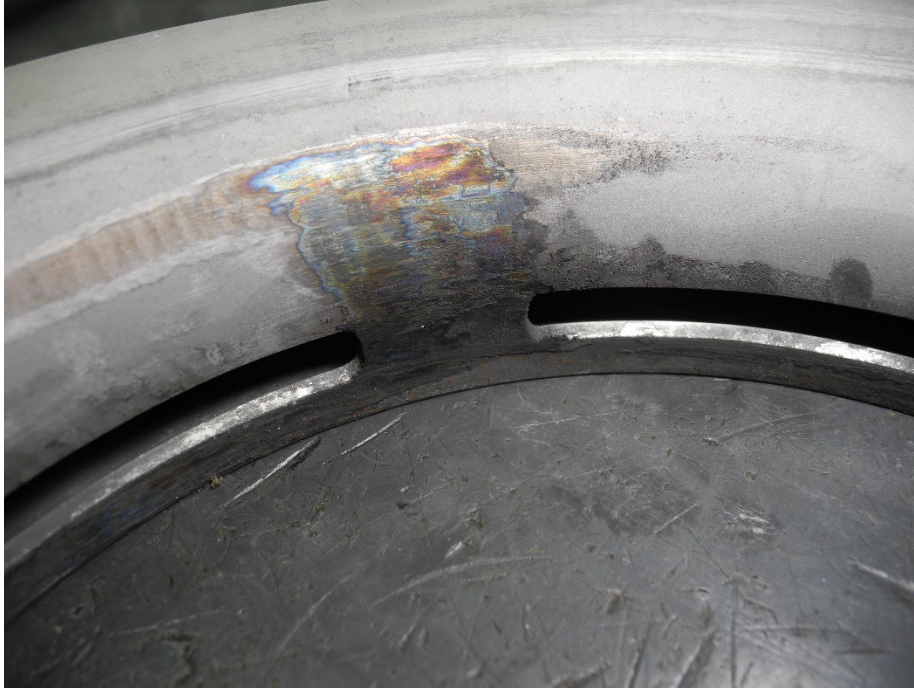
**Photo 41** - Detail of Rotational Scoring on Impeller Shroud near Inducer

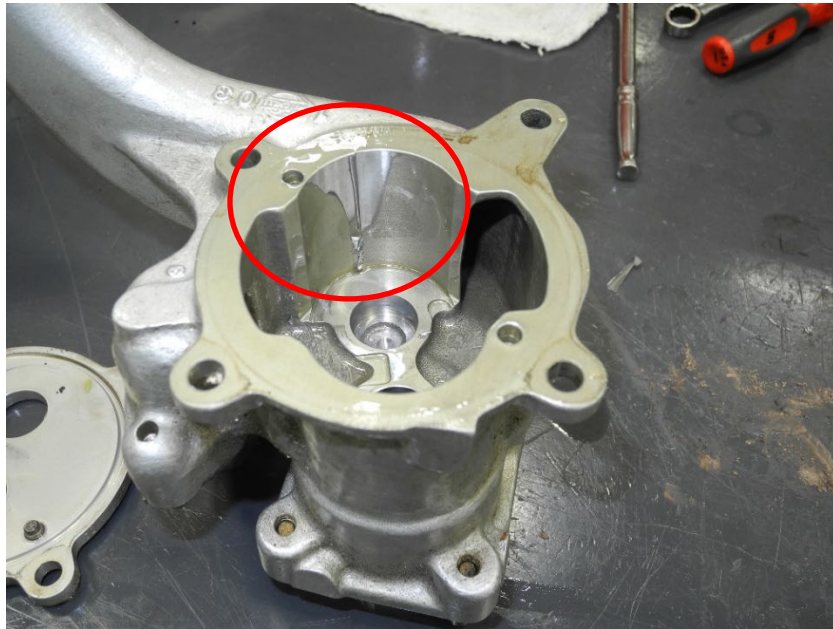
The RGB housing scavenge pump inner surface was scored from contact with the pumping gears (**Photo 45**).

**Photo 45** - RGB Housing Scavenge Pump

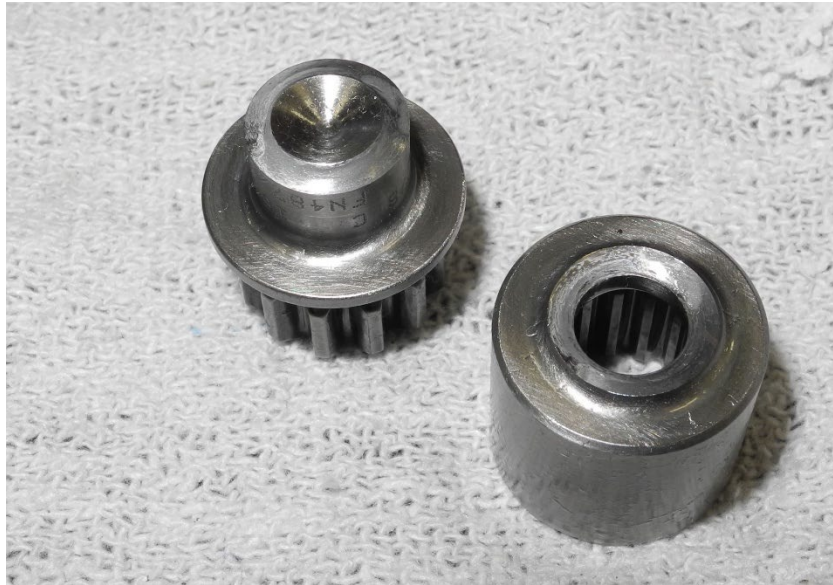
An examination of the internal oil scavenge pumps revealed a sheared coupling shaft (**Photo 47**). The fracture surface was smeared, consistent with continued rotation after the fracture occurred.

**Photo 47** - Oil Pump Coupling Shaft - Sheared

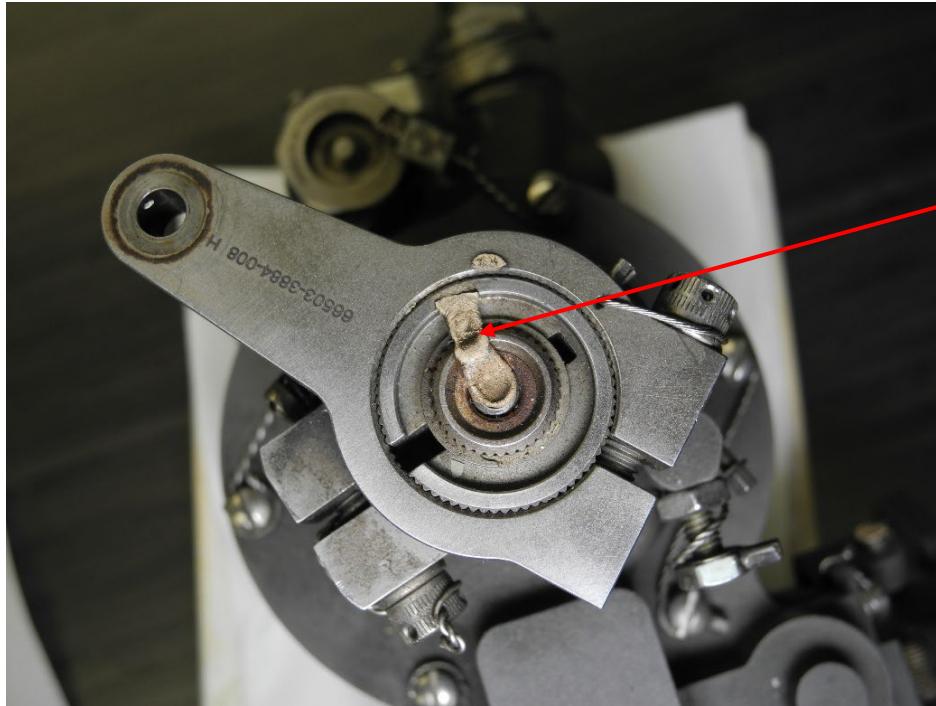
It was noted that the torque stripe of the speed setting lever (**Photo 54**) was fractured, and the lever had been moved from its original position. According to Woodward, there are no instructions for moving or adjusting the speed setting lever. A check of the Textron Aviation manuals found adjustment guidance for adjusting the lever in the field in the Cessna maintenance manual 76-12-05.

Note  
Fractured  
Torque Stripe

**Photo 54** - Detail of the Speed Setting Lever - Note Torque Stripe was Fractured

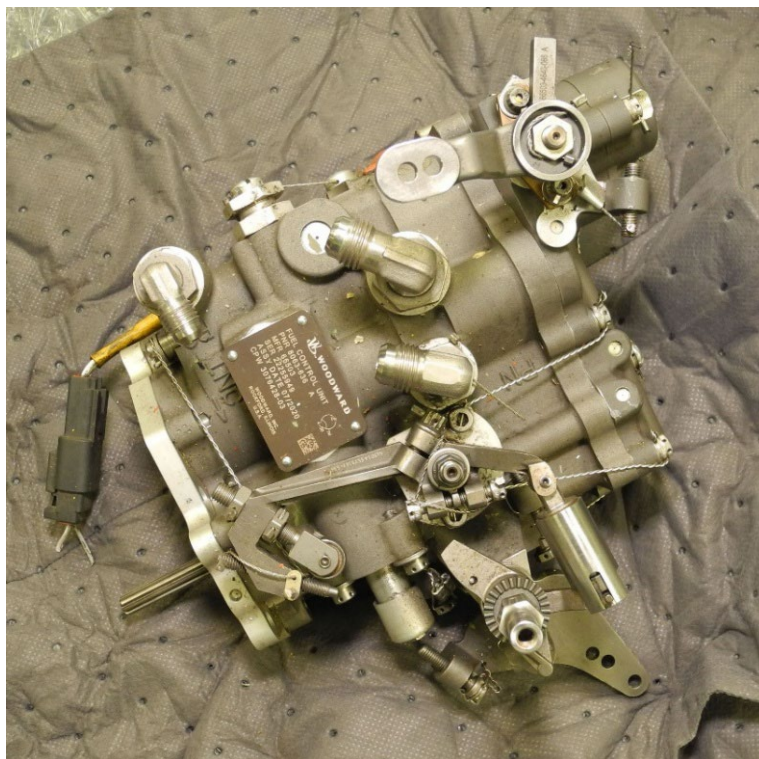
The FCU (**Photo 56** and **Photo 57**) was intact; however, there were various dents and scratches on the housing, consistent with impact damage. Most of the lockwire was not the Woodward original. The lock wire and safety cables in various locations were broken, consistent with impact damage.

**Photo 56** - FCU P/N 8063-636, S/N 22255949

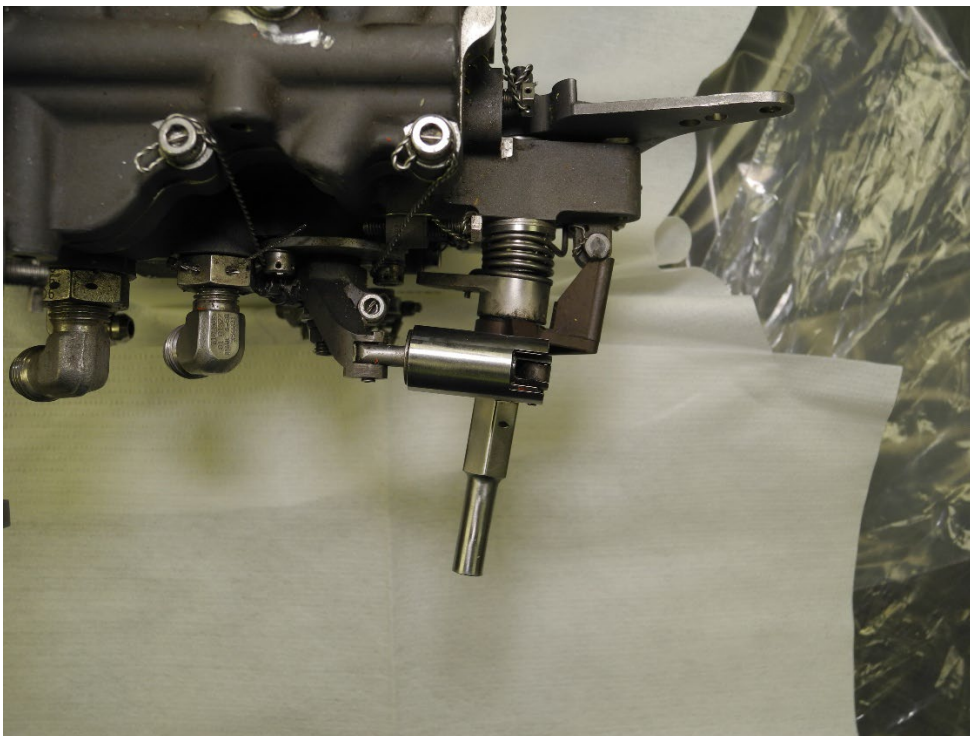
The power lever (PL) shaft was bent (**Photo 58**). The PL maximum forward stop screw was bent and the PL was over-travelled (**Photo 59**) beyond the max stop screw. The PL could not be rotated; however, once the yield mechanism linkage was removed, the throttle lever could be rotated normally.

**Photo 58** - Power Lever Input Shaft - Bent

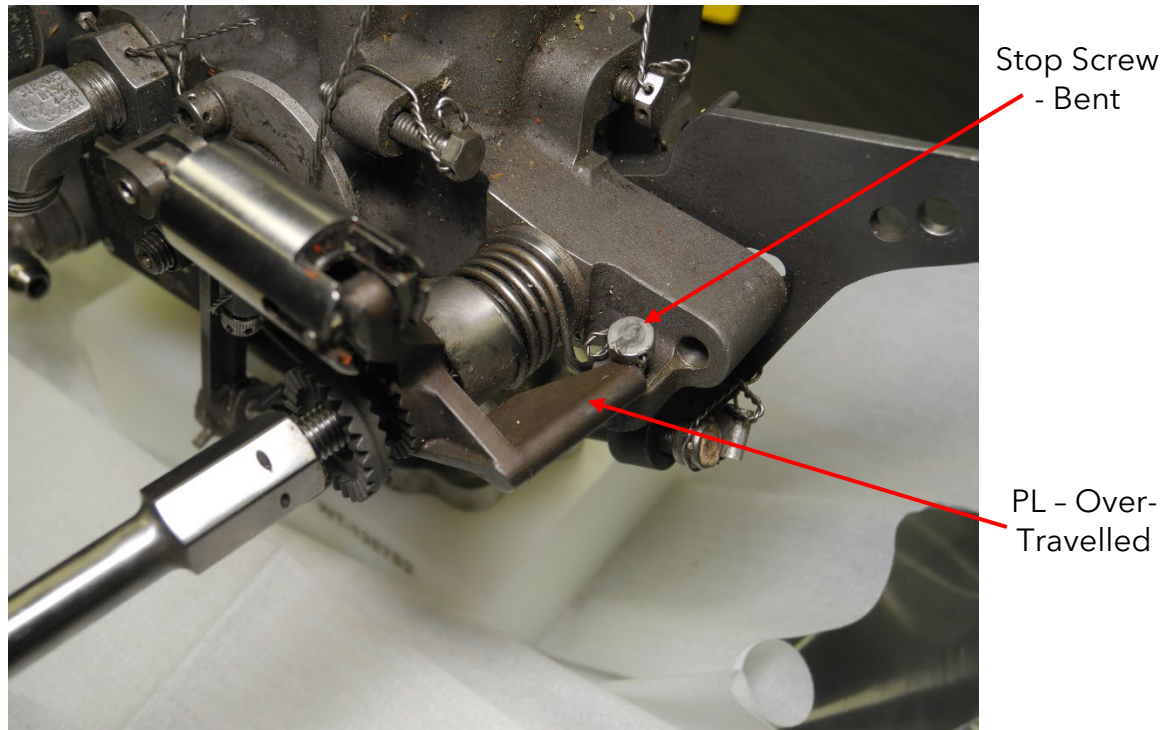
**Photo 59** - PL was Over-travelled Beyond the Stop Screw

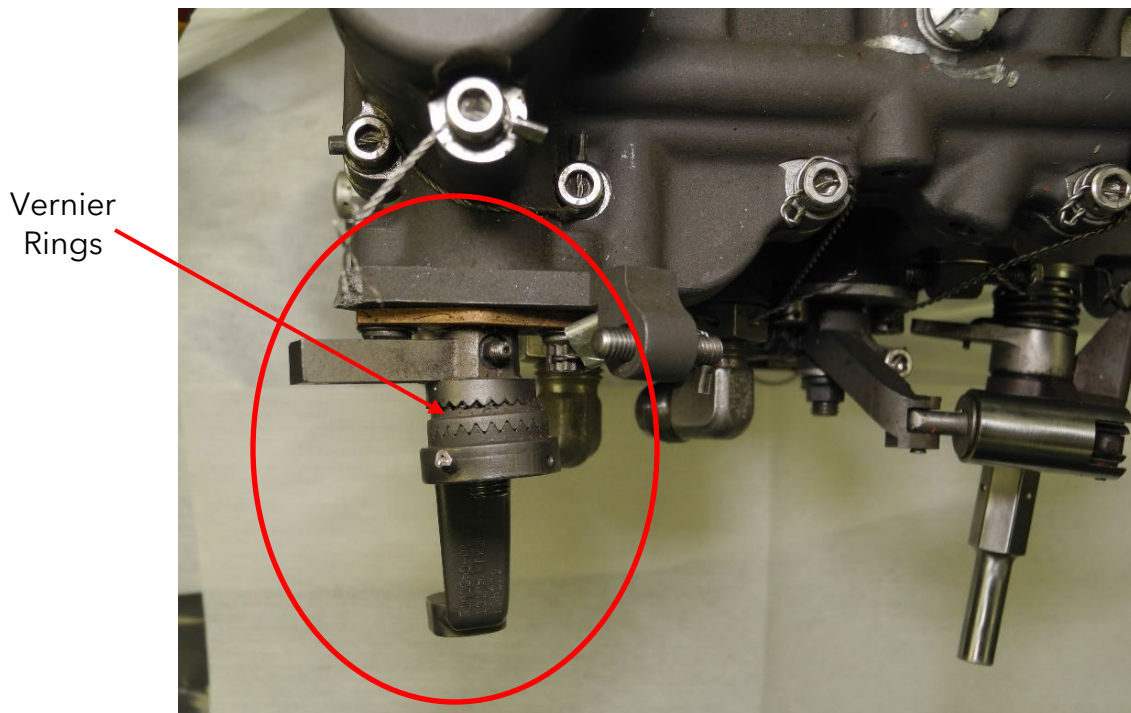
The MOR input shaft was bent (**Photo 60**), and O/R minimum stop housing boss was fractured. The input lever and vernier rings were displaced.

**Photo 60** - MOR Lever - Bent and Vernier Rings Displaced
