# National Transportation Safety Board

ANC25MA018

## **POWERPLANTS - PROPELLER**

Group Chair's Factual Report

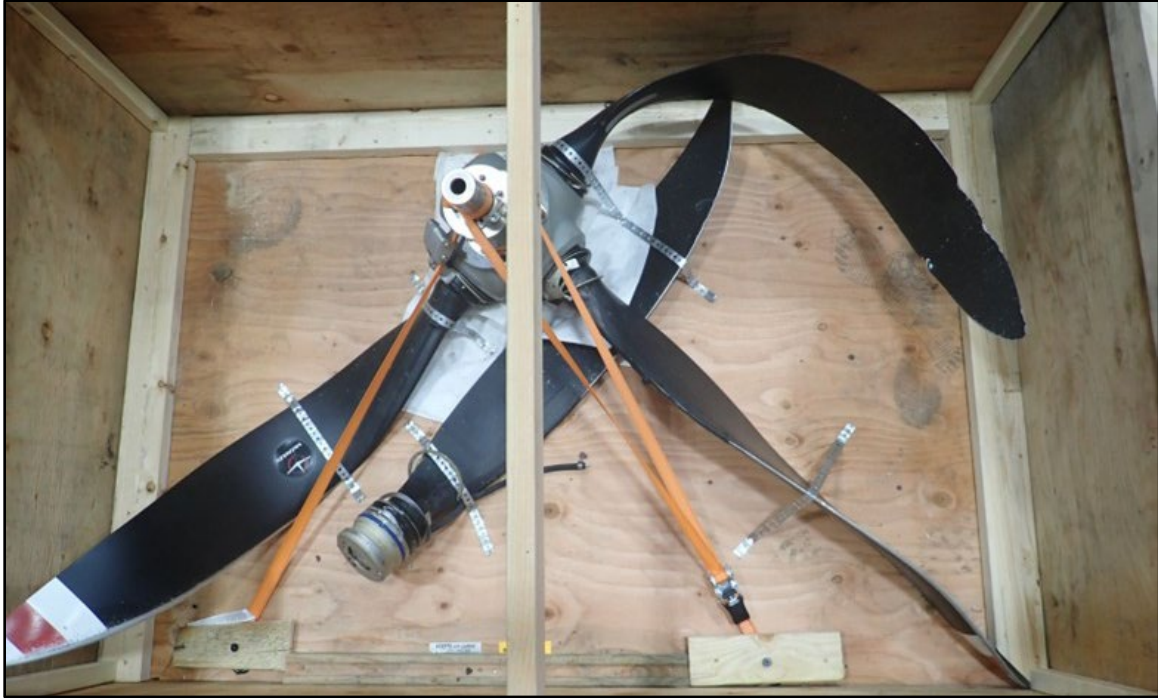
The shipping crate was stored inside a secure building at McCauley and was opened by the investigation team present for examination of the propeller (Figure 2). The propeller, with three blades attached to the hub and one separated blade, was found secured within the crate (Figure 3).

**Figure 3.** Propeller - As Received

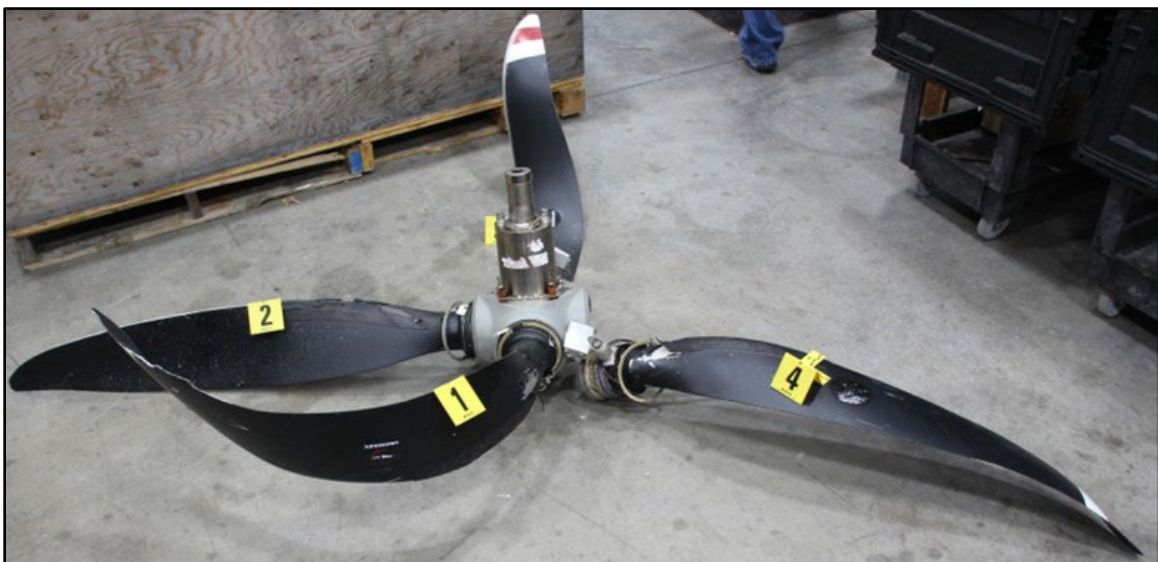
The propeller assembly and the separated No. 4 blade were removed from the shipping crate, placed on the floor for initial visual examination and numbered according to the numbered hub sockets (Figure 4 and Figure 5). Blade Nos. 1 and 3 appeared rotated 180 degrees with the leading edges facing to the aft side of the hub but all three attached blades were found to freely rotate within their respective hub sockets. The propeller was rolled over with the No. 4 blade socket facing down to facilitate inspection of the hub flange; a small amount of red propeller lubricating oil drained out of the hub.

**Figure 4.** Propeller Removed - As Received

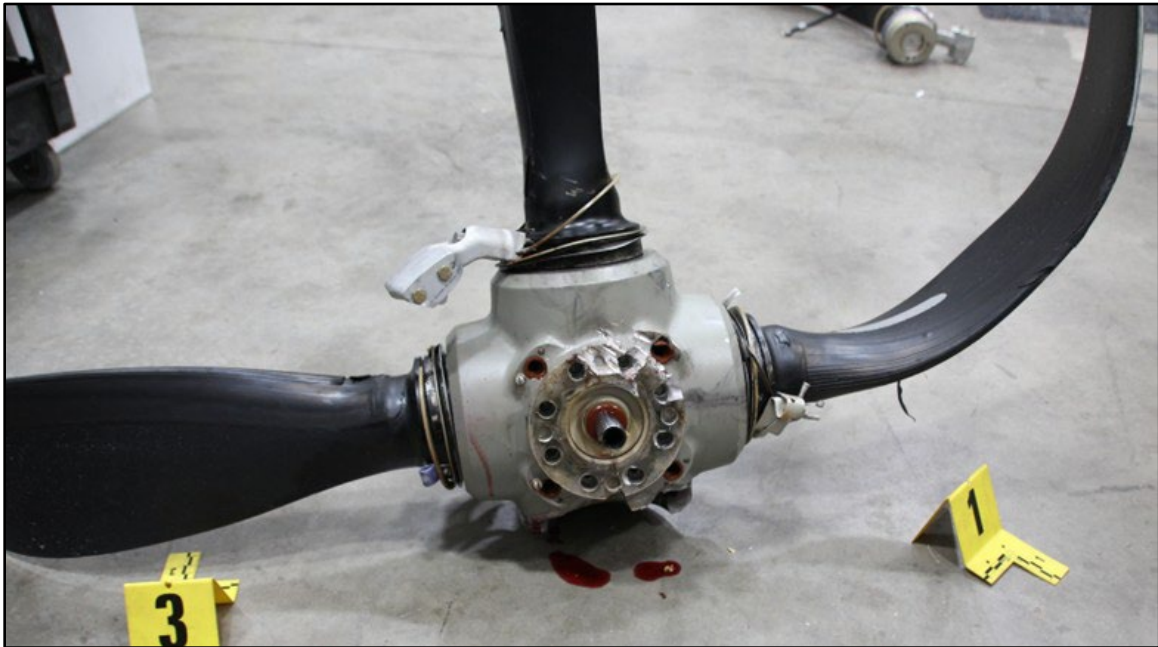
**Figure 5.** Propeller Hub Flange - As Received

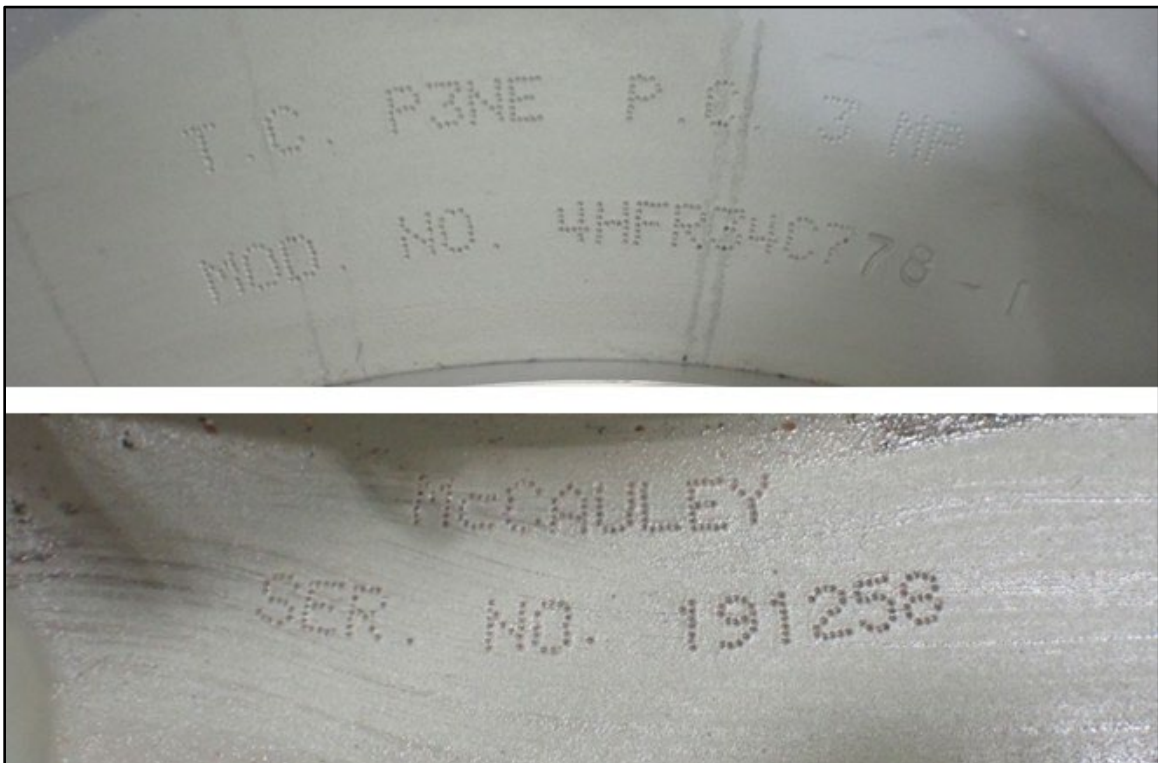
The propeller model number and SN were confirmed on the propeller hub as model number 4HFR34C778-I and SN 191258 (Figure 6).

**Figure 6.** Propeller Data Plate and SN Confirmation

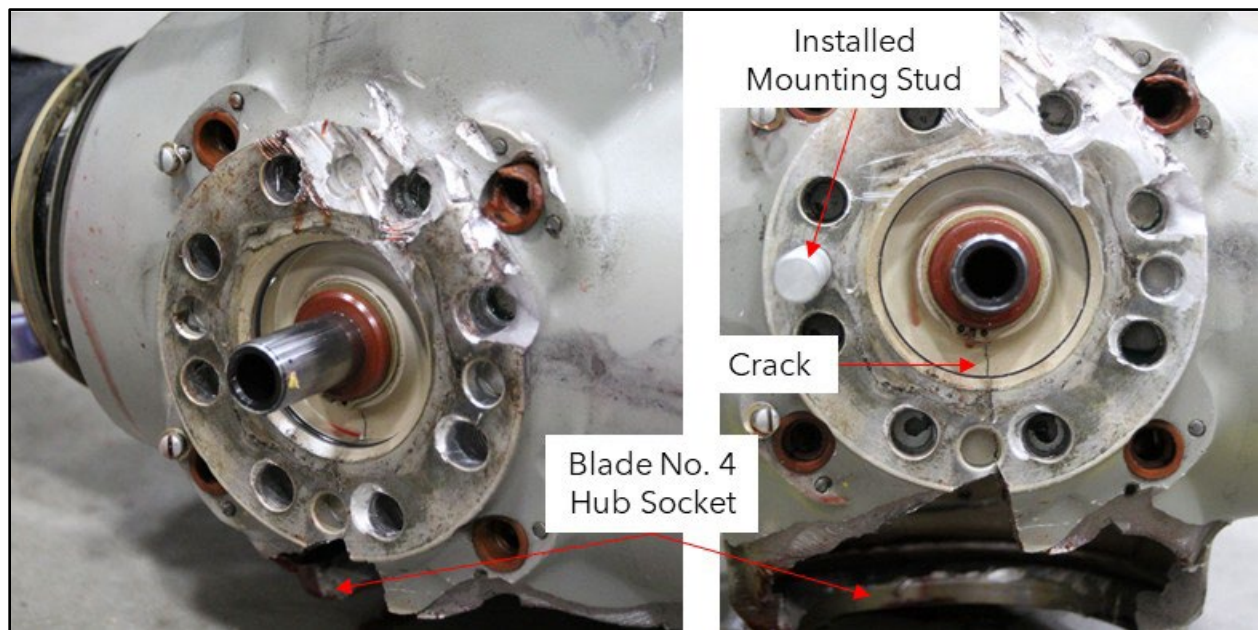
The No. 4 blade was fracture separated from the propeller hub and the hub was cracked between the No. 4 blade socket and the center of the hub. The propeller hub flange exhibited damage to approximately one quarter of the flange face/circumference. All 8 threaded studs, which attach the propeller hub to the engine propeller shaft, were not present and the damage to the hub's threaded holes were consistent with the bolts being pulled out with only remnants of the stud threads remaining within the threaded holes (Figure 7). One alignment dowel (a Pratt & Whitney Canada supplied component) was found loose and not engaged in the hub; the second alignment dowel was not found. They were tapped and threaded to install two mounting studs to facilitate mounting the propeller to the test/disassembly stand.

**Figure 7.** Propeller Hub Flange - As -Received

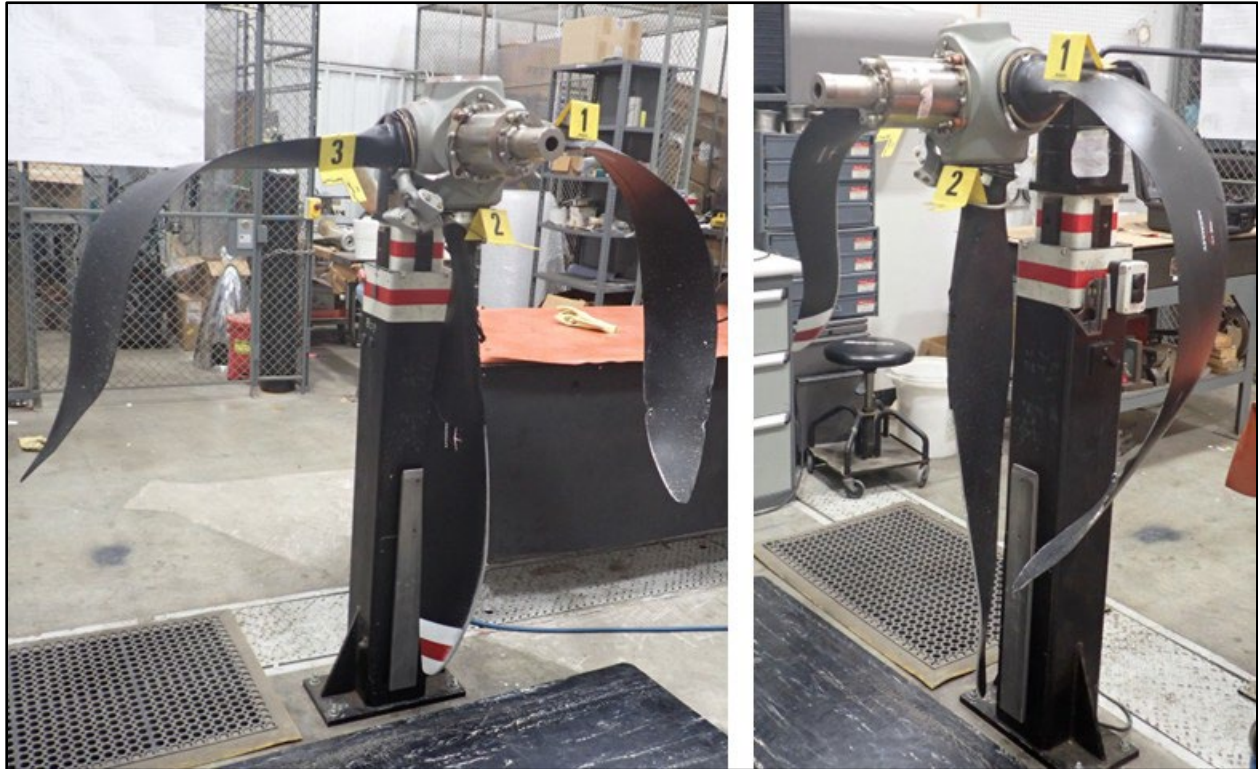
The propeller was mounted onto the test/disassembly stand for further examination and disassembly (Figure 8). All four blade snap rings were displaced from their respective blade grooves, which is consistent with blade making contact while the propeller was rotating at impact according to McCauley personnel. The anti-icing feed shoe on all four blades were torn at various locations along the leading edges. The anti-icing hardware was found on blades Nos. 1, 2, and 4. Blade No. 3 was missing the spray head assembly but the bracket holding it appeared torn and damaged, indicating the hardware was installed but separated during the accident sequence.

There were multiple bends present on all four blades; blade Nos. 2 and 3 contained "S" bends and blade Nos. 1 and 4 contained bends at different locations (Figure 8 and Figure 9). The No. 1 blade counterweight was not attached and missing

**Figure 8.** Propeller Mounted in a Test Stand

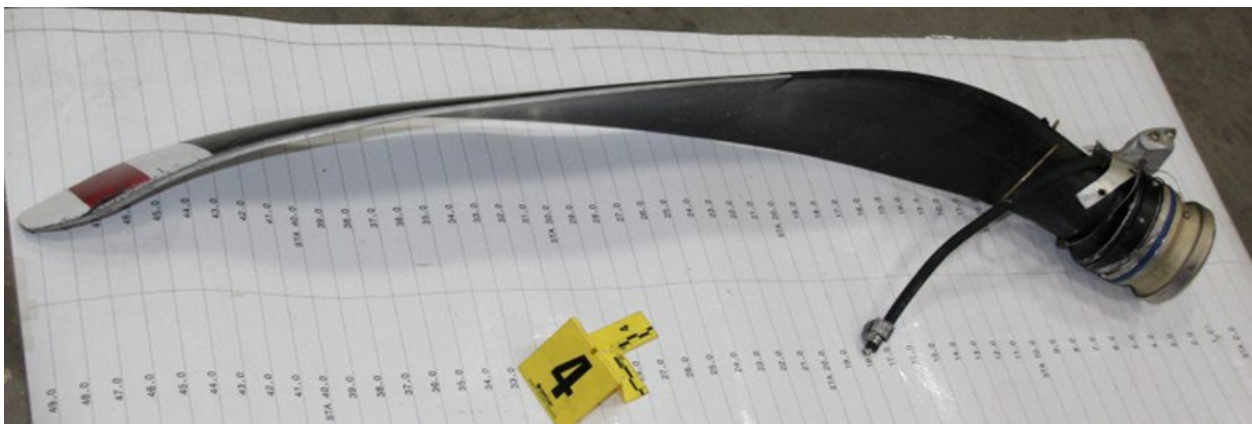
(not recovered). The No. 1 blade had hard body impact damage to the leading and trailing edges. The No. 4 blade counterweight was still attached to the blade. The leading and trailing edges of the No. 4 blade appeared typical of use with some scratching and loss of paint.

**Figure 9.** Separated No. 4 Blade

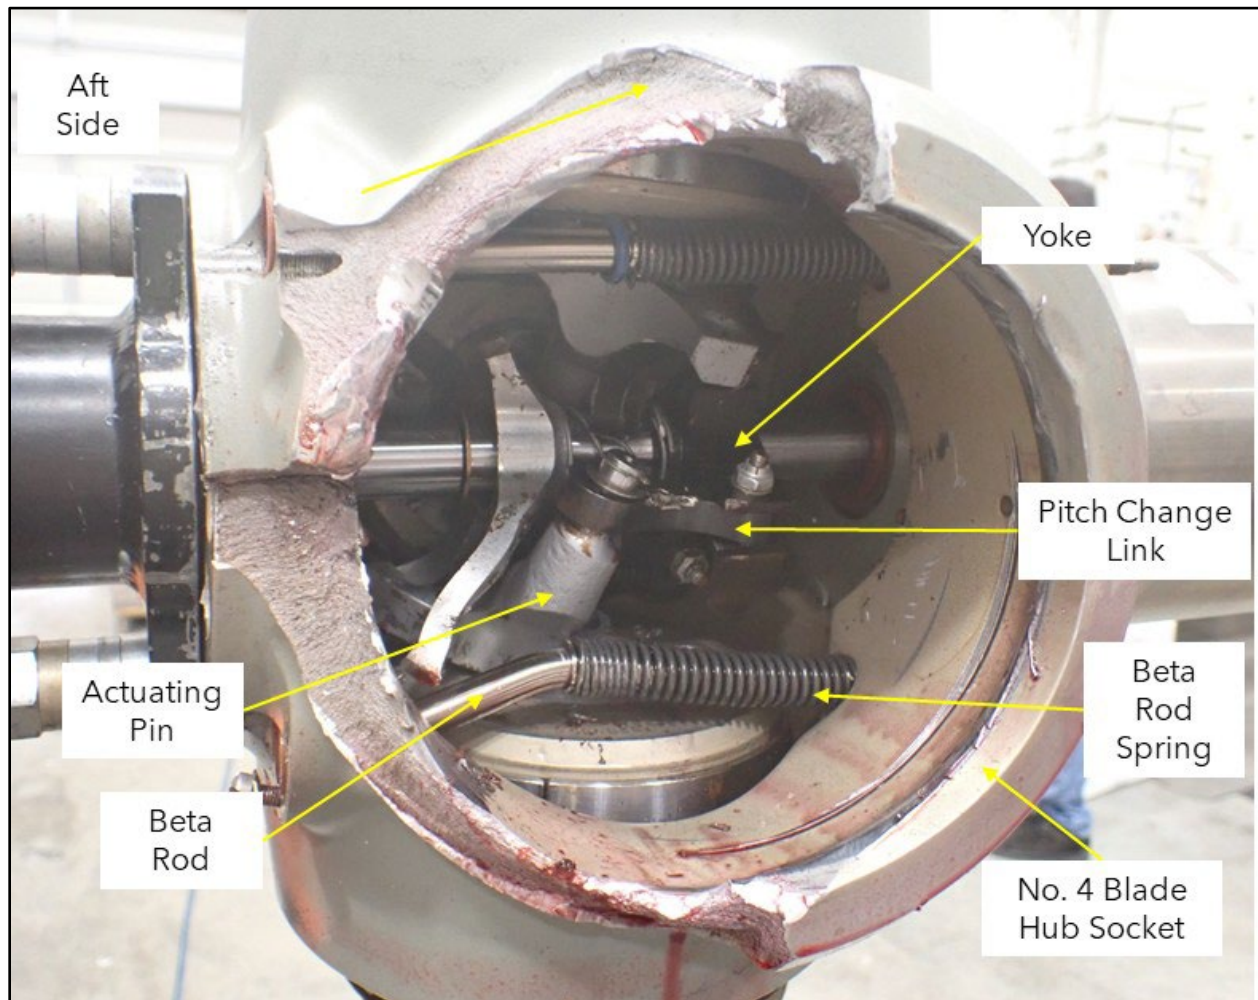
The hub, made of an aluminum alloy, was fractured at the No. 4 blade socket with approximately half of the blade socket rim missing and the fracture surface was of a consistent texture indicating an overload failure. There was no evidence of fatigue.

The hub, made of an aluminum alloy, was fractured at the No. 4 blade socket with approximately half of the blade socket rim missing. The fracture surface appeared to have a consistent texture indicating overload failure with no evidence of fatigue. Looking into the hub through the fractured No. 4 blade socket, the beta yoke was

found fractured, all four beta rods were damaged, and two of the four beta rods were bent (Figure 10). The actuating pin for the No. 4 blade was not found.

**Figure 10.** Fractured No. 4 Blade Hub Socket and Internal Hub Hardware

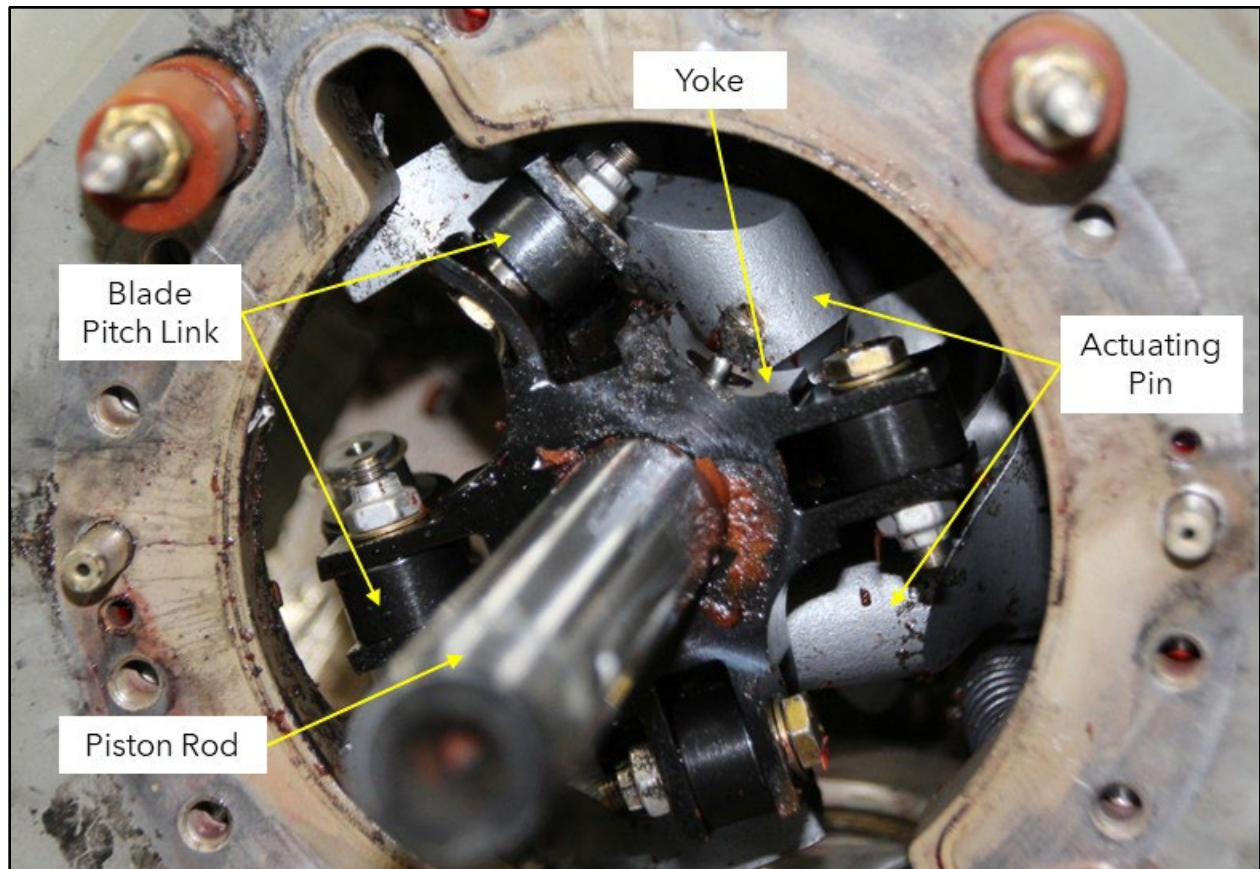
All four blade pitch change links, attached to the piston rod yoke, were intact but deformed (Figure 11). The actuation pins for blade Nos. 1, 2, and 3 were intact and attached to their respective links but the fasteners attaching the pins to the blade butts were fractured. Blade No. 4's actuating pin was missing, and its respective link was deformed in the same manner as the other links and the No. 4 blade butt end contained the remnants of pin attachment fasteners.

**Figure 11.** Internal Hub Hardware - Cylinder/Spring Housing Removed

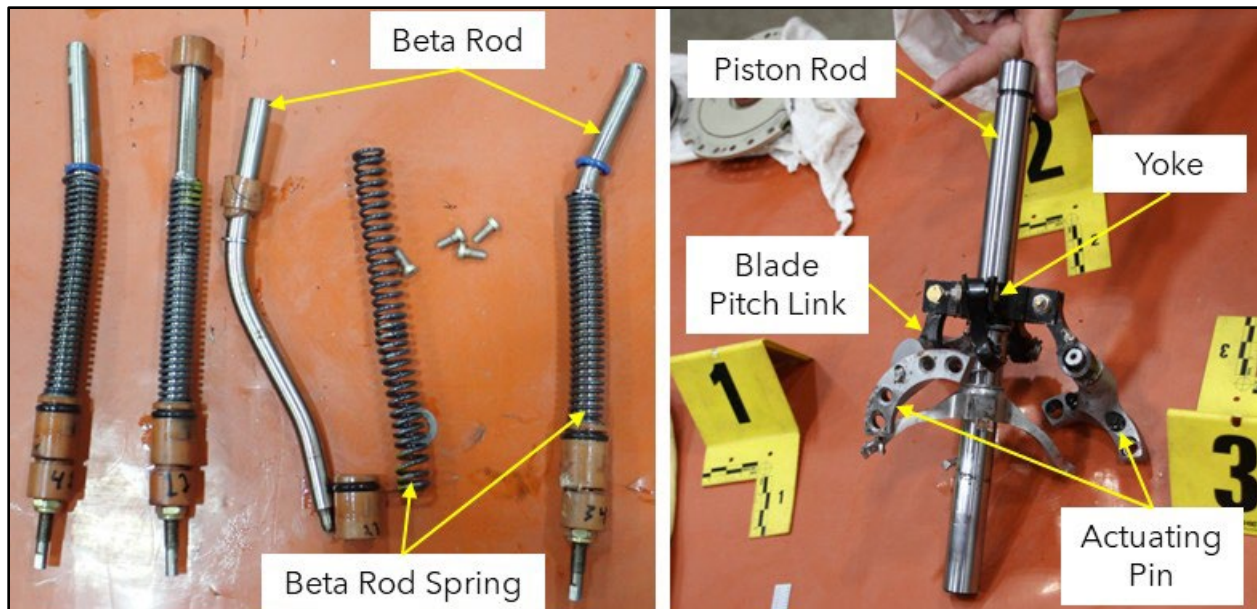
The piston rod with the attached yoke, links and remaining actuation pins were removed from the hub, followed by the beta rods. All four beta rods were still found installed and intact but showed varying amounts of bending from contact with the actuating pins (Figure 12). The beta ring normally on the aft side of the hub was missing.

**Figure 12.** Beta Rods (Left) and Piston Rod Yoke - Removed

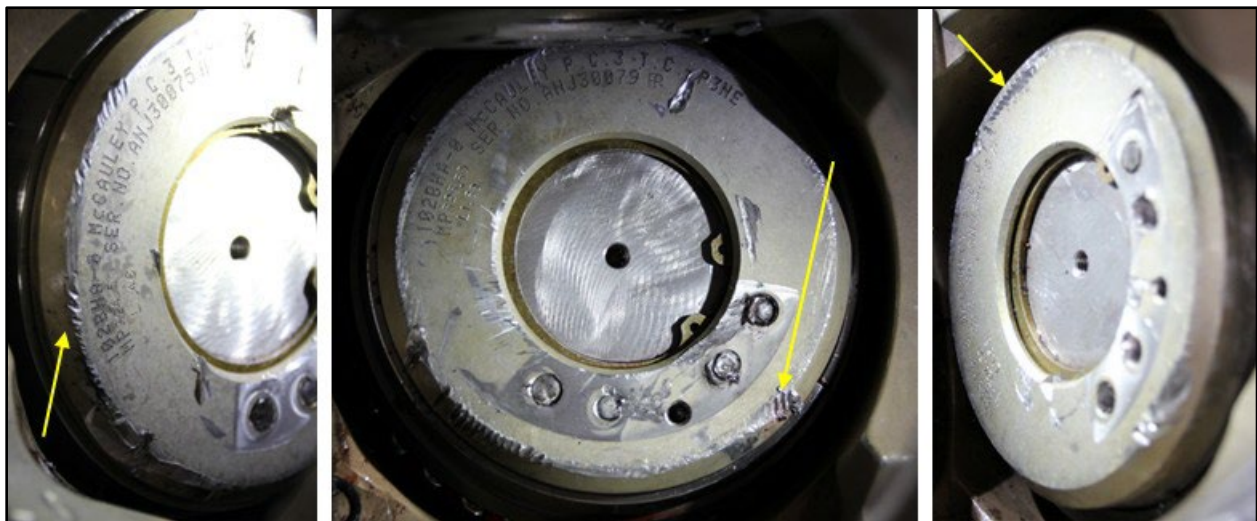
With the internal hub components removed, the three remaining blade butts exhibited multiple witness marks that correspond to the beta rod springs (Figure 13).

**Figure 13.** Blade Nos. 1 (Left), 2 (Center), and 3 (Right) Butt Damage

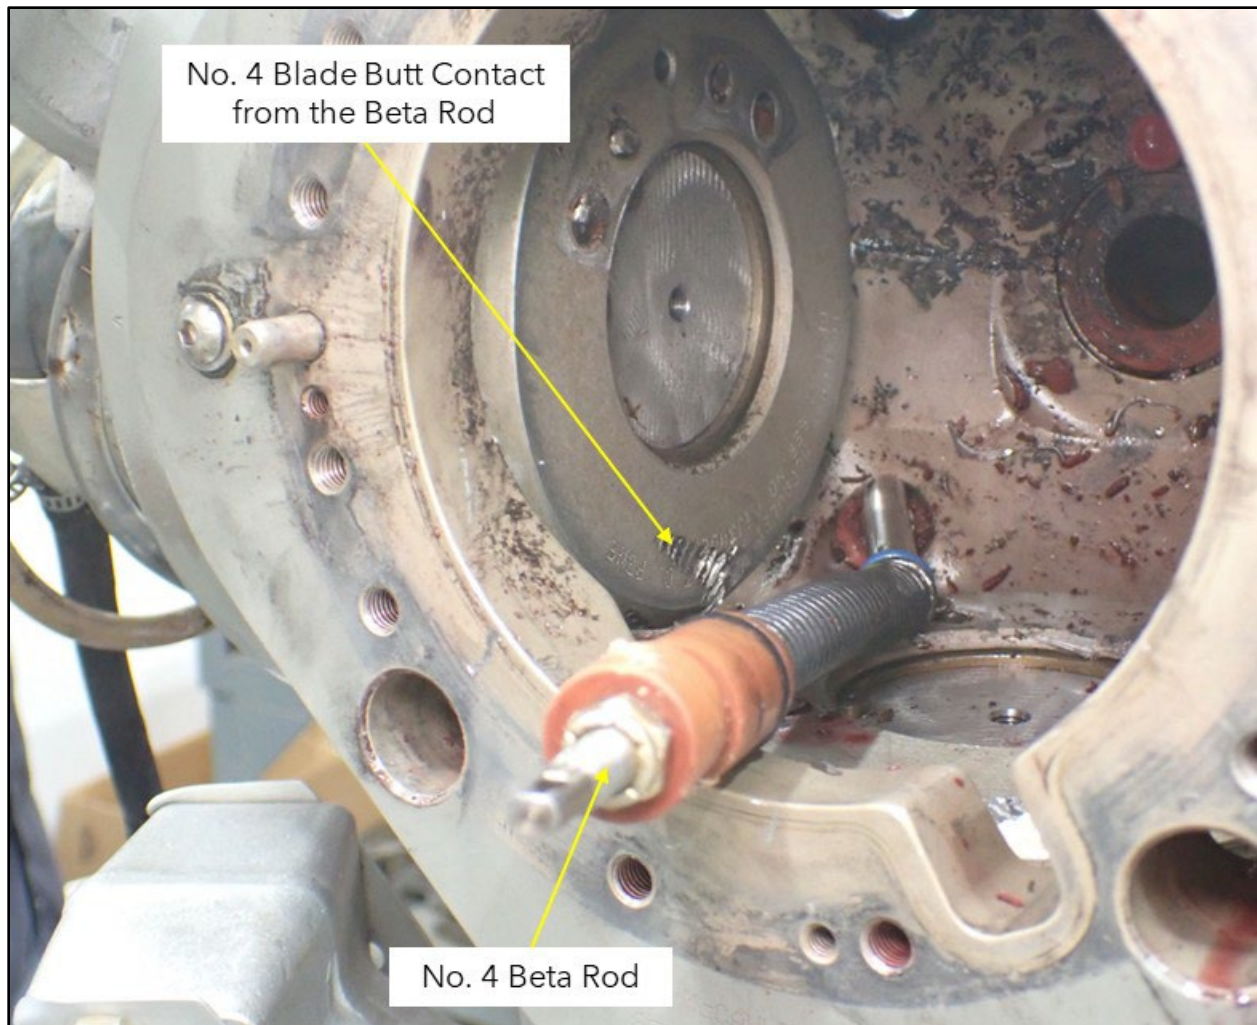
The butt of the No. 4 blade was damaged due to contact with a beta rod/spring, where the beta rod spring imparted contact witness marks (Figure 14).

**Figure 14.** No. 4 Blade Butt Viewed Through the Hub

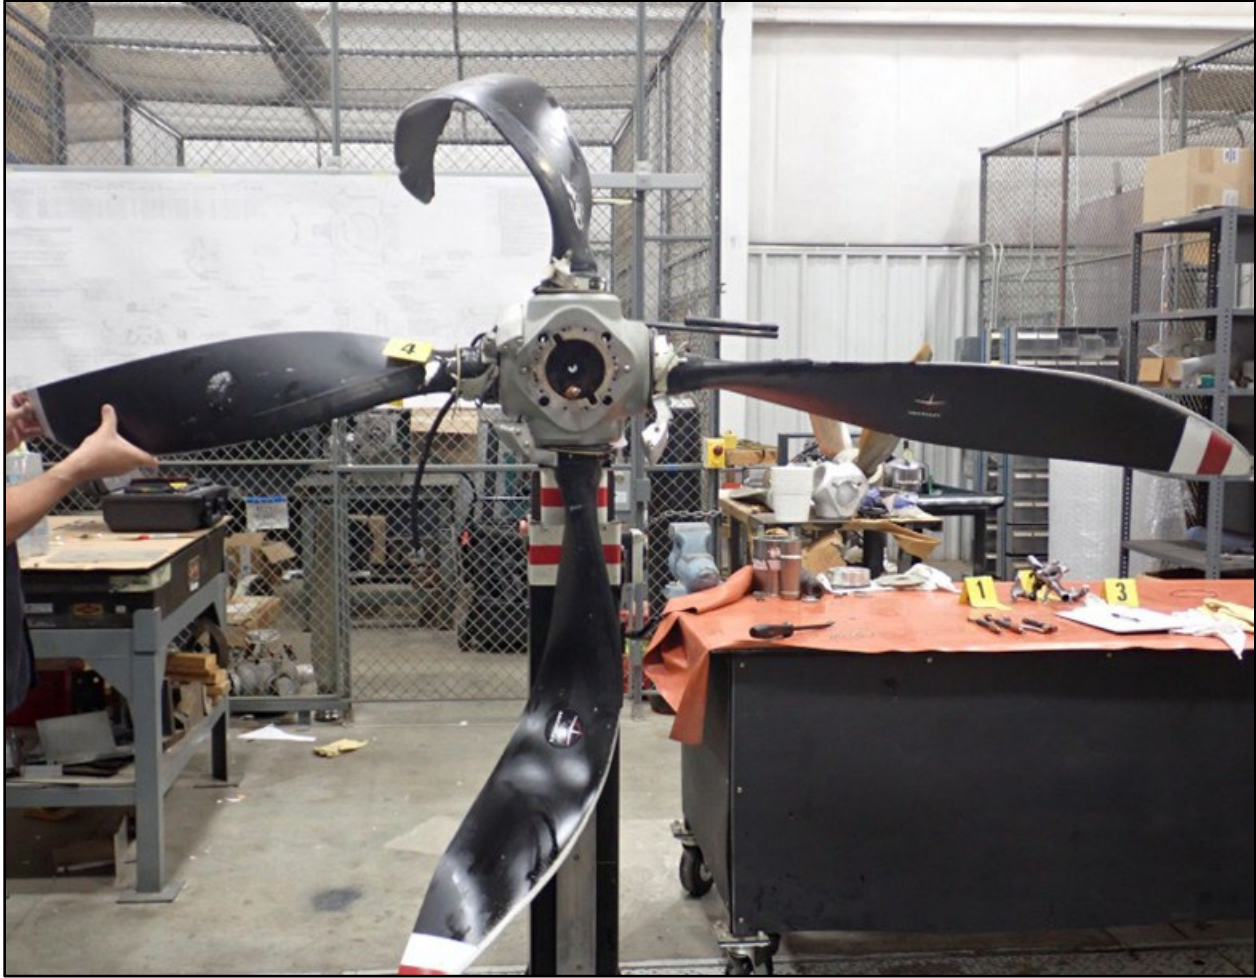
The No. 4 blade was held up next to the No. 4 hub socket and the three remaining blades were rotated in their respective hub sockets to a position where the blade butt witness marks would have made contact with the beta rod springs in order to estimate the blade angle at the time of impact. From this estimated blade position, the propeller appears to have been in a high-power forward thrust condition at the time of propeller impact.

**Figure 15.** Propeller with Blades Aligned to Beta Rod Witness Marks
