**From:** Donald Kramer  
**Sent:** Tuesday, March 4, 2025 9:59 AM  
**To:** Tim Sorensen  
**Subject:** Materials Laboratory Factual Report - Email - ANC25MA018  
**Attachments:** Mat\_Lab\_0743.JPG; Mat\_Lab\_0746.JPG; Mat\_Lab\_0750.JPG; Mat\_Lab\_0752.JPG

**Location:** Nome, Alaska  
**Date:** February 6, 2025  
**Vehicle:** Cessna 208B, N321BA  
**Investigator:** Timothy Sorensen, AS-CEN

Piece of elevator torque tube and separated flanged tube-end fitting.  
Left-side flap interconnect rod assembly, separated into two pieces.

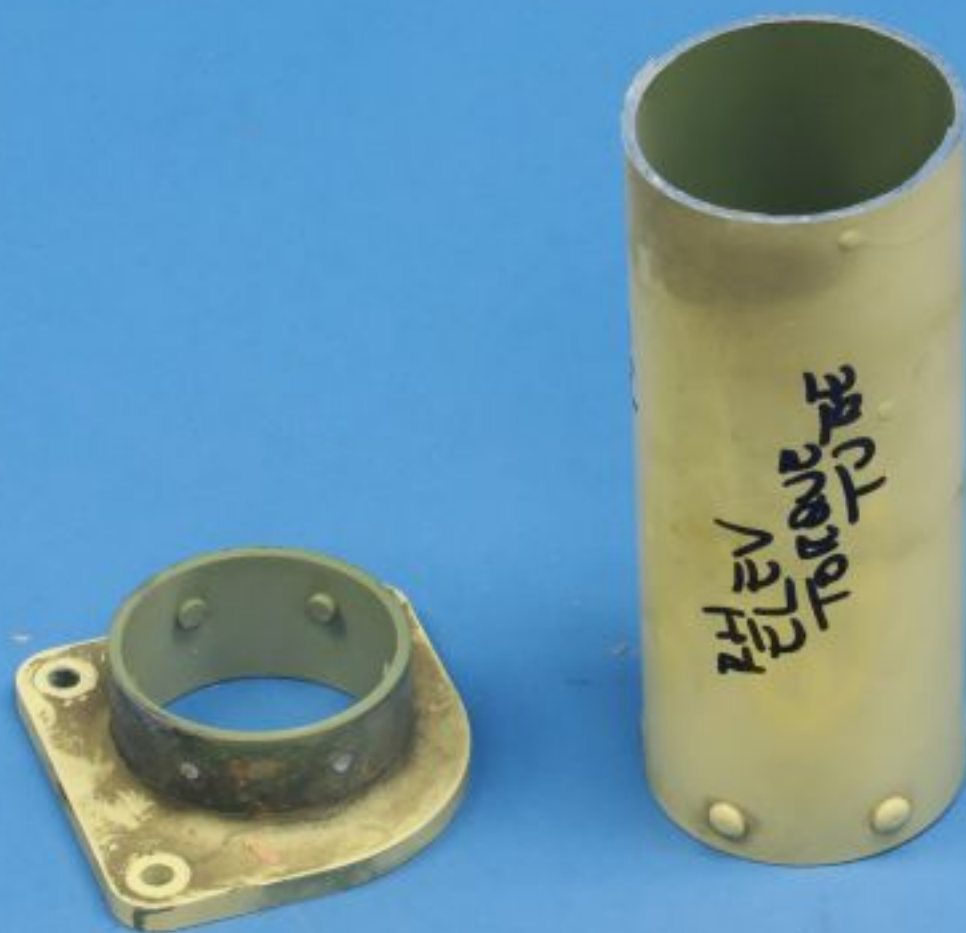
The elevator torque tube was originally connected to the tube end fitting. The fitting contained a ring-shaped flange that lapped approximately 0.75 inches inside the end of the tube. Six equally spaced rivets joined the tube to the ring-shaped flange around the circumference of the tube. All rivets exhibited shear deformation and all fractures exhibited shear sliding features consistent with overstress shear fractures. Two adjacent rivets exhibited shear fracture features aligned primarily in the longitudinal direction of the tube. On either side of these two rivets, the adjacent rivets exhibited shear fracture features in a mixed longitudinal and circumferential direction. The final two rivets, adjacent to one another and 180 degrees opposite of the longitudinally sheared rivet pair, the shear features were aligned primarily in the circumferential direction. The combined deformation and fracture features were consistent with overstress separation of the torque tube from the fitting from bending followed by torsion loads on the torque tube.

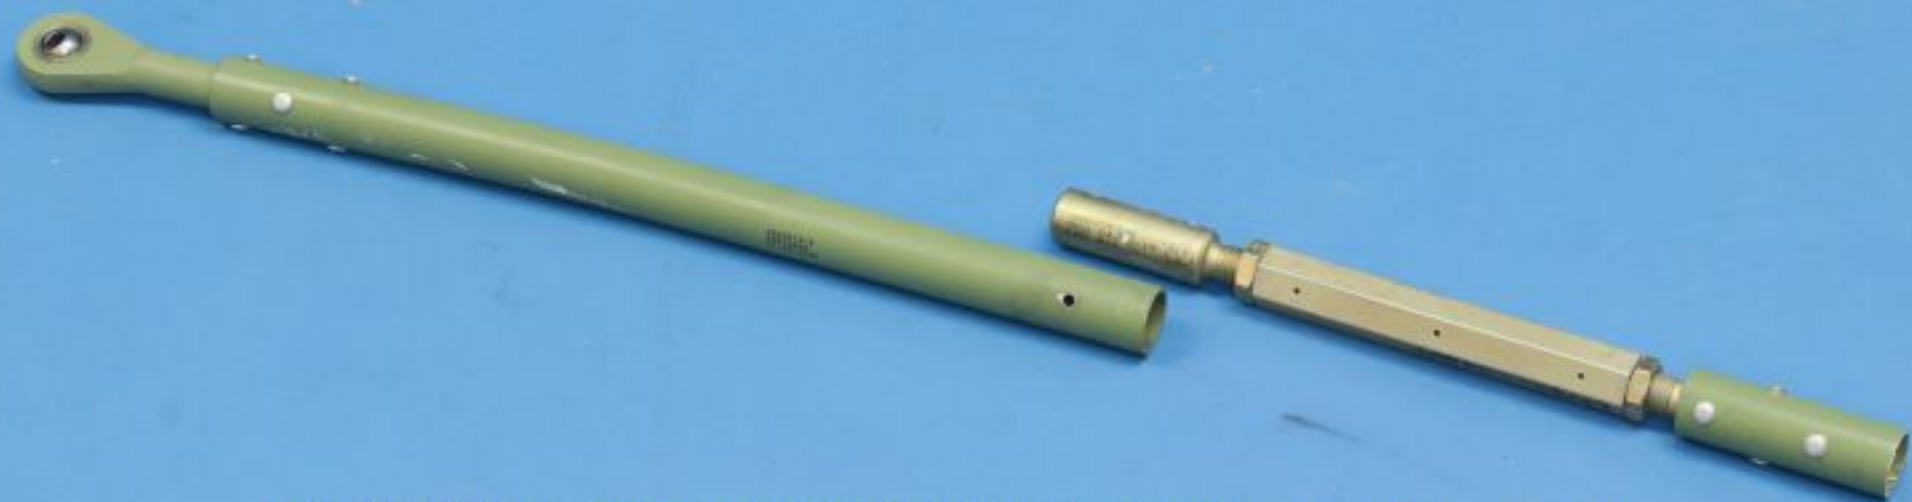
The flap interconnect rod assembly contained a lapped and riveted joint where the hollow tube was fit over and joined to an approximately 1.75-inch-long fitting by six rivets. The rivets were spaced at 90-degree intervals around the circumference of the tube, such that there were two rivets at each of two diametrically opposed clock positions and one rivet at each of the other two clock positions. All rivets were fractured at the interface between the tube and the fitting. The rivets exhibited shear deformation

oriented in the longitudinal direction of the rod assembly and the fracture surfaces exhibited shear sliding marks, also in the longitudinal direction. The combined deformation and fracture features were consistent with a tensile overstress separation of the tube assembly.
