# National Transportation Safety Board

**ANC25MA018**

## **AIRCRAFT SYSTEMS**

Specialist's Factual Report

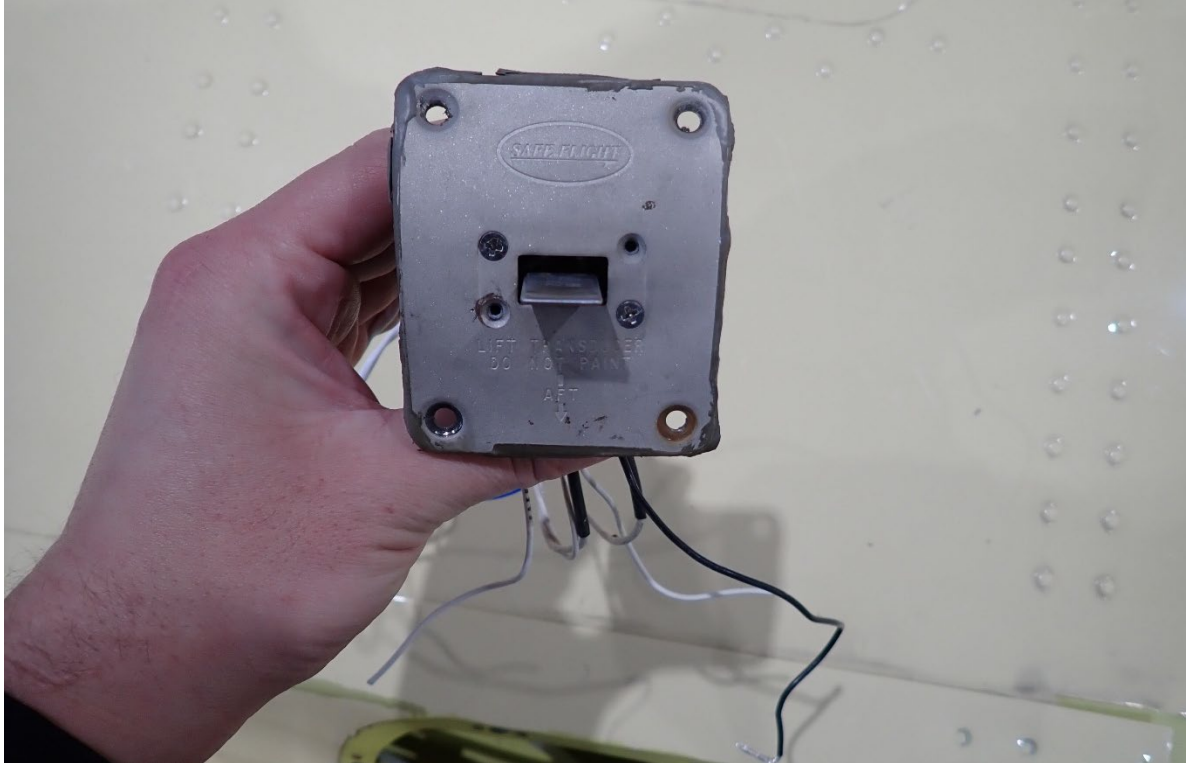
The airplane's lift transducer mounting plate was removed from the leading edge of the airplane's left wing (See Figure 4). The transducer was visually examined; no faults were found. The lift vane could be moved by hand with no restrictions noted. The lift vane and plate heating elements were confirmed as operational when electrical power was applied.

**Figure 4.** The airplane's stall warning vane and mounting plate, as removed from the left wing.

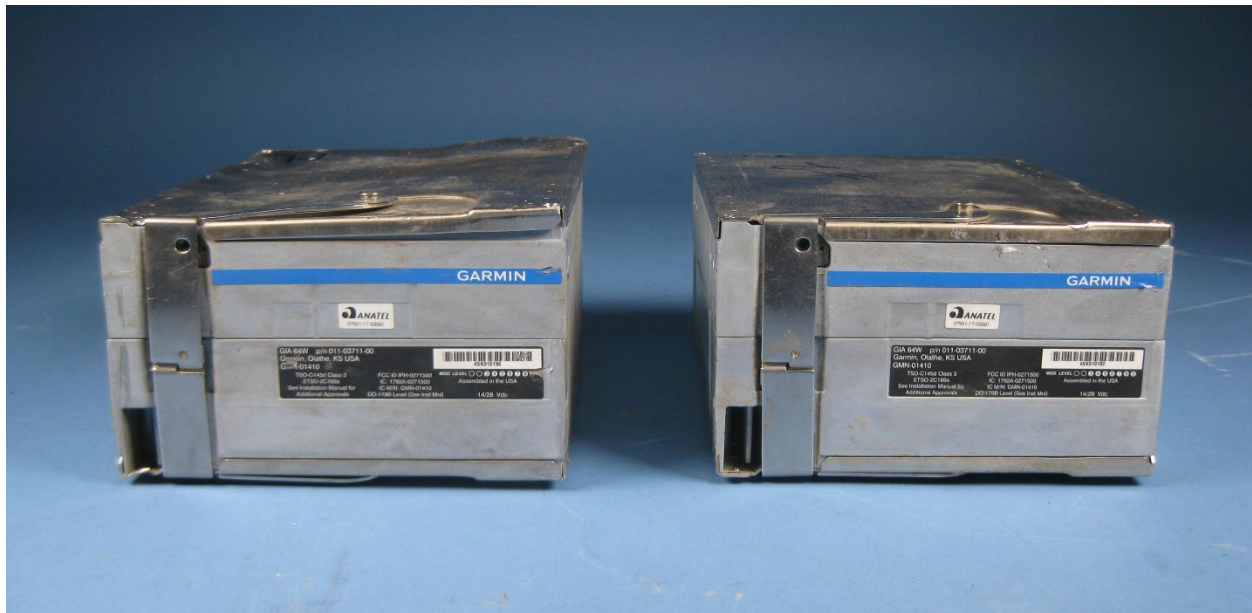
**Figure 5.** The two GIA 64W units.

The exterior of GIA 64W serial number 4SK010182 was undamaged, with only minor scratches noted.

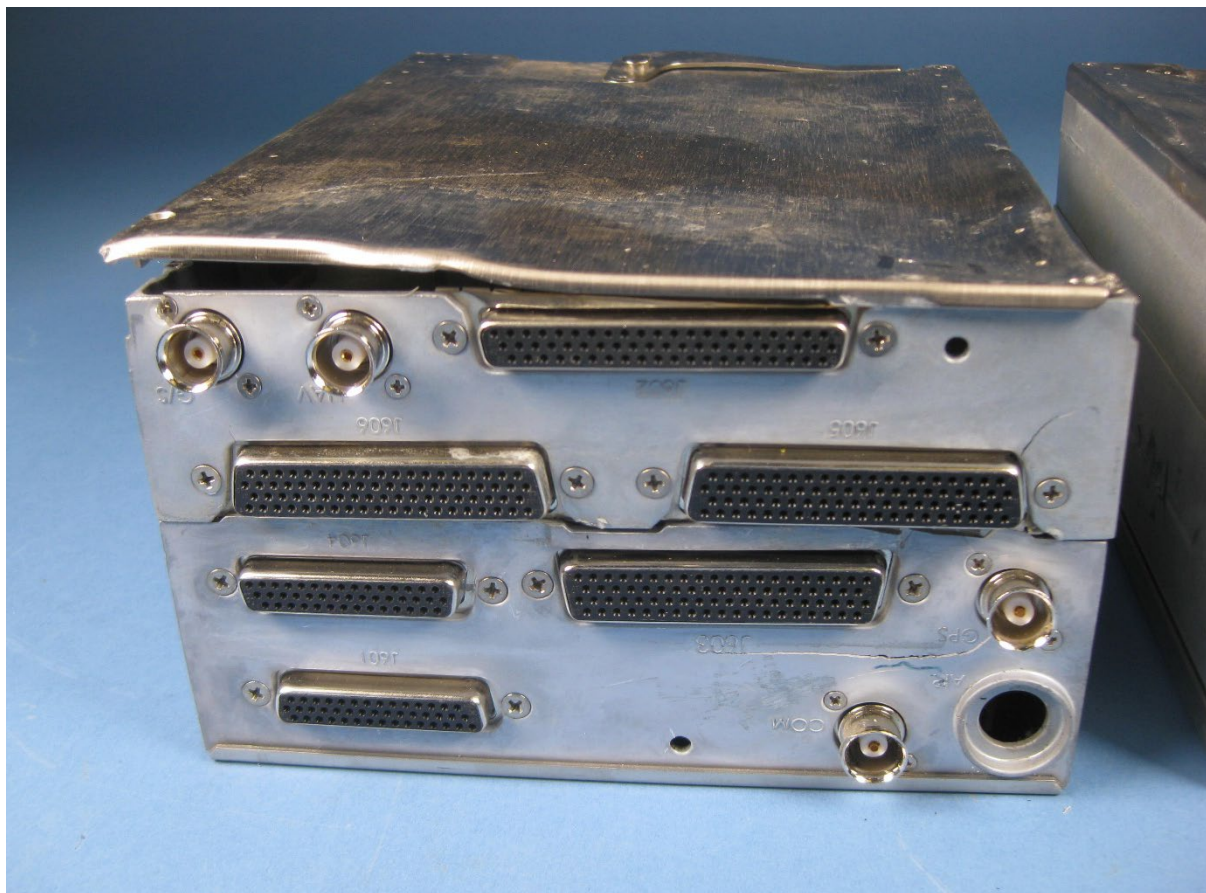
The top cover of GIA 64W serial number 4SK010156 was separated from the unit's chassis in the front right and back left corners. See Figure 6.

**Figure 6.** The rear exterior panel of the GIA 64W, serial number 4SK010156.

A crack in the upper back cover panel was noted near the corner of the J605 connector. The lower back cover panel was fractured from the area of the GPS connector to near the J603 connector.

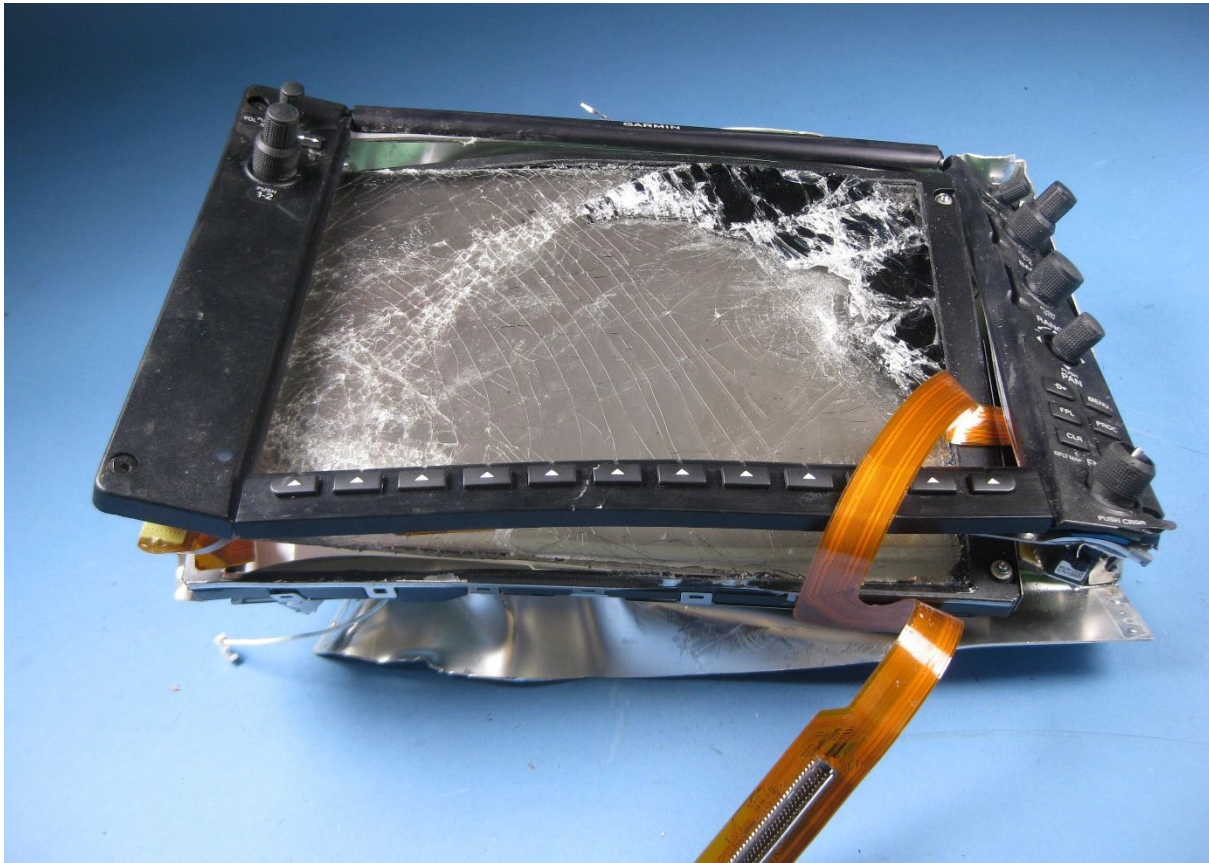
The display was damaged from the accident sequence impact. The glass front display was shattered and broken. The display's plastic front panel was broken and separated from the display along the top edge. The display chassis was bent and broken open and the internal circuit cards were displaced. Two internal ribbon cables were disconnected and loose. See Figure 7.

**Figure 7.** Primary flight display number 1, a Garmin GDU 1050A display unit.

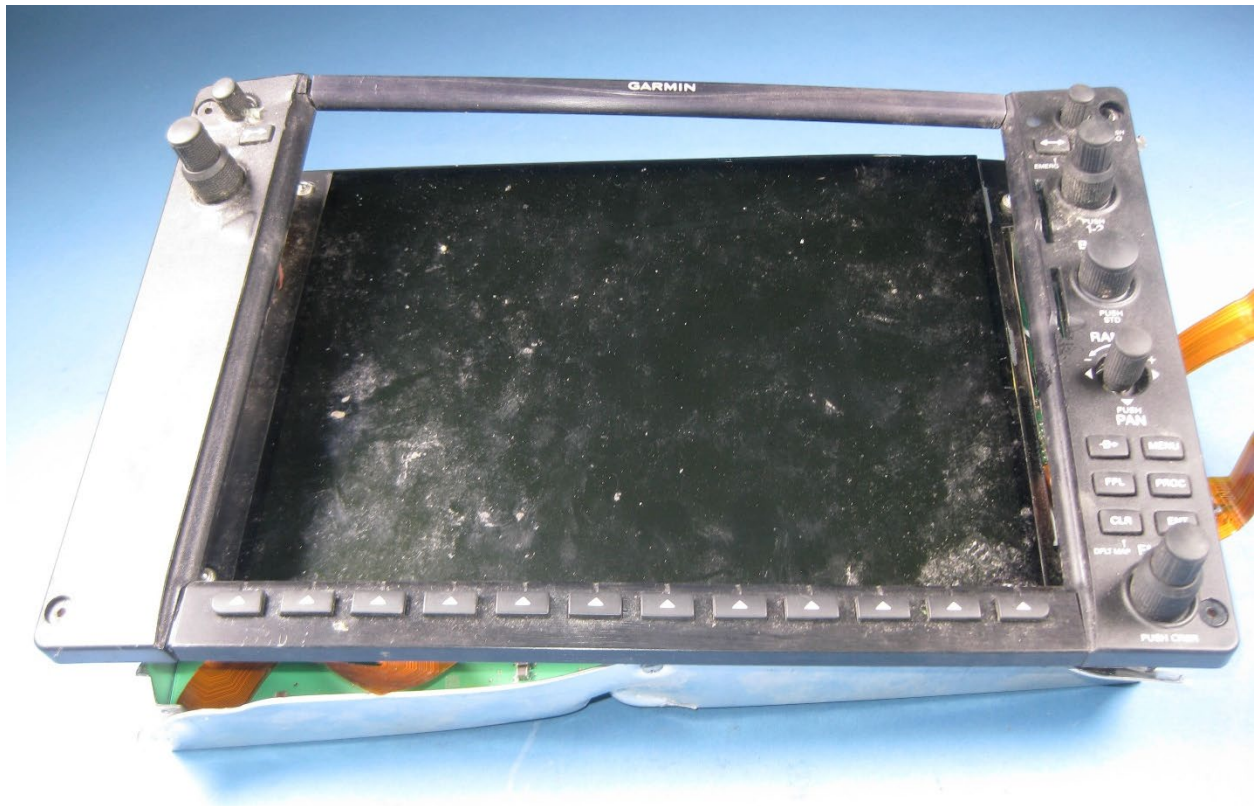
The display was damaged from the accident sequence impact. The glass front display was abraded in several areas. The display's plastic front panel was broken and separated from the display along the top edge. The rear chassis was bent and broken open and the internal circuit cards displaced. Two ribbon cables were disconnected and loose. See Figure 8.

**Figure 8.** Garmin display unit, serial number 494105937.

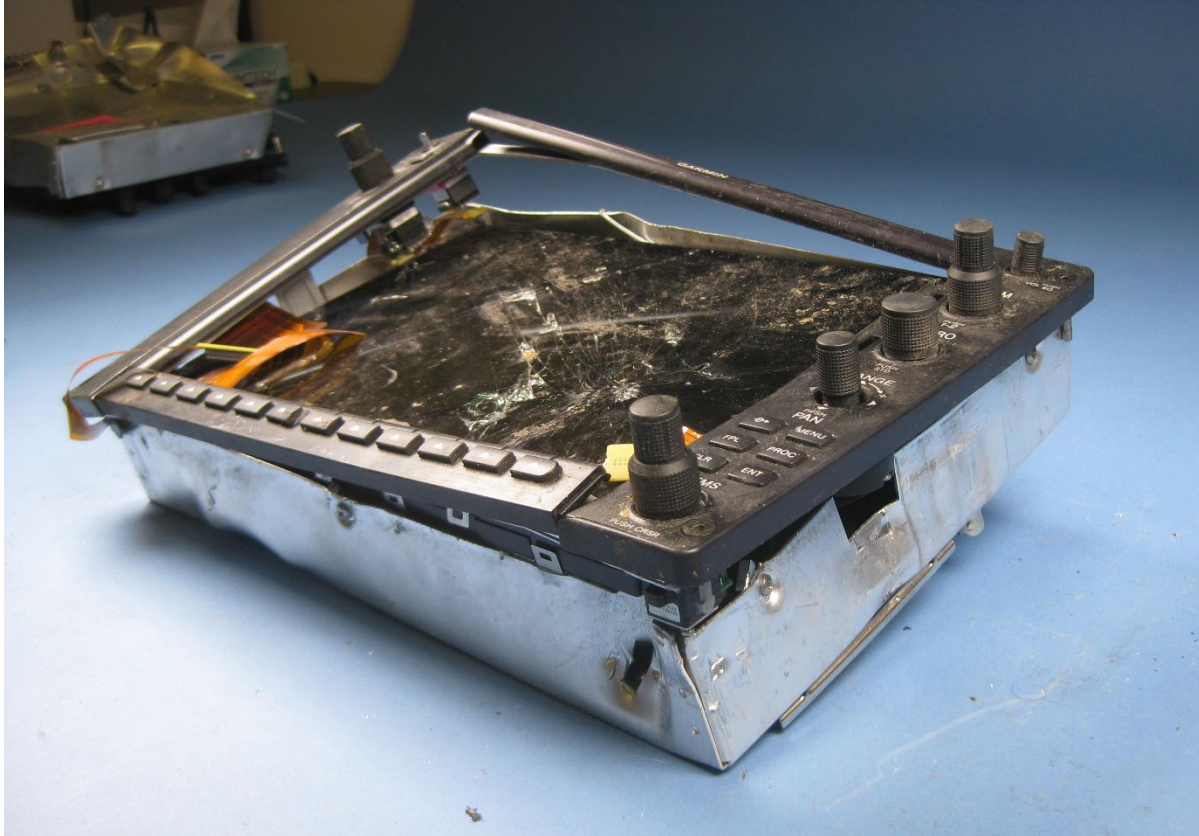
The display was damaged from the accident sequence impact. The glass front display was shattered and broken. The display's plastic front panel was broken and separated from the display along the top and left side edges. The display chassis was bent and broken open and the internal circuit cards were displaced. See Figure 9.

**Figure 9.** Display unit, Garmin GDU 1050A, serial number 494105862.

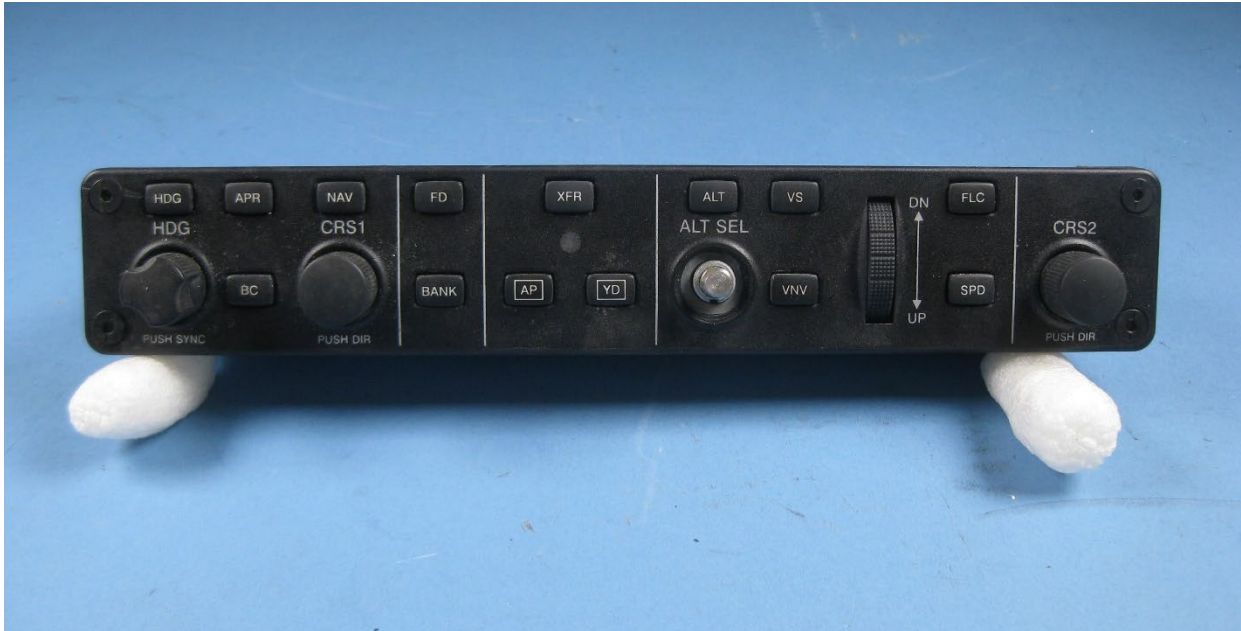
The cover for the altitude select (ALT SEL) knob was missing. No other external damage was noted during a visual examination of the unit's exterior. See Figure 10.

**Figure 10.** The front panel of the Autopilot Mode Control Unit, with the ALT SEL knob cover missing.

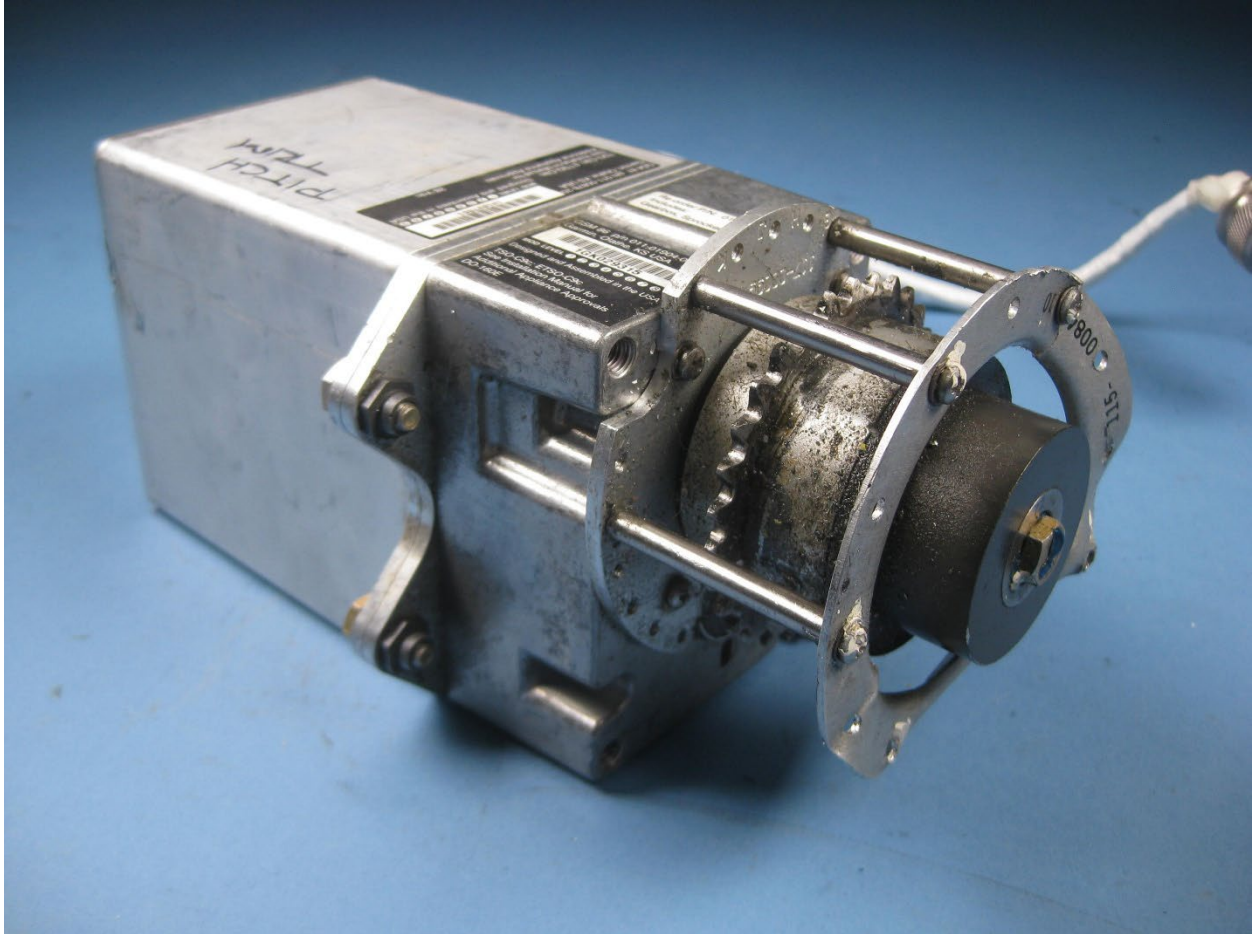
The servo's exterior was visually examined. No evidence of external physical damage was noted except for the outer capstan cover panel, which was bent inwards towards the servo. See Figure 11. The unit's electrical connector and cable were noted, with no visible damage. All of the connector pins were found straight, with no evidence of corrosion or electrical arcing noted.

**Figure 11.** The airplane's autopilot pitch trim servo and attached servo gearbox.

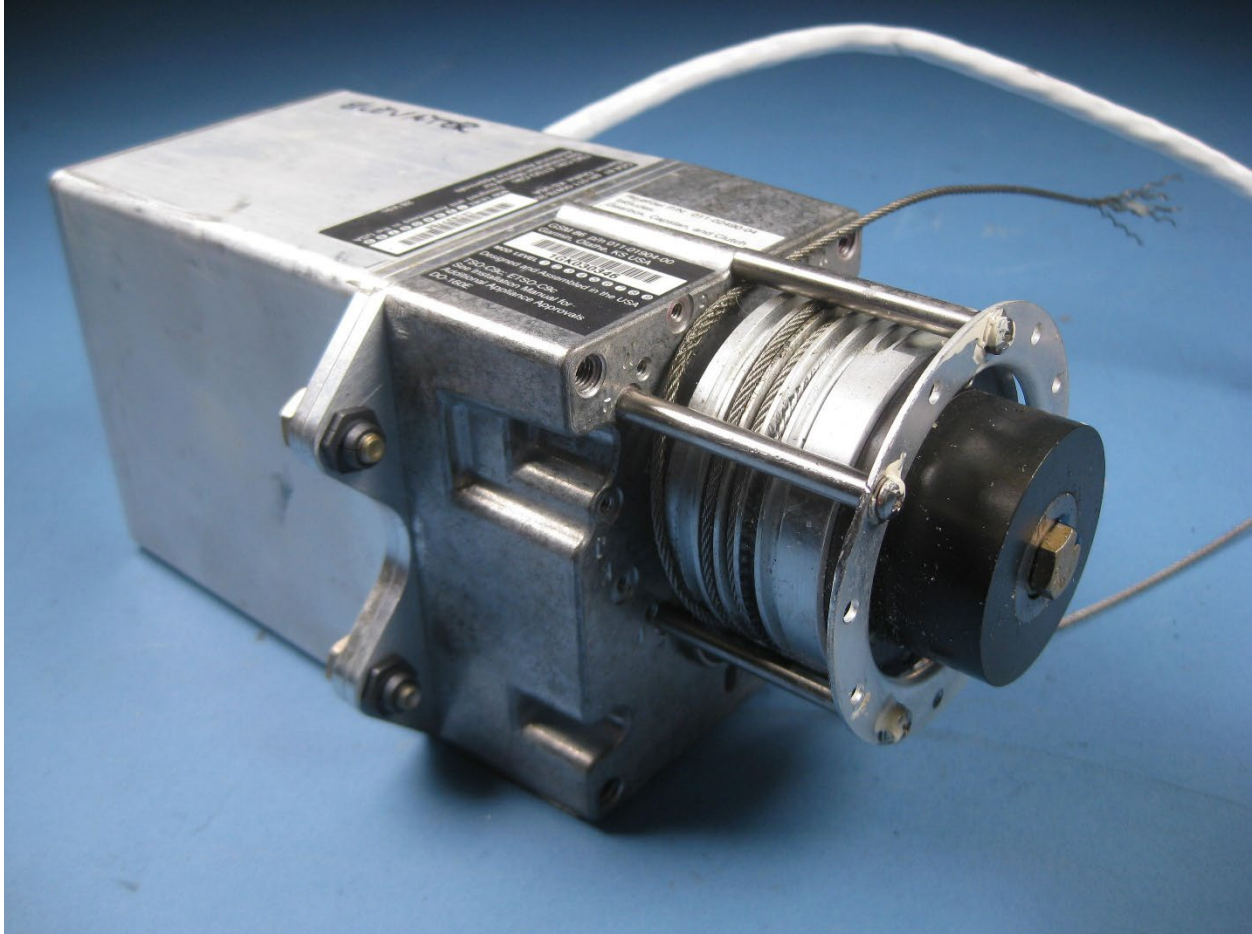
The servo's exterior was visually examined. No evidence of external physical damage was noted. Portions of a servo control cable were wrapped around the capstan and extended off the servo. The unit's electrical connector and cable were noted, with no visible damage. All of the connector's pins were found straight and no evidence of corrosion or electrical arcing was noted.

**Figure 12.** The airplane's autopilot elevator servo and attached servo gearbox.

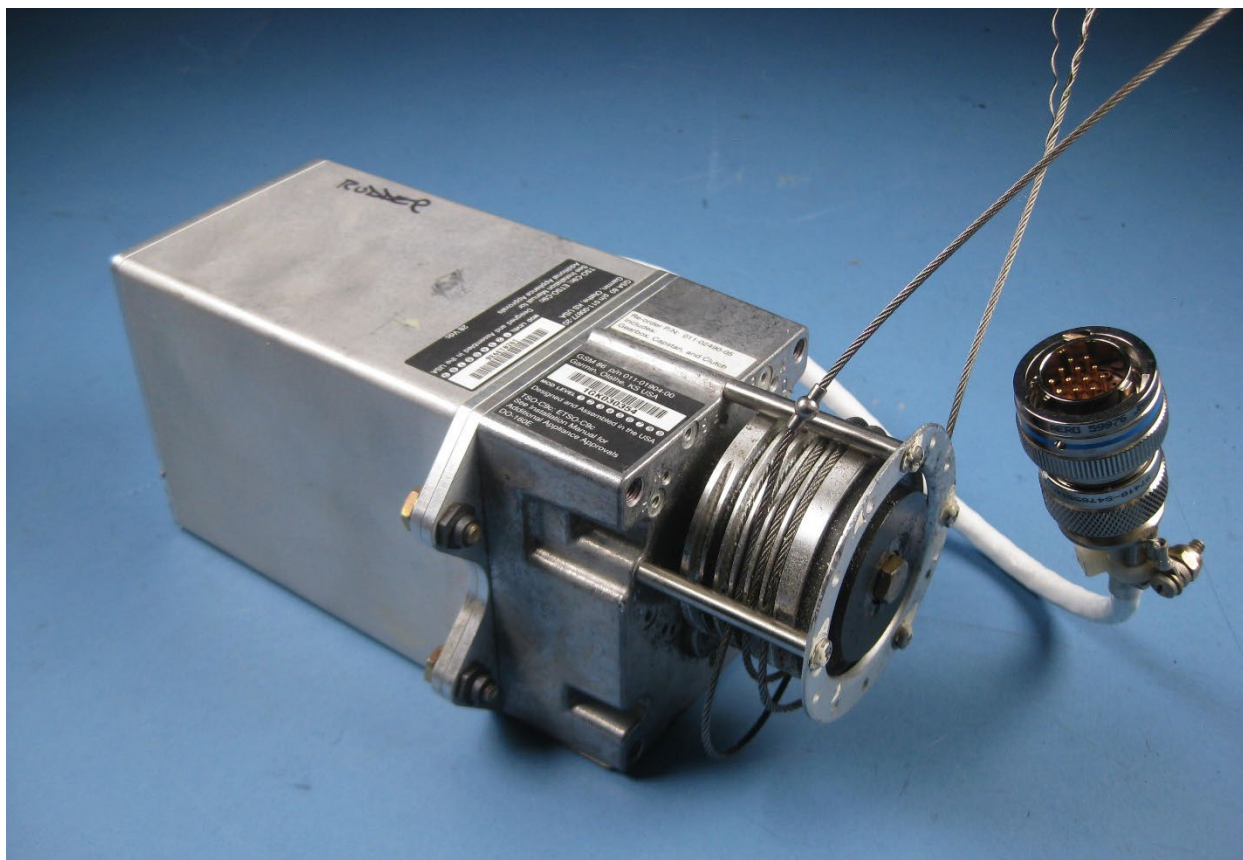
The servo's exterior was visually examined. No evidence of external physical damage was noted. Portions of a servo control cable were wrapped around the capstan and extended off the servo. The unit's electrical connector and cable were noted, with no visible damage. All of the connector's pins were found straight, with no evidence of corrosion or electrical arcing noted.

**Figure 13.** The airplane's autopilot rudder servo and attached servo gearbox.

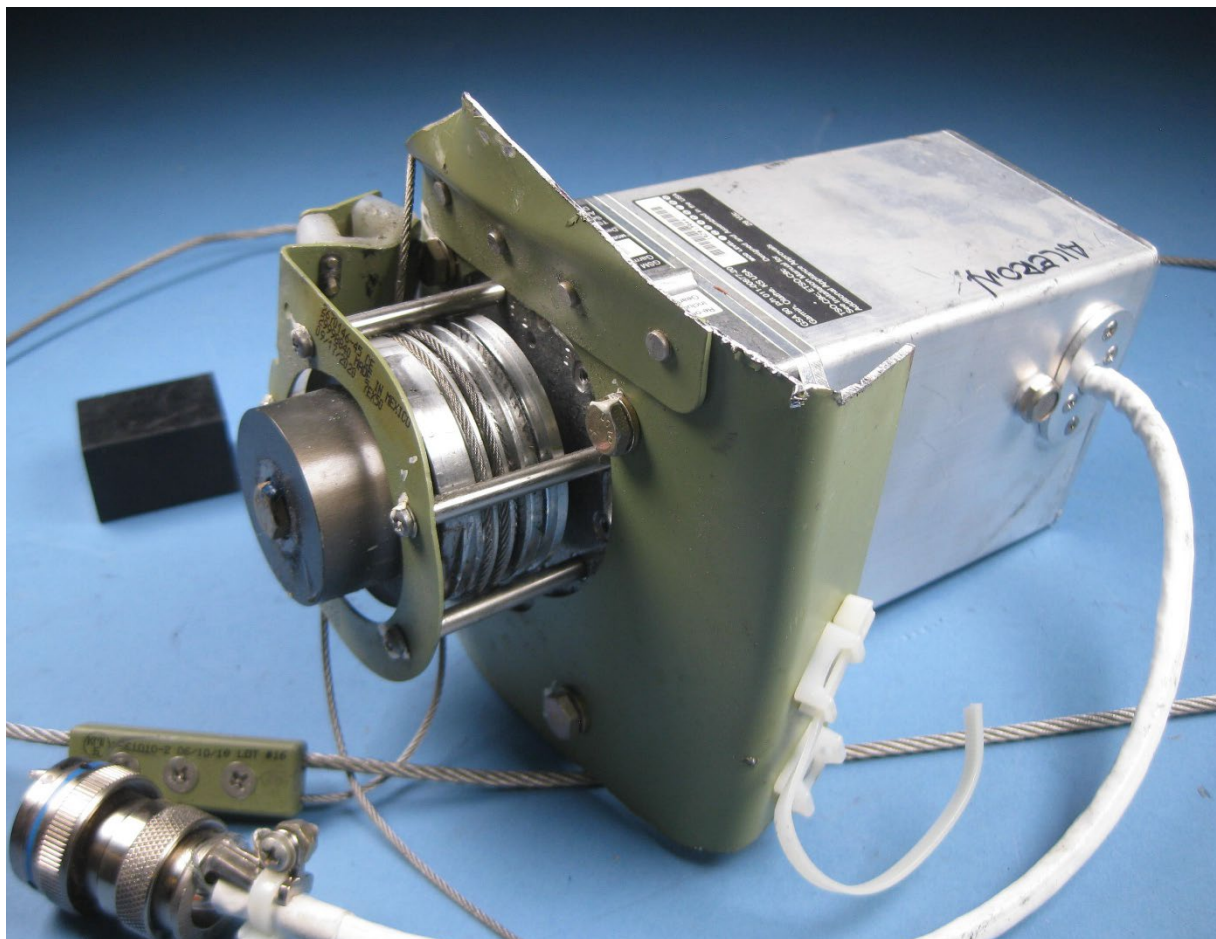
The servo's exterior was visually examined. No evidence of external physical damage was noted. Portions of the servo's control cable were wrapped around the capstan and extended off the servo. The servo cable was connected to its associated flight control cable via a connecting bridle. The unit's electrical connector and cable were noted, with no visible damage. All of the connector's pins were found straight and no evidence of corrosion or electrical arcing were noted.

**Figure 14.** The airplane's aileron autopilot servo, the attached servo gearbox, and associated components.
