National Transportation Safety Board  
Office of Aviation Safety  
Washington, DC 20594

ANC25MA018

## **OPERATIONAL FACTORS**

Group Chair's Factual Report  
November 24, 2025

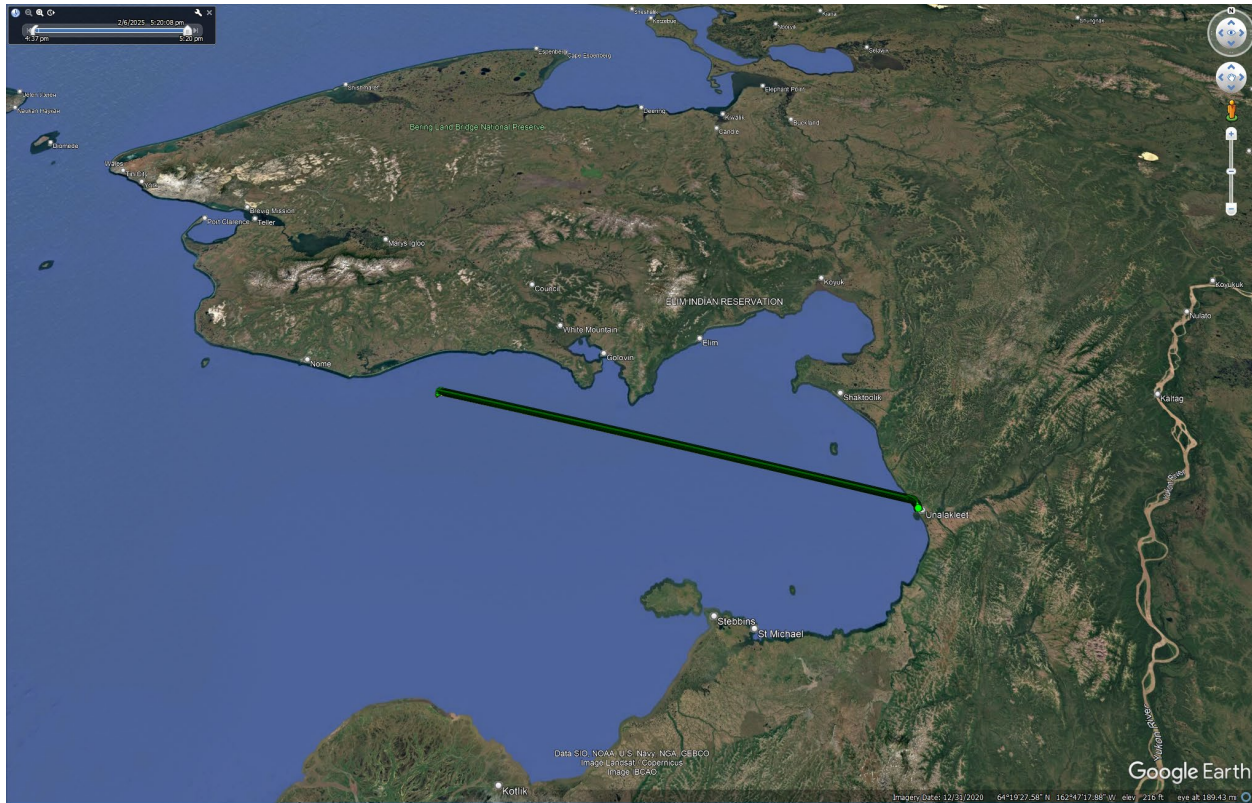
| 0019:47 | BRG445 indicates 3500 ft and 101kt, then begins a rapid descent and concurrent loss of speed, followed by a left turn. |
| 0020:17 | Last data point - ADS-B 200 ft, H121, 52 kts |

**Figure 1. Accident flight track (maximum altitude 7,750 ft msl). (Source: FAA)**
