**National Transportation Safety Board**

ANC25MA018

**AIRWORTHINESS FACTUAL REPORT**

Location: Nome, Alaska  
Date: February 6, 2025  
Time: 1520 Alaska standard time  
Aircraft: Textron Aviation 208B, N321BA

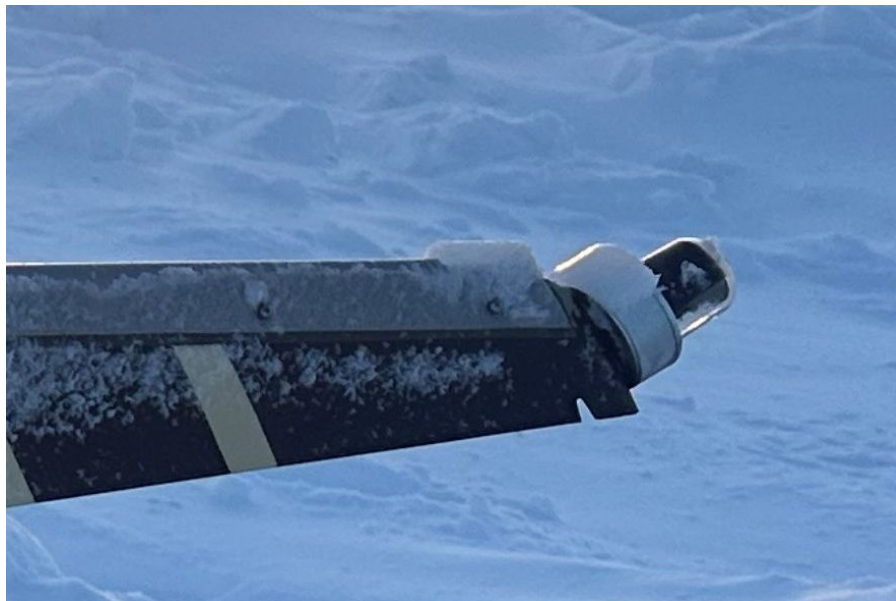
Limited ice accumulation was observed on the leading-edge surfaces aft of the TKS porous membranes. Significant ice accumulation was observed on the base of the beacon/strobe light and above the TKS protected area at the top of the vertical stabilizer.

*Figure 1 - Vertical Stabilizer at Accident Site*

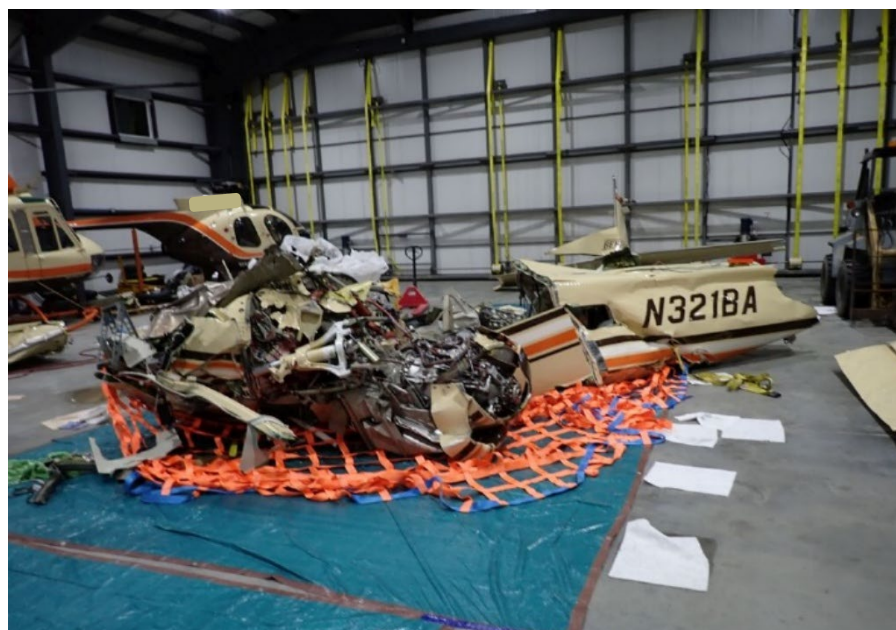
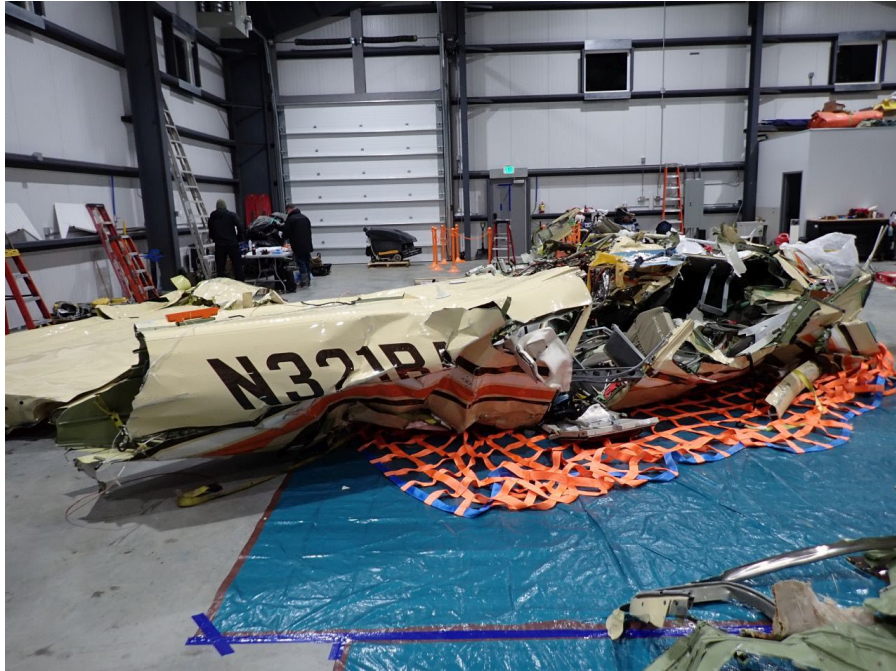
Both main landing gears were found twisted and bent aft with the wheels separated. The nose landing gear exhibited impact damage and was found partially attached and the wheel was separated.

*Figure 2 - Fuselage during post-recovery examination (Textron photo)*

Figure 3 - Fuselage during post-recovery examination (Textron photo)

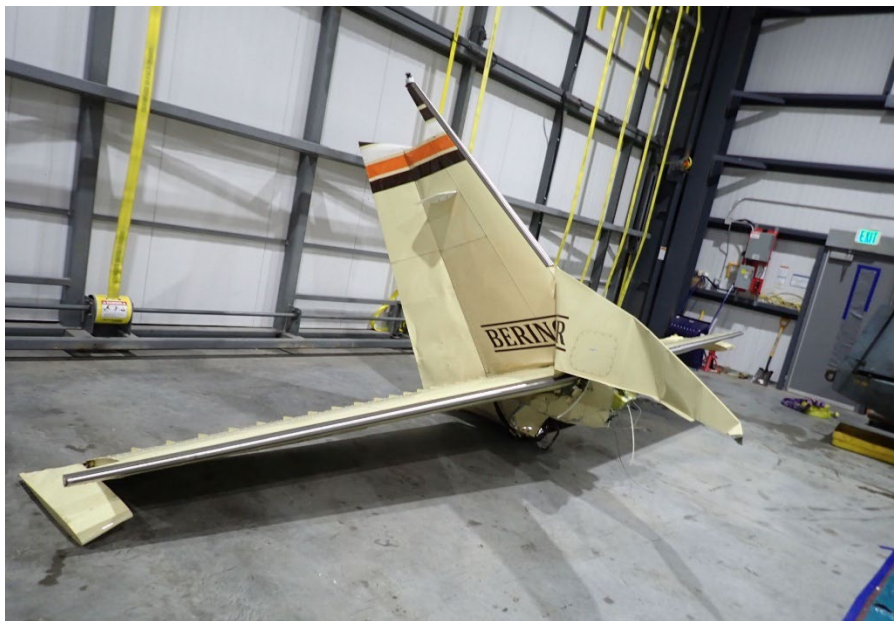
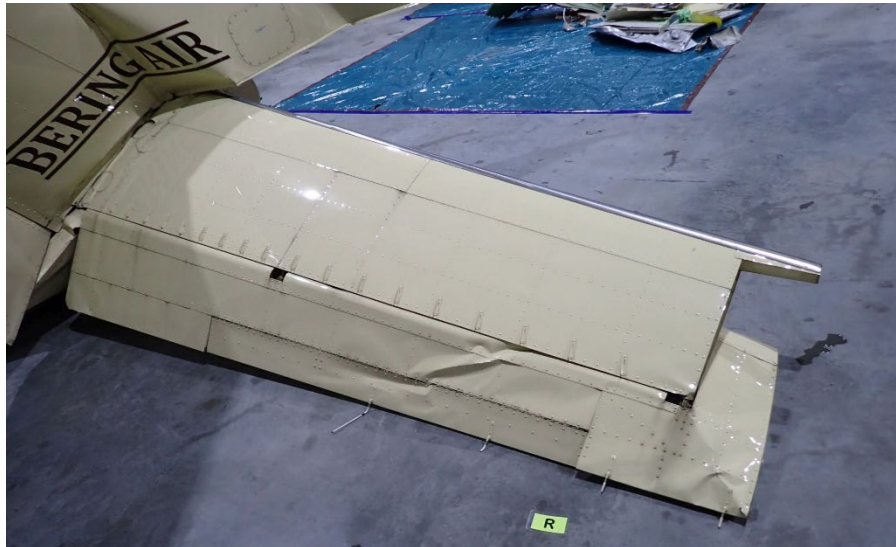
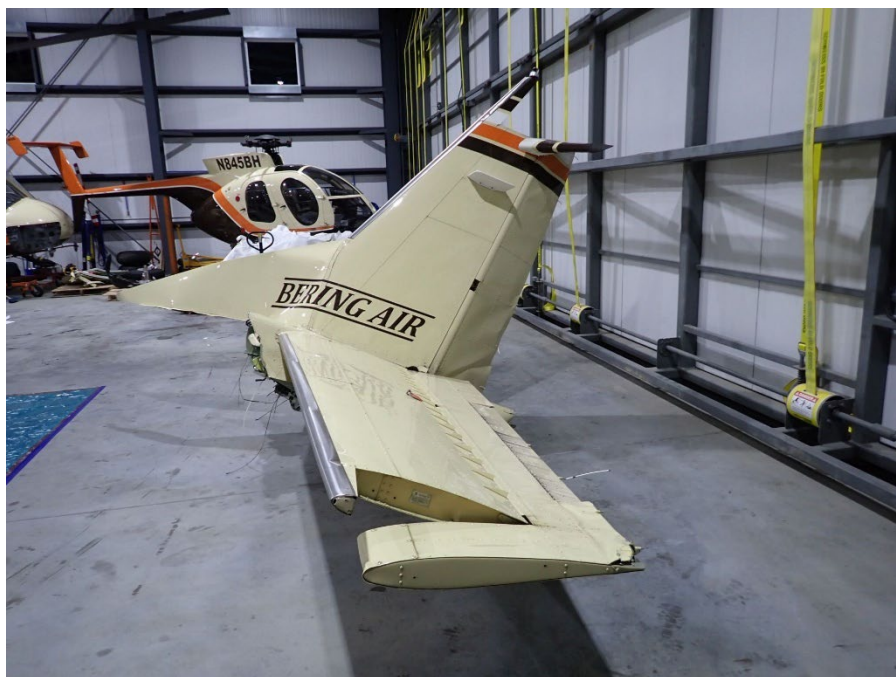
vertical stabilizer. All vortex generators remained attached to both horizontal stabilizers. The right elevator exhibited diagonal buckling about 20 inches inboard from the outboard hinge. The right elevator near the counterweight horn was bent downward. The left outboard trailing edge of the left elevator was impact damaged.

The right elevator torque tube attachment rivets were sheared at the attachment flange. Metallurgical examination of the rivet fracture surfaces revealed features consistent with overstress separation. The left elevator torque tube remained attached to the flange.

*Figure 4 - Empennage during post-recovery examination (NTSB photo)*

Figure 5 - Empennage during post-recovery examination (NTSB photo)

Figure 6 - Empennage during post-recovery examination (NTSB photo)

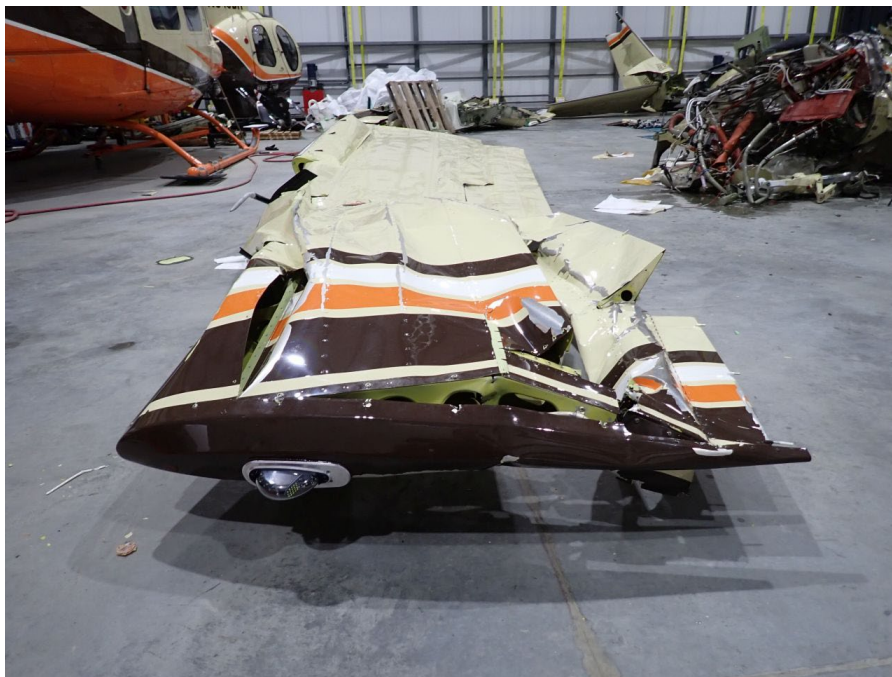
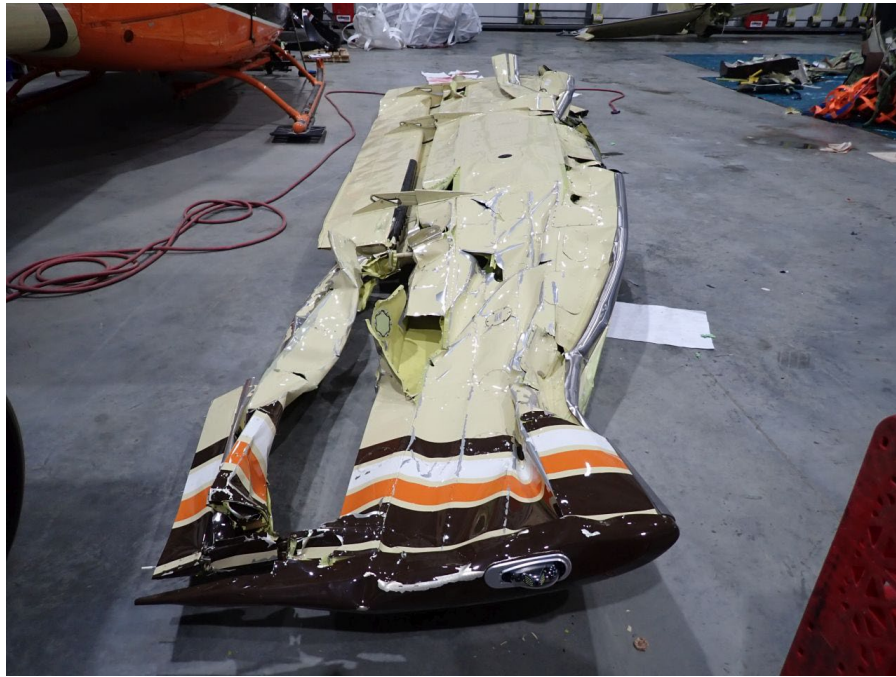
The leading edge had upward and aft impact damage. The aileron was impact damaged. All vortex generators remained attached. The aileron trim tab remained attached to the aileron. The pitot tube remained attached and was impact damaged. An STC stall fence was installed outboard of the landing light.

The flap interconnect (long tube) rod assembly between the right inboard forward flap bellcrank and the left inboard forward flap bellcrank was separated. Metallurgical examination of the rivet fracture surfaces revealed features consistent with overstress separation.

*Figure 7 - Left wing (top) during post-recovery examination (NTSB photo)*

*Figure 8 - Left wing (bottom) during post-recovery examination (NTSB photo)*

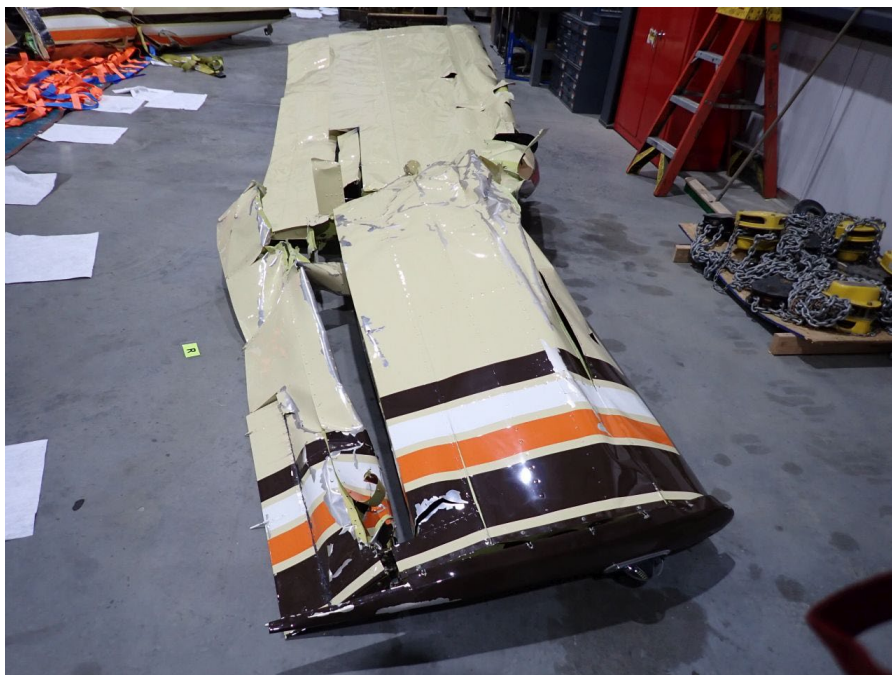
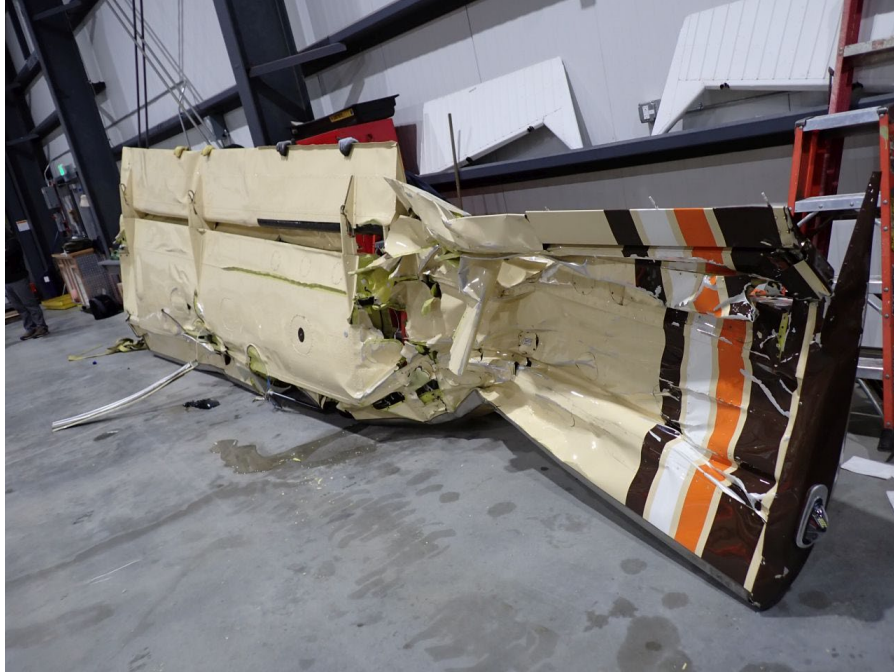
There was a 4.5' semicircular impact damage upward and aft of the leading edge outboard of the landing light. The leading edge was impact damaged upward and aft from the landing light inboard. All vortex generators remained attached. The aileron was impact damaged and remained attached to its attachment points. The aileron trim tab remained attached to the aileron. The aileron trim position was measured from the actuator to the center bolt and was found at about 2 inches, which

*Figure 9 - Right wing (top) during post-recovery examination (NTSB photo)*

*Figure 10 - Right wing (bottom) during post-recovery examination (Textron photo)*

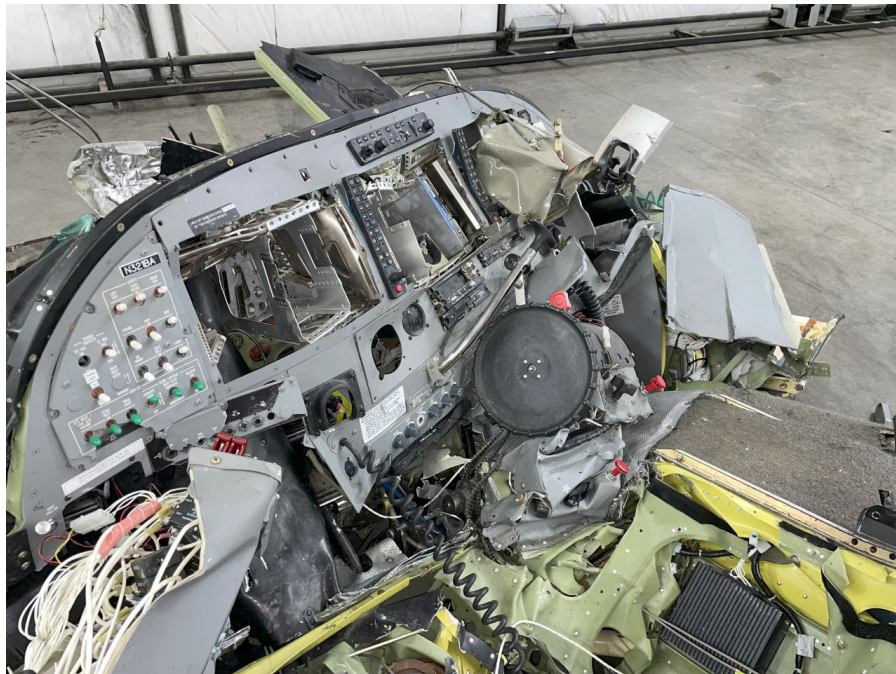
*Figure 11 – Cockpit instrument panel during follow-up examination (NTSB photo)*

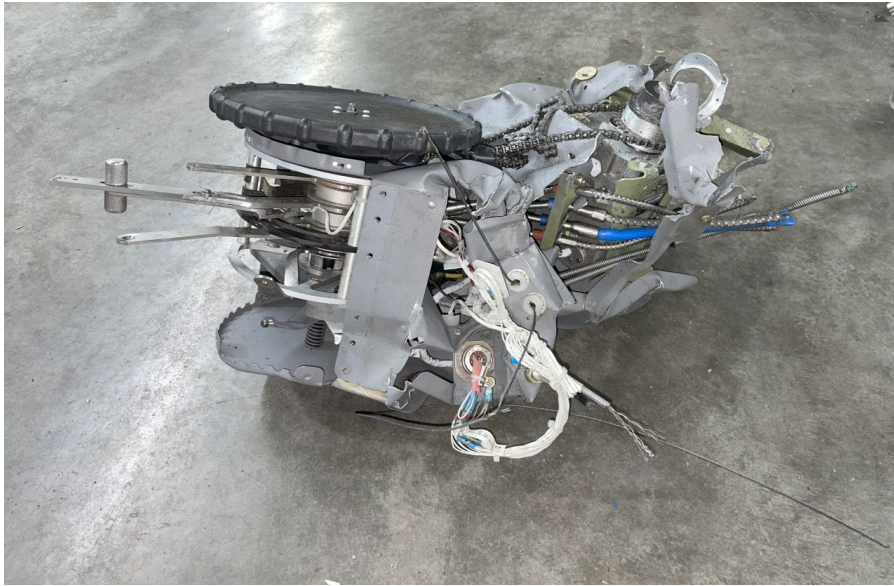
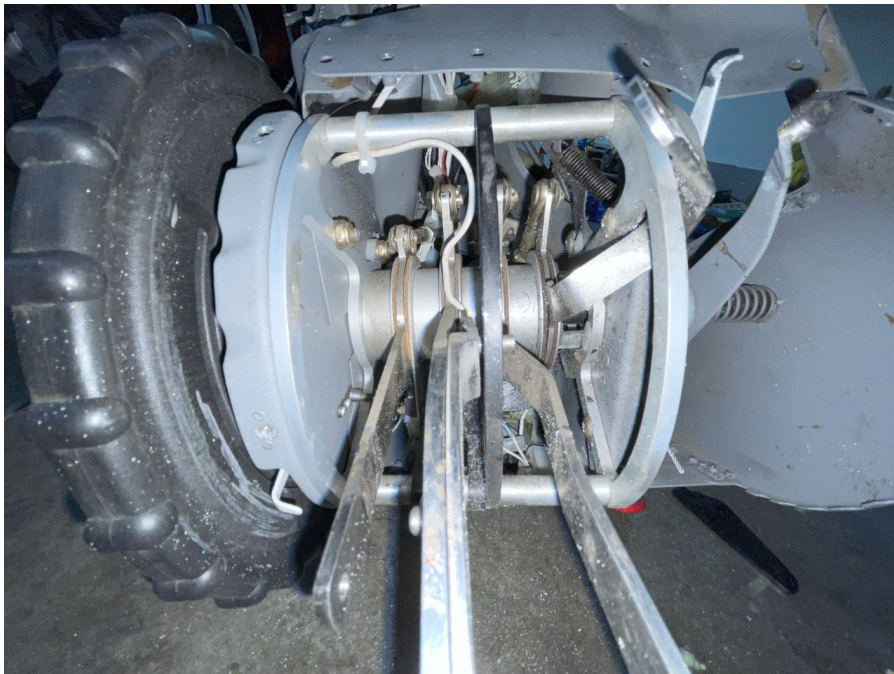
The cockpit power quadrant was damaged and dislocated to the right consistent with impact forces. The flap handle and flap position indicator remained attached to the rod. The rod was engaged with the friction knob and the engine control lever shaft. The engine control levers – power, condition, emergency power, propeller, flap – remained in place on the mating shaft. The friction knob, spring, and spacers were in place. The right-side panel of the quadrant was deformed consistent with impact. Each control engine control lever moved freely through the full range of motion. Adjustment of the friction knob between full tight and full loose and control levers were retained at full and moved freely at low consistent with normal operation.

*Figure 12 - Power quadrant during follow-up examination (NTSB photo)*

*Figure 13 - Power quadrant during follow-up examination (NTSB photo)*

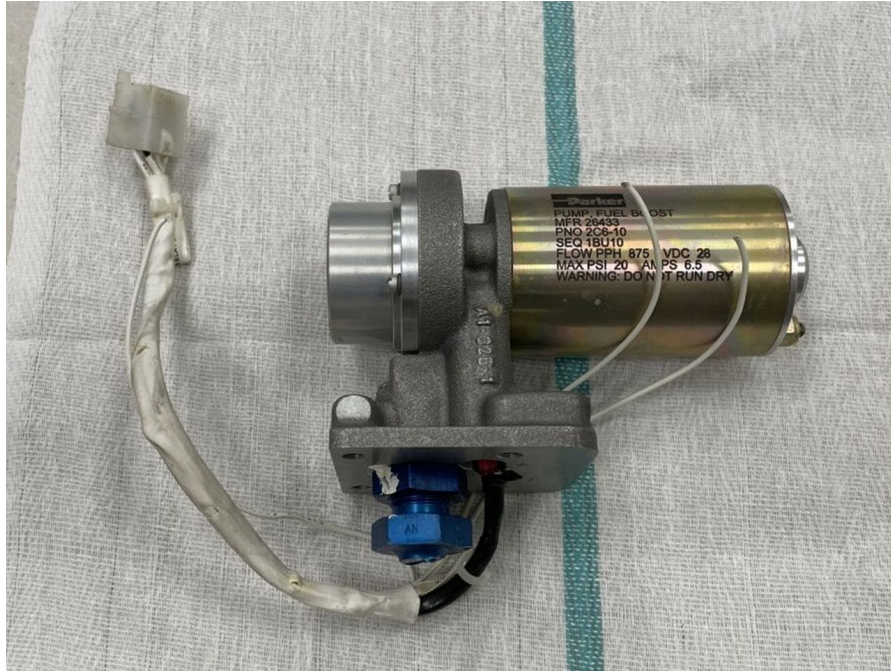
The electric backup fuel pump was securely installed within the fuel reservoir (header) tank. However, the tank was deformed consistent with impact forces. The pump was removed for further examination and testing.

Figure 14 - Fuel boost pump (NTSB photo)

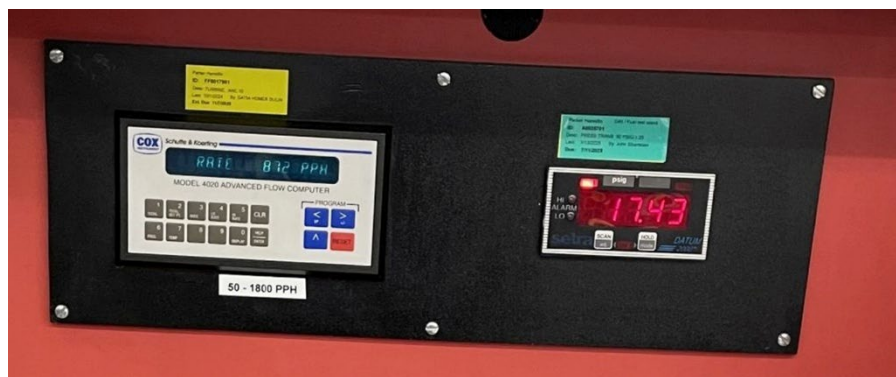
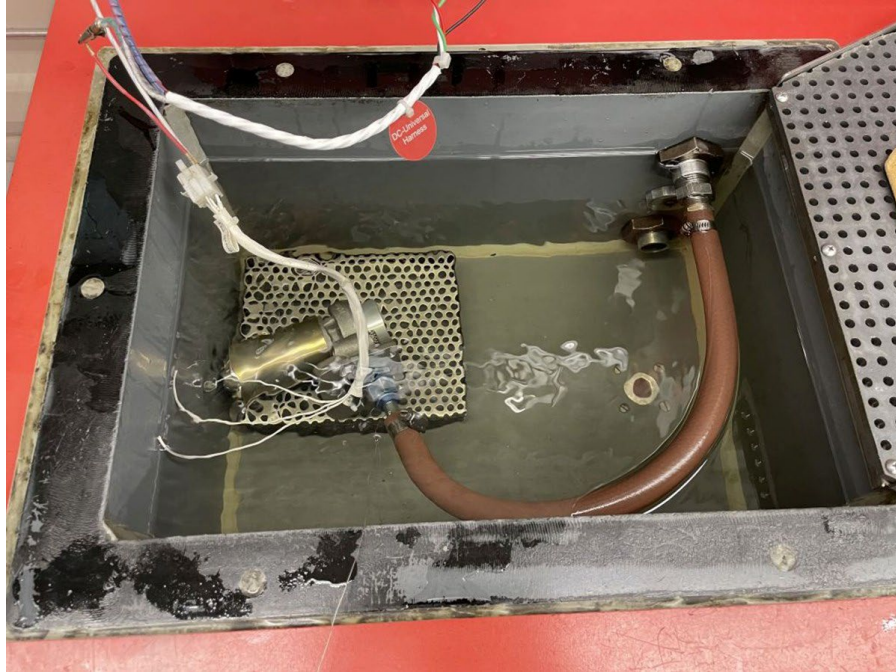
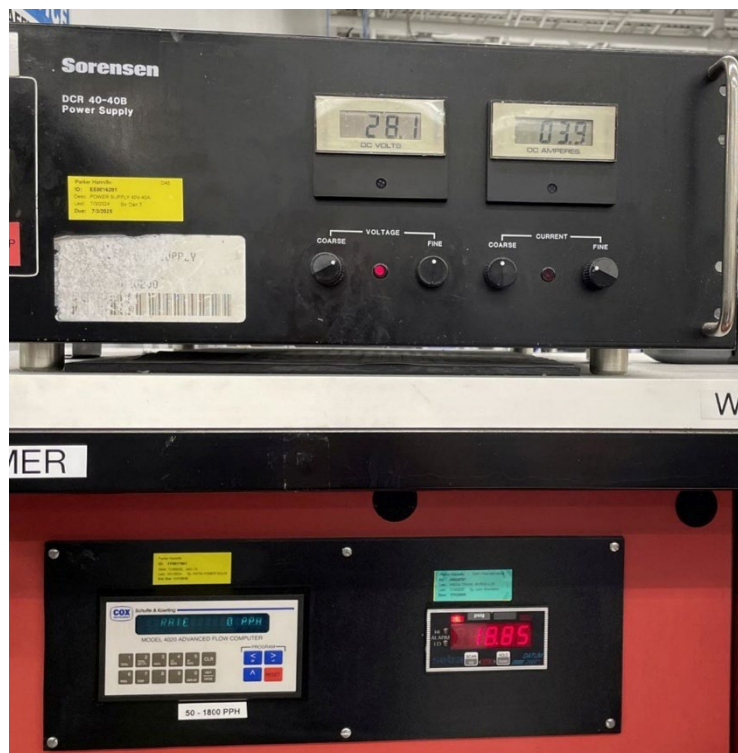
The fuel boost pump appeared intact and undamaged. It was placed on the test bench, submerged in test fluid, and 28-volts electrical power was applied. At a flow rate of 872 pounds per hour (pph), the pump provided a pressure of 17.47 psi and drew 4.2 amps. The test specification required a minimum pressure of 7.0 psi and a maximum electrical current draw of 6.5 amps. With the flow rate reduced to 0 pph, the pump outlet pressure was 18.9 psi at 3.9 amps. The maximum pressure allowable per the test specification was 20.0 psi.

Figure 15 - Test bench readings at 872 pph test point (NTSB photo)

Figure 16 - Fuel boost pump connected to test bench (NTSB photo)

The pump performed in accordance with the manufacturer's test standard. No anomalies were observed. The pump was not disassembled.

Figure 17 - Test bench readings at 0 pph test point (NTSB photo)

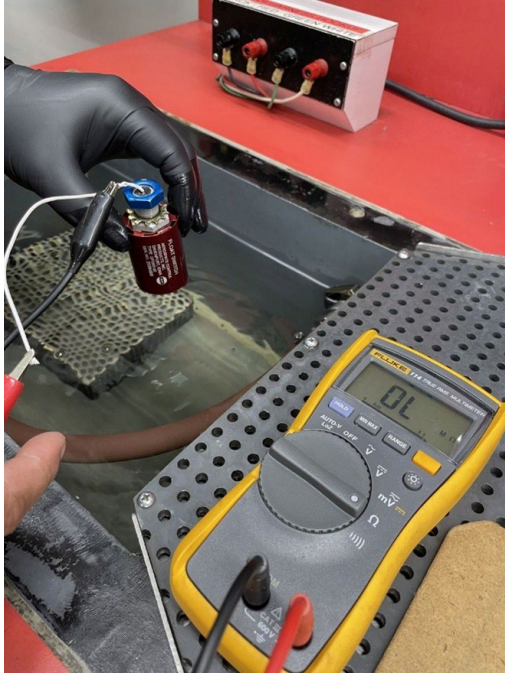
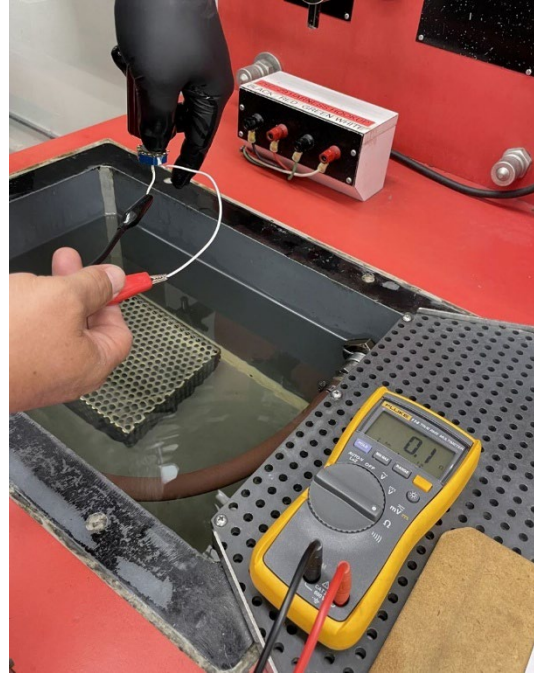
Figure 18 - Float switch in open position during testing (NTSB photo)

Figure 19 - Float switch in closed position during testing (NTSB photo)

The float switch appeared intact and undamaged. The float was free to move within the housing as the orientation was changed. Electrical continuity of the switch was confirmed using a multimeter. With the assembly held in a vertical orientation, the switch was open. When the assembly housing was rotated upside-down, the switch moved to the closed position. An identical result was observed when the housing was submerged in the test fluid. No anomalies were observed. The switch was not disassembled.

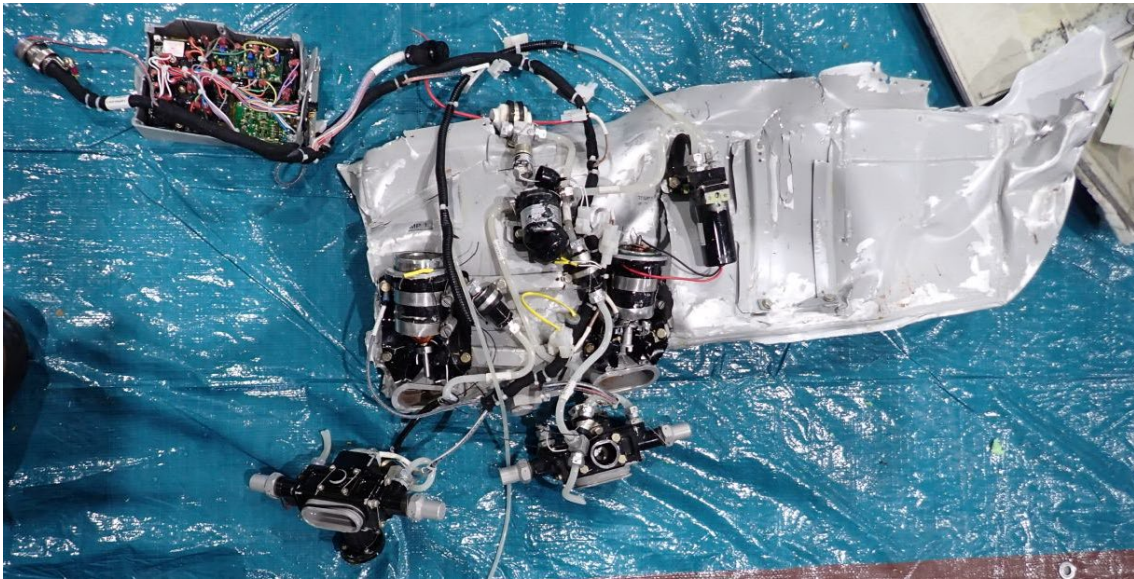
*Figure 20 - TKS system components recovered during post-recovery examination (NTSB photo)*

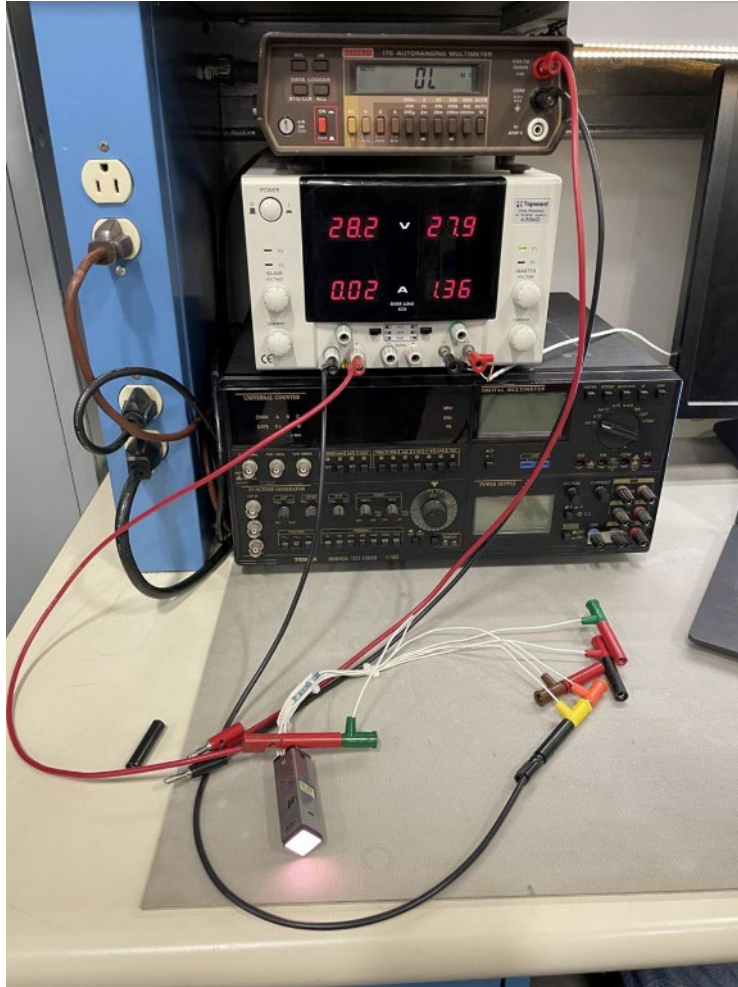
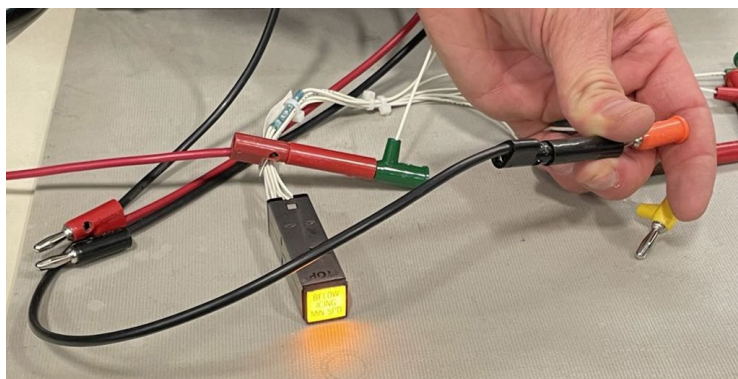
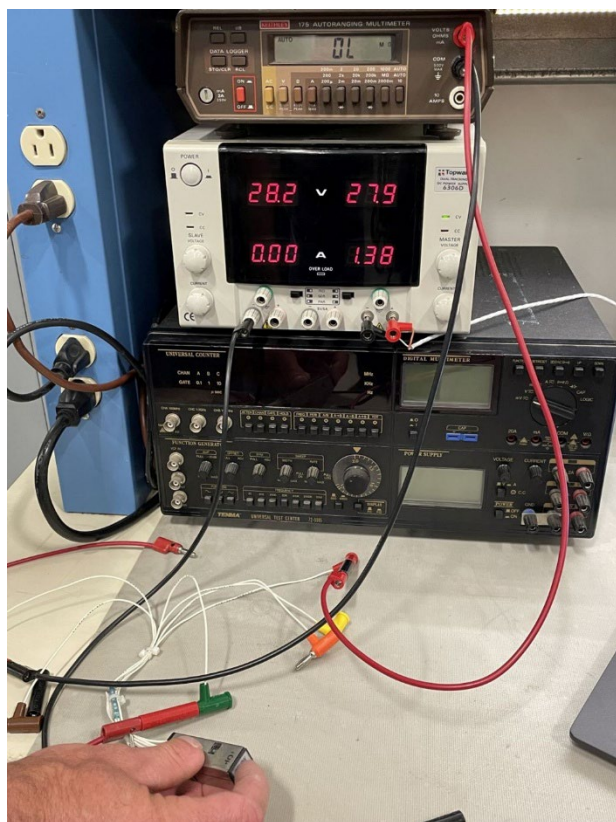
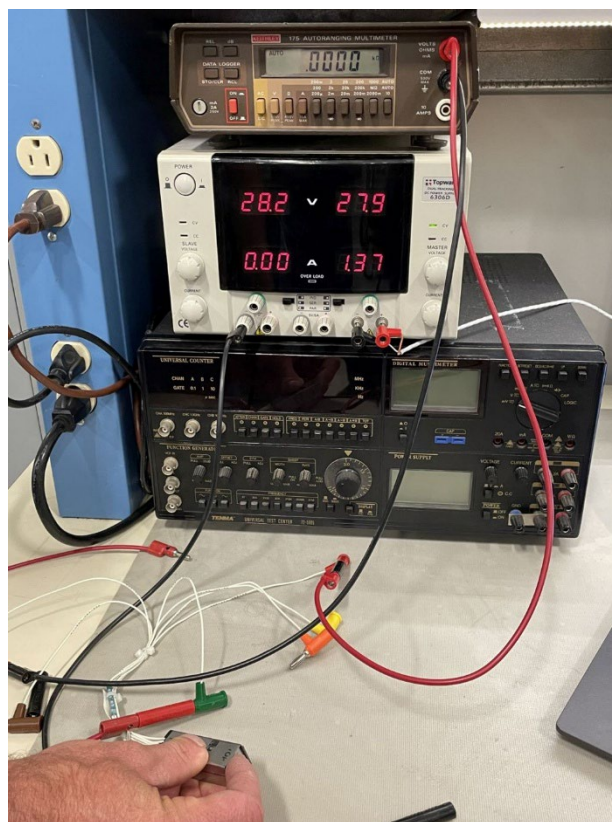
The LAA system indicator switch appeared intact and undamaged. Electrical power was supplied to the switch. The LED illuminated both white and amber as the corresponding leads were connected to the 28-volt power supply. Electrical continuity of the switch function was confirmed using a multimeter. No anomalies were observed with respect to the lighted switch assembly.

Figure 21 - Indicator switch on test bench with white LED powered (NTSB photo)

Figure 22 -Indicator switch on test bench with amber LED powered (NTSB photo)

Figure 23 - Indicator switch on test bench in open (undepressed) position (NTSB photo)

Figure 24 - Indicator switch on test bench in closed (depressed position) (NTSB photo)
