In Reply, Refer to: L-175-26-008

**Subject: 2020 Textron Aviation 208B; Serial number: 208B5613; REG: N321BA  
Location: Nome, AK; D/A: February 6, 2025  
NTSB report number: ANC25MA018**

Thank you for the opportunity to review the contents of the NTSB Docket, Textron Aviation has the following comments:

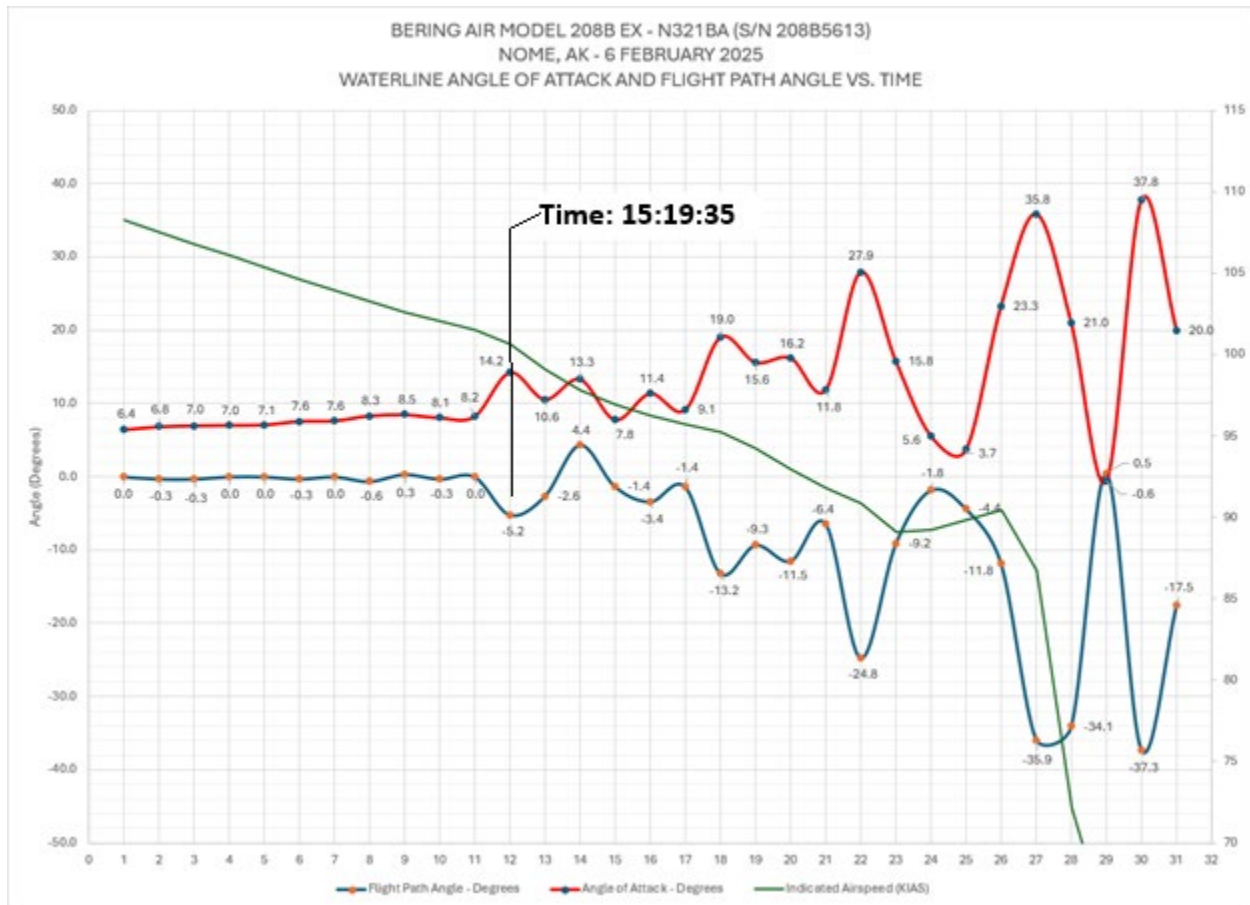
For most of the duration of the flight, the flight path angles were within normal flight indications. 11 seconds prior to the autopilot disconnecting, the aircraft flight path angle was approximately zero and body alpha was 6.5 degrees and steadily increased to 8.5 degrees. At 15:19:35 time in the data, the body alpha abruptly increased six degrees from 8.2 to 14.2 degrees. One sec later, airspeed decreased to 99 kts and the autopilot disconnected. This airspeed is within the 97.5 +/- 2.2 kts tolerance of the Low Airspeed Awareness (LAA) system activation and associated stall warning annunciation per the TKS Ice Protection System POH Supplement. As noted in the Garmin Pilot's Guide, the stall warning will cause the autopilot to disconnect. Shortly after the autopilot disconnected, a series of pitch and roll oscillations occurred over the next 6 seconds that further increased the body alpha to 19.0 degrees at an airspeed of 95 kts.

It is Textron Aviation's position that the aircraft was inadvertently stalled by the pilot by improperly attempting to level off at the last ATC assigned altitude with a low engine power setting (recorded 1100 ft-lbs. torque vs. 2,397 ft-lbs. available at max rated) and at a relatively high pitch attitude (9 deg pitch). This caused the LAA system to activate the stall warning, which disconnected the autopilot.

Once the autopilot disconnected, excessive flight path and pitch excursions began, likely from pilot induced oscillations of the flight controls. These oscillations rapidly caused the aircraft to further increase AOA and ultimately exceeded the critical AOA which stalled the aircraft and subsequently caused a departure from controlled flight.
