ANC26LA025

## INVESTIGATION PHOTOGRAPHS

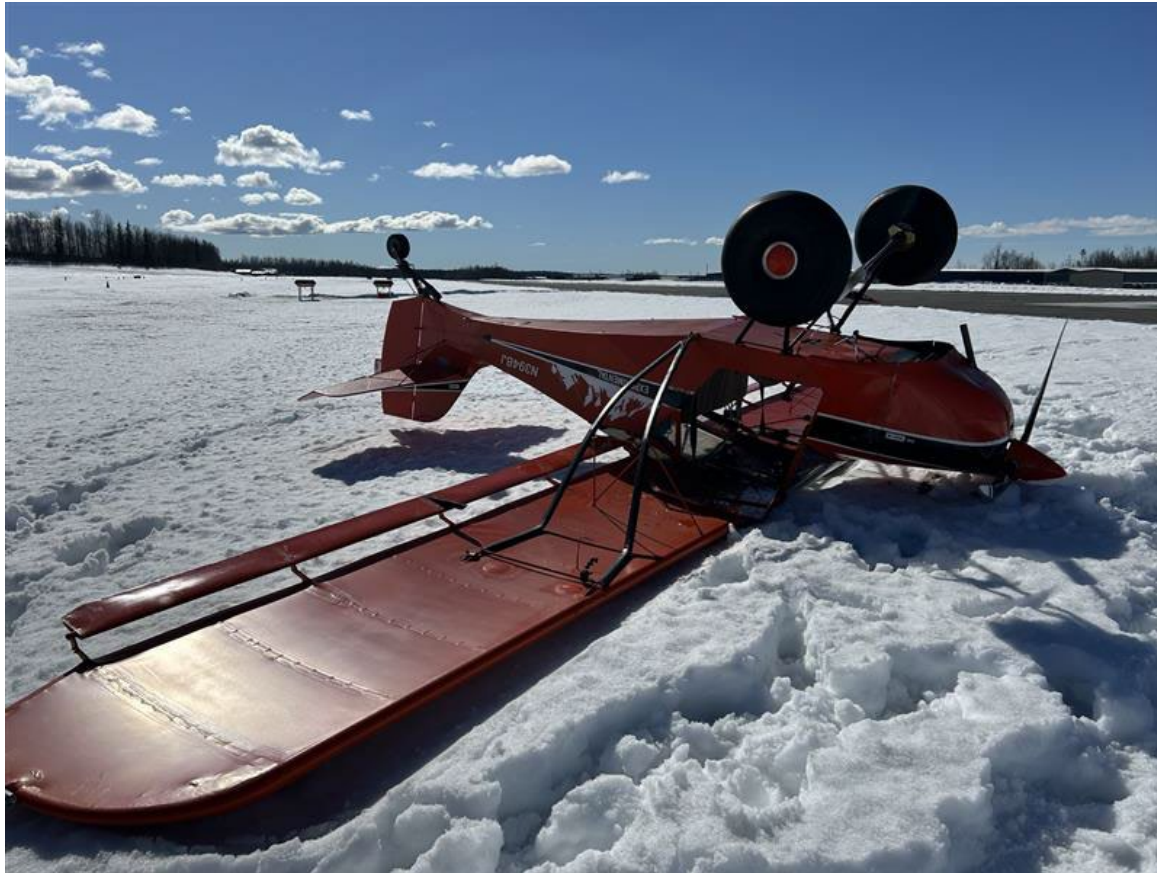
**Photograph 1 - Image of accident airplane at accident site (Courtesy of Operator)**

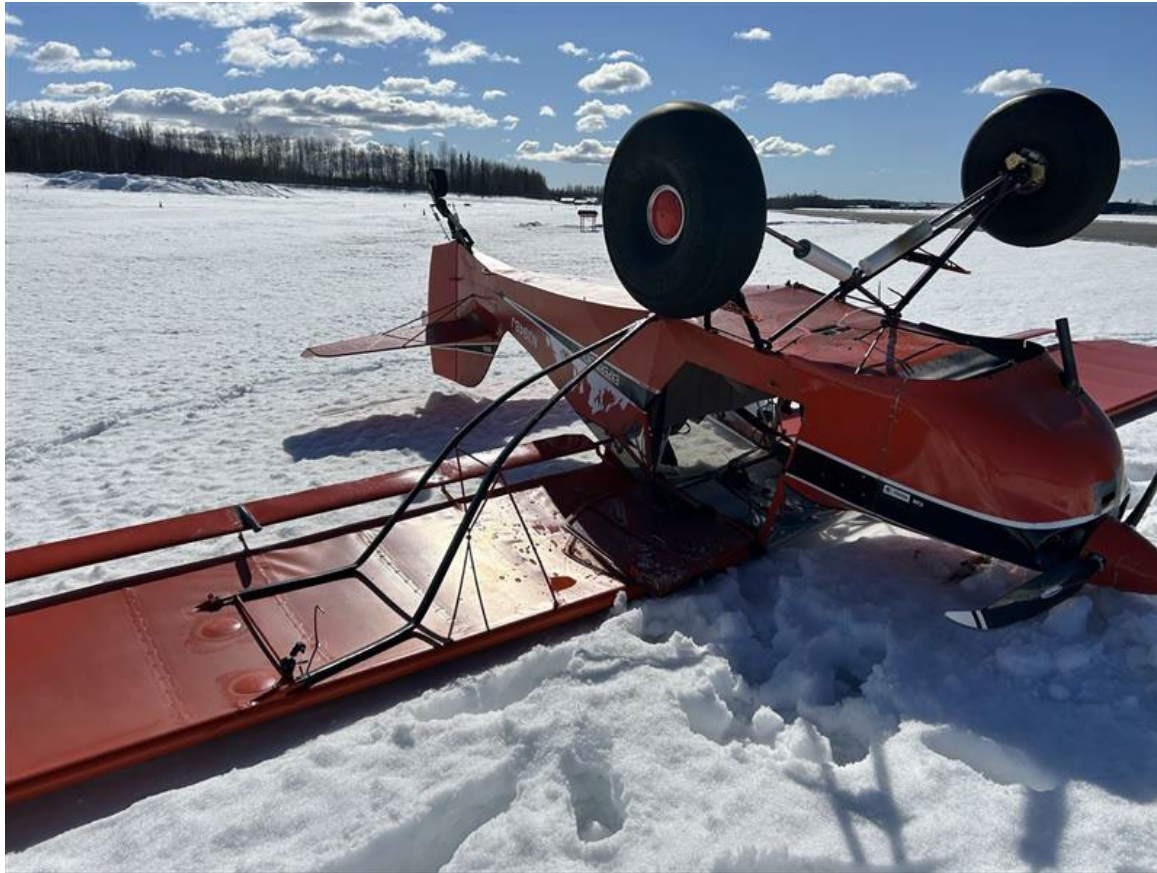
**Photograph 2 - Image of left wing lift strut (Courtesy of Operator)**
