**NATIONAL TRANSPORTATION SAFETY BOARD  
Office of Aviation Safety  
Washington, DC 20594**

**ATC GROUP CHAIRMAN'S FACTUAL REPORT**

**CEN11FA468**

**Location:** Rising Sun, Indiana  
**Date:** July 9, 2011  
**Time:** 0924 Eastern Daylight Time / 1324 Coordinated Universal Time  
**Aircraft:** N42333, Robinson R44 helicopter

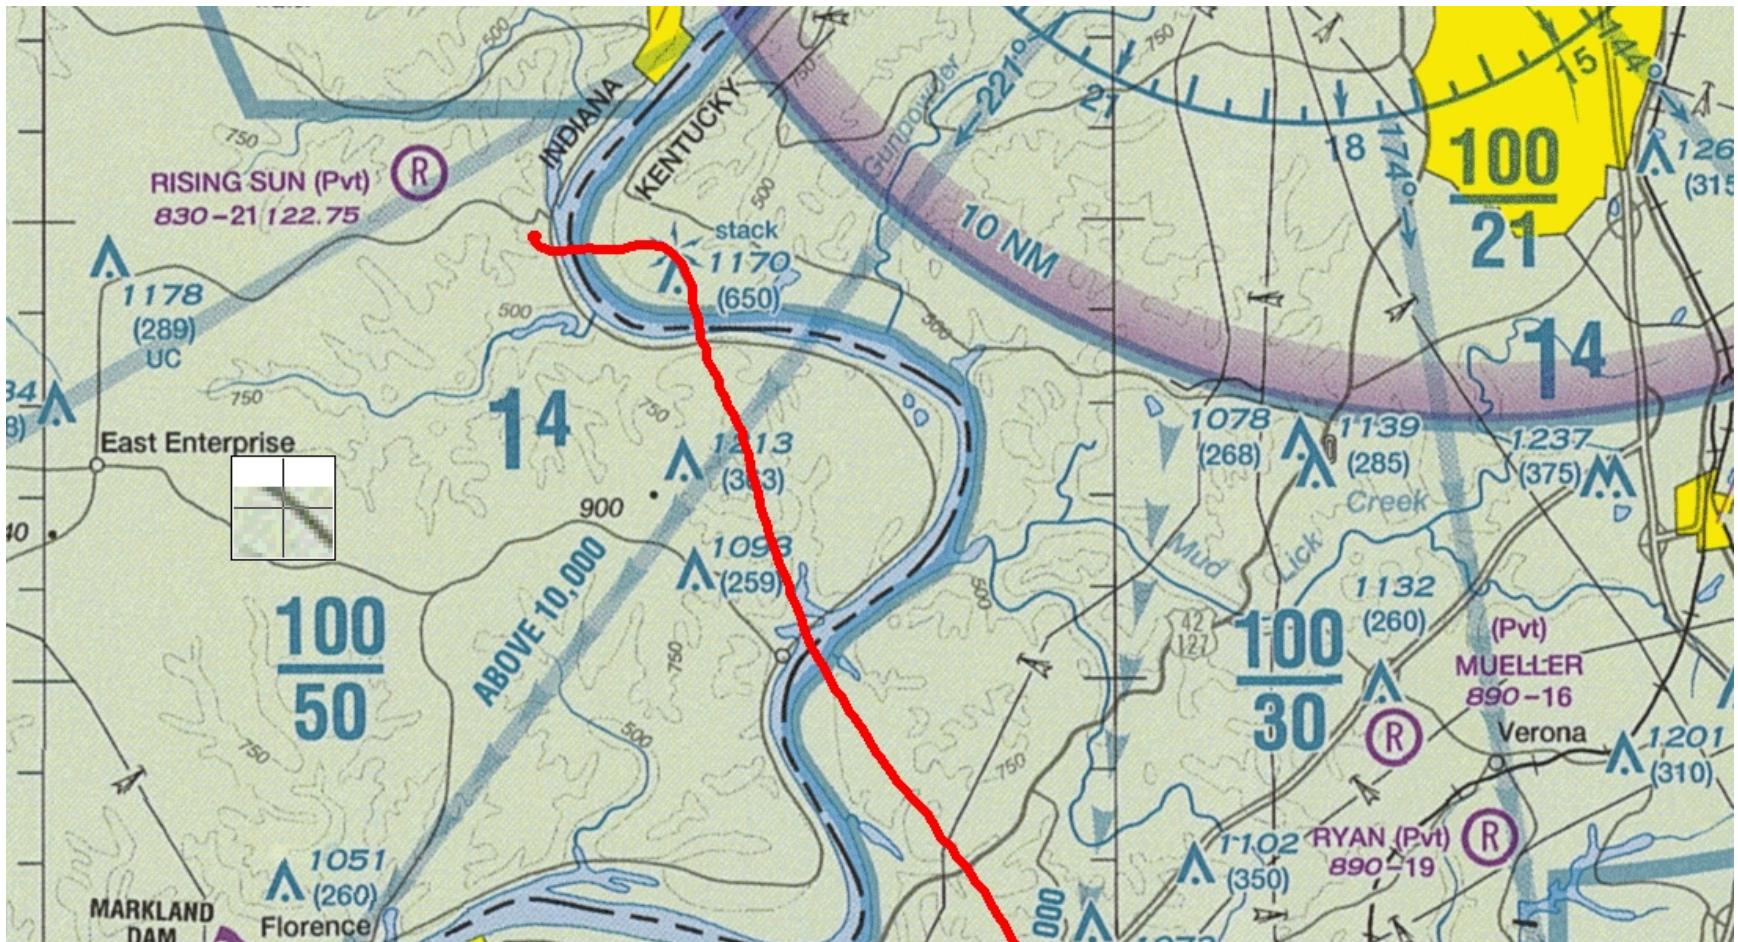
Figure 1 - N42333 flight track on the Cincinnati Terminal Area Chart. The accident site is at the northwest end of the track.

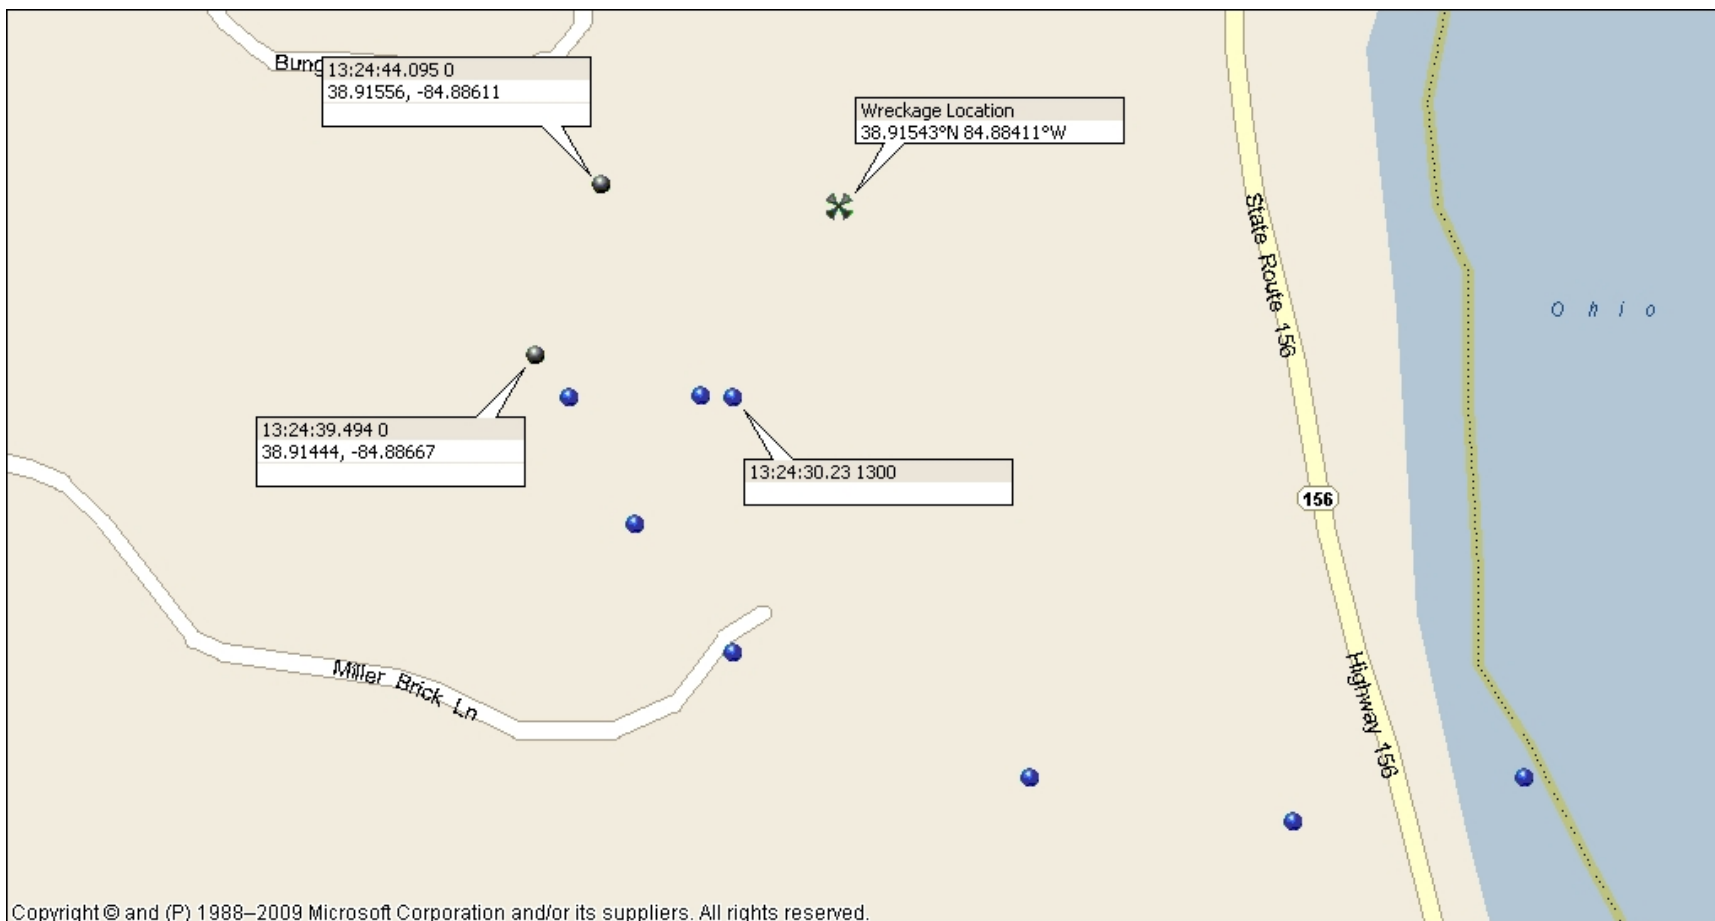
Figure 2 – View of radar data near the accident site. Blue dots are transponder targets.  
Black dots are primary targets. Times shown are UTC (Fours later than local time.)
