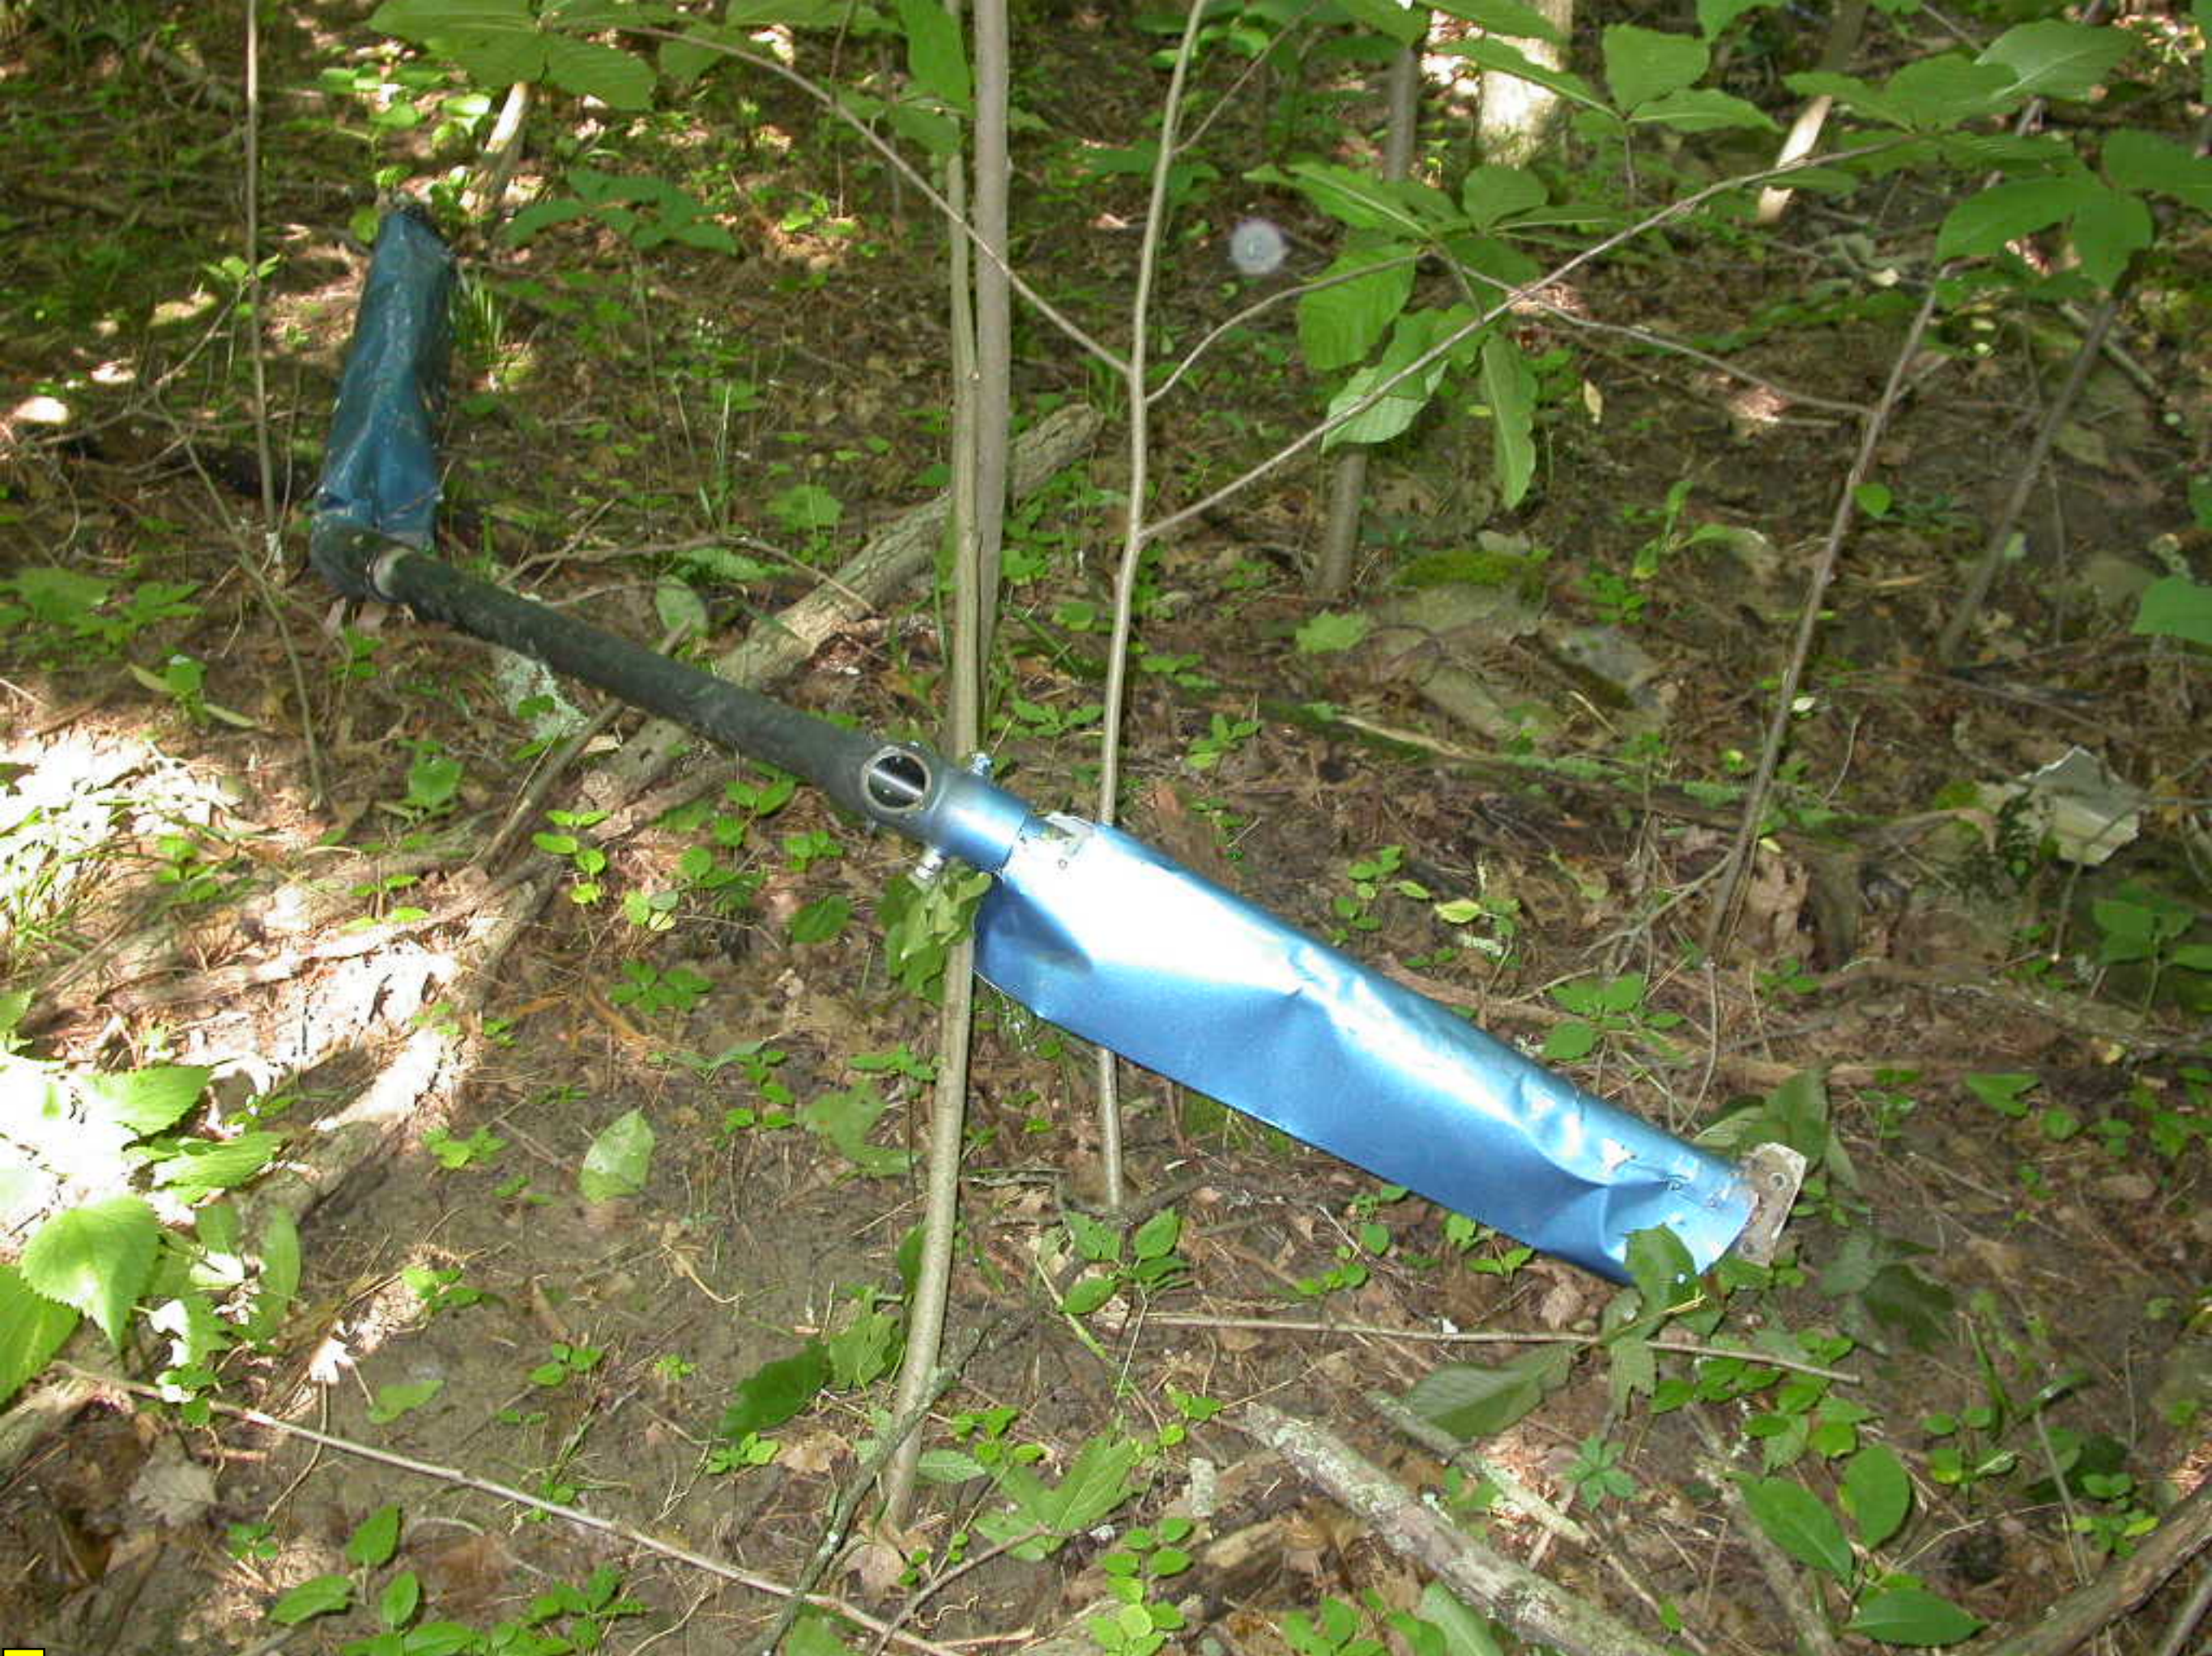
Photo 3. Part of langing gear in the wreckage path.
