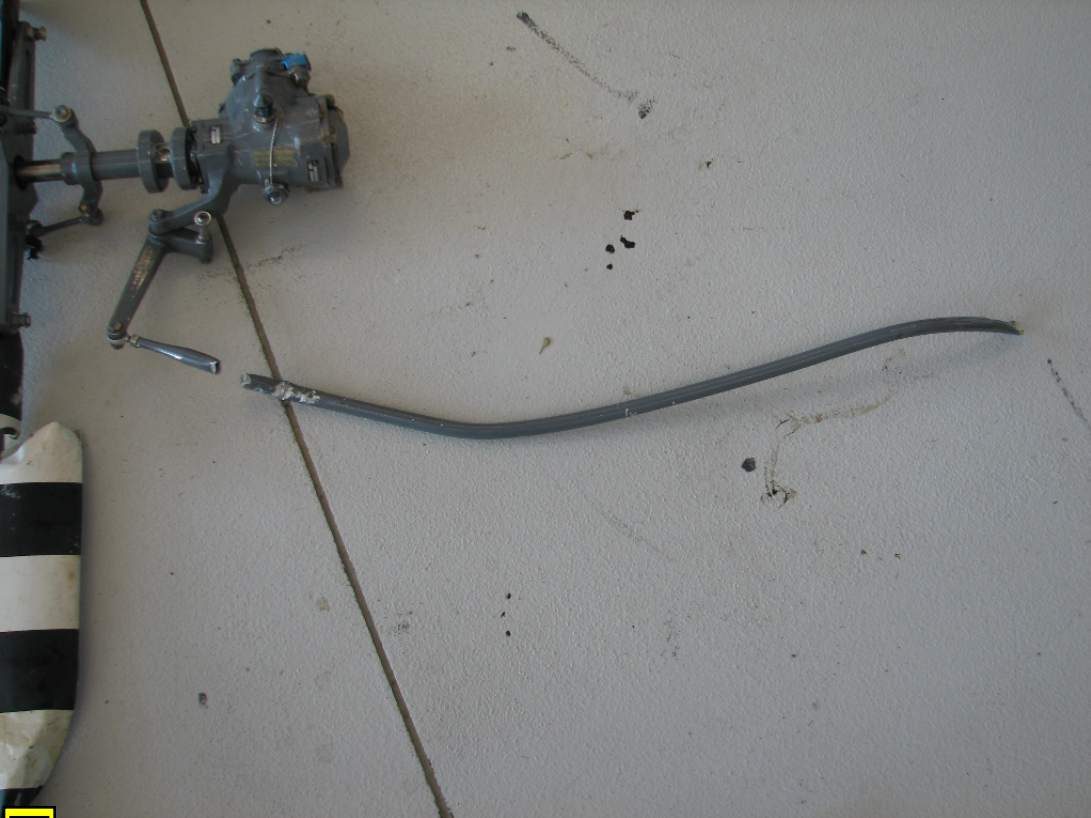
Photo 18. Tail rotor gearbox and broken pitch control tube.
