## IIC's SUMMARY OF FINDINGS

**NTSB Accident Number: CEN12FA088 – N6485L, Piper PA-31 at New Orleans, LA**

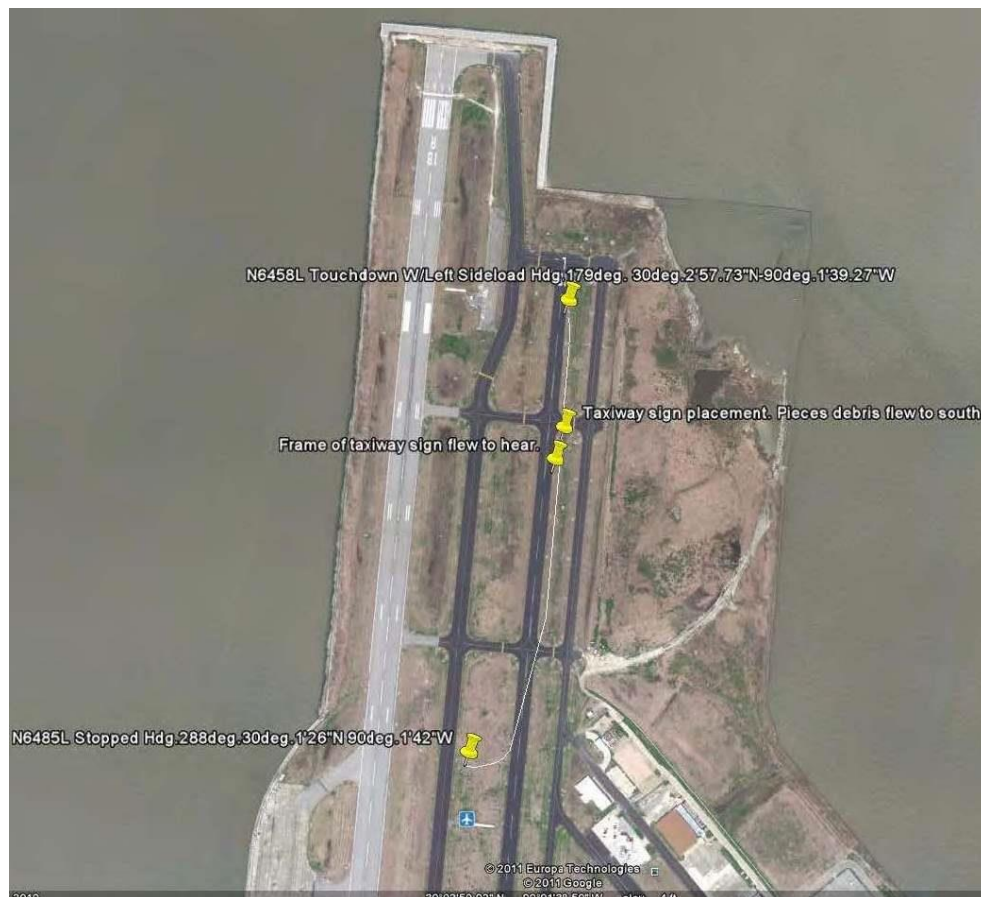
Ground scars and impact marks show the airplane first impacted with a left side load about 300 feet south of the north end of the runway 18L and slightly to the left of the runway center line.

The airplane exited the left edge of the runway surface and impacted obstructions in the grassy area to the east of runway 18L. The taxiway sign at taxiway K was damaged and the ground scars continued in the grass on the east side of runway 18L to other damaged obstructions near taxiway J. The ground scars show the airplane then crossed runway 18L and came to rest in the grassy area to the west of runway 18L and to the east taxiway B with the nose oriented to 288 degrees. The total distance from first impact to final resting location was estimated to be about 2,500 feet.

Figure 1 – Showing location of first impacts and the final resting location.
