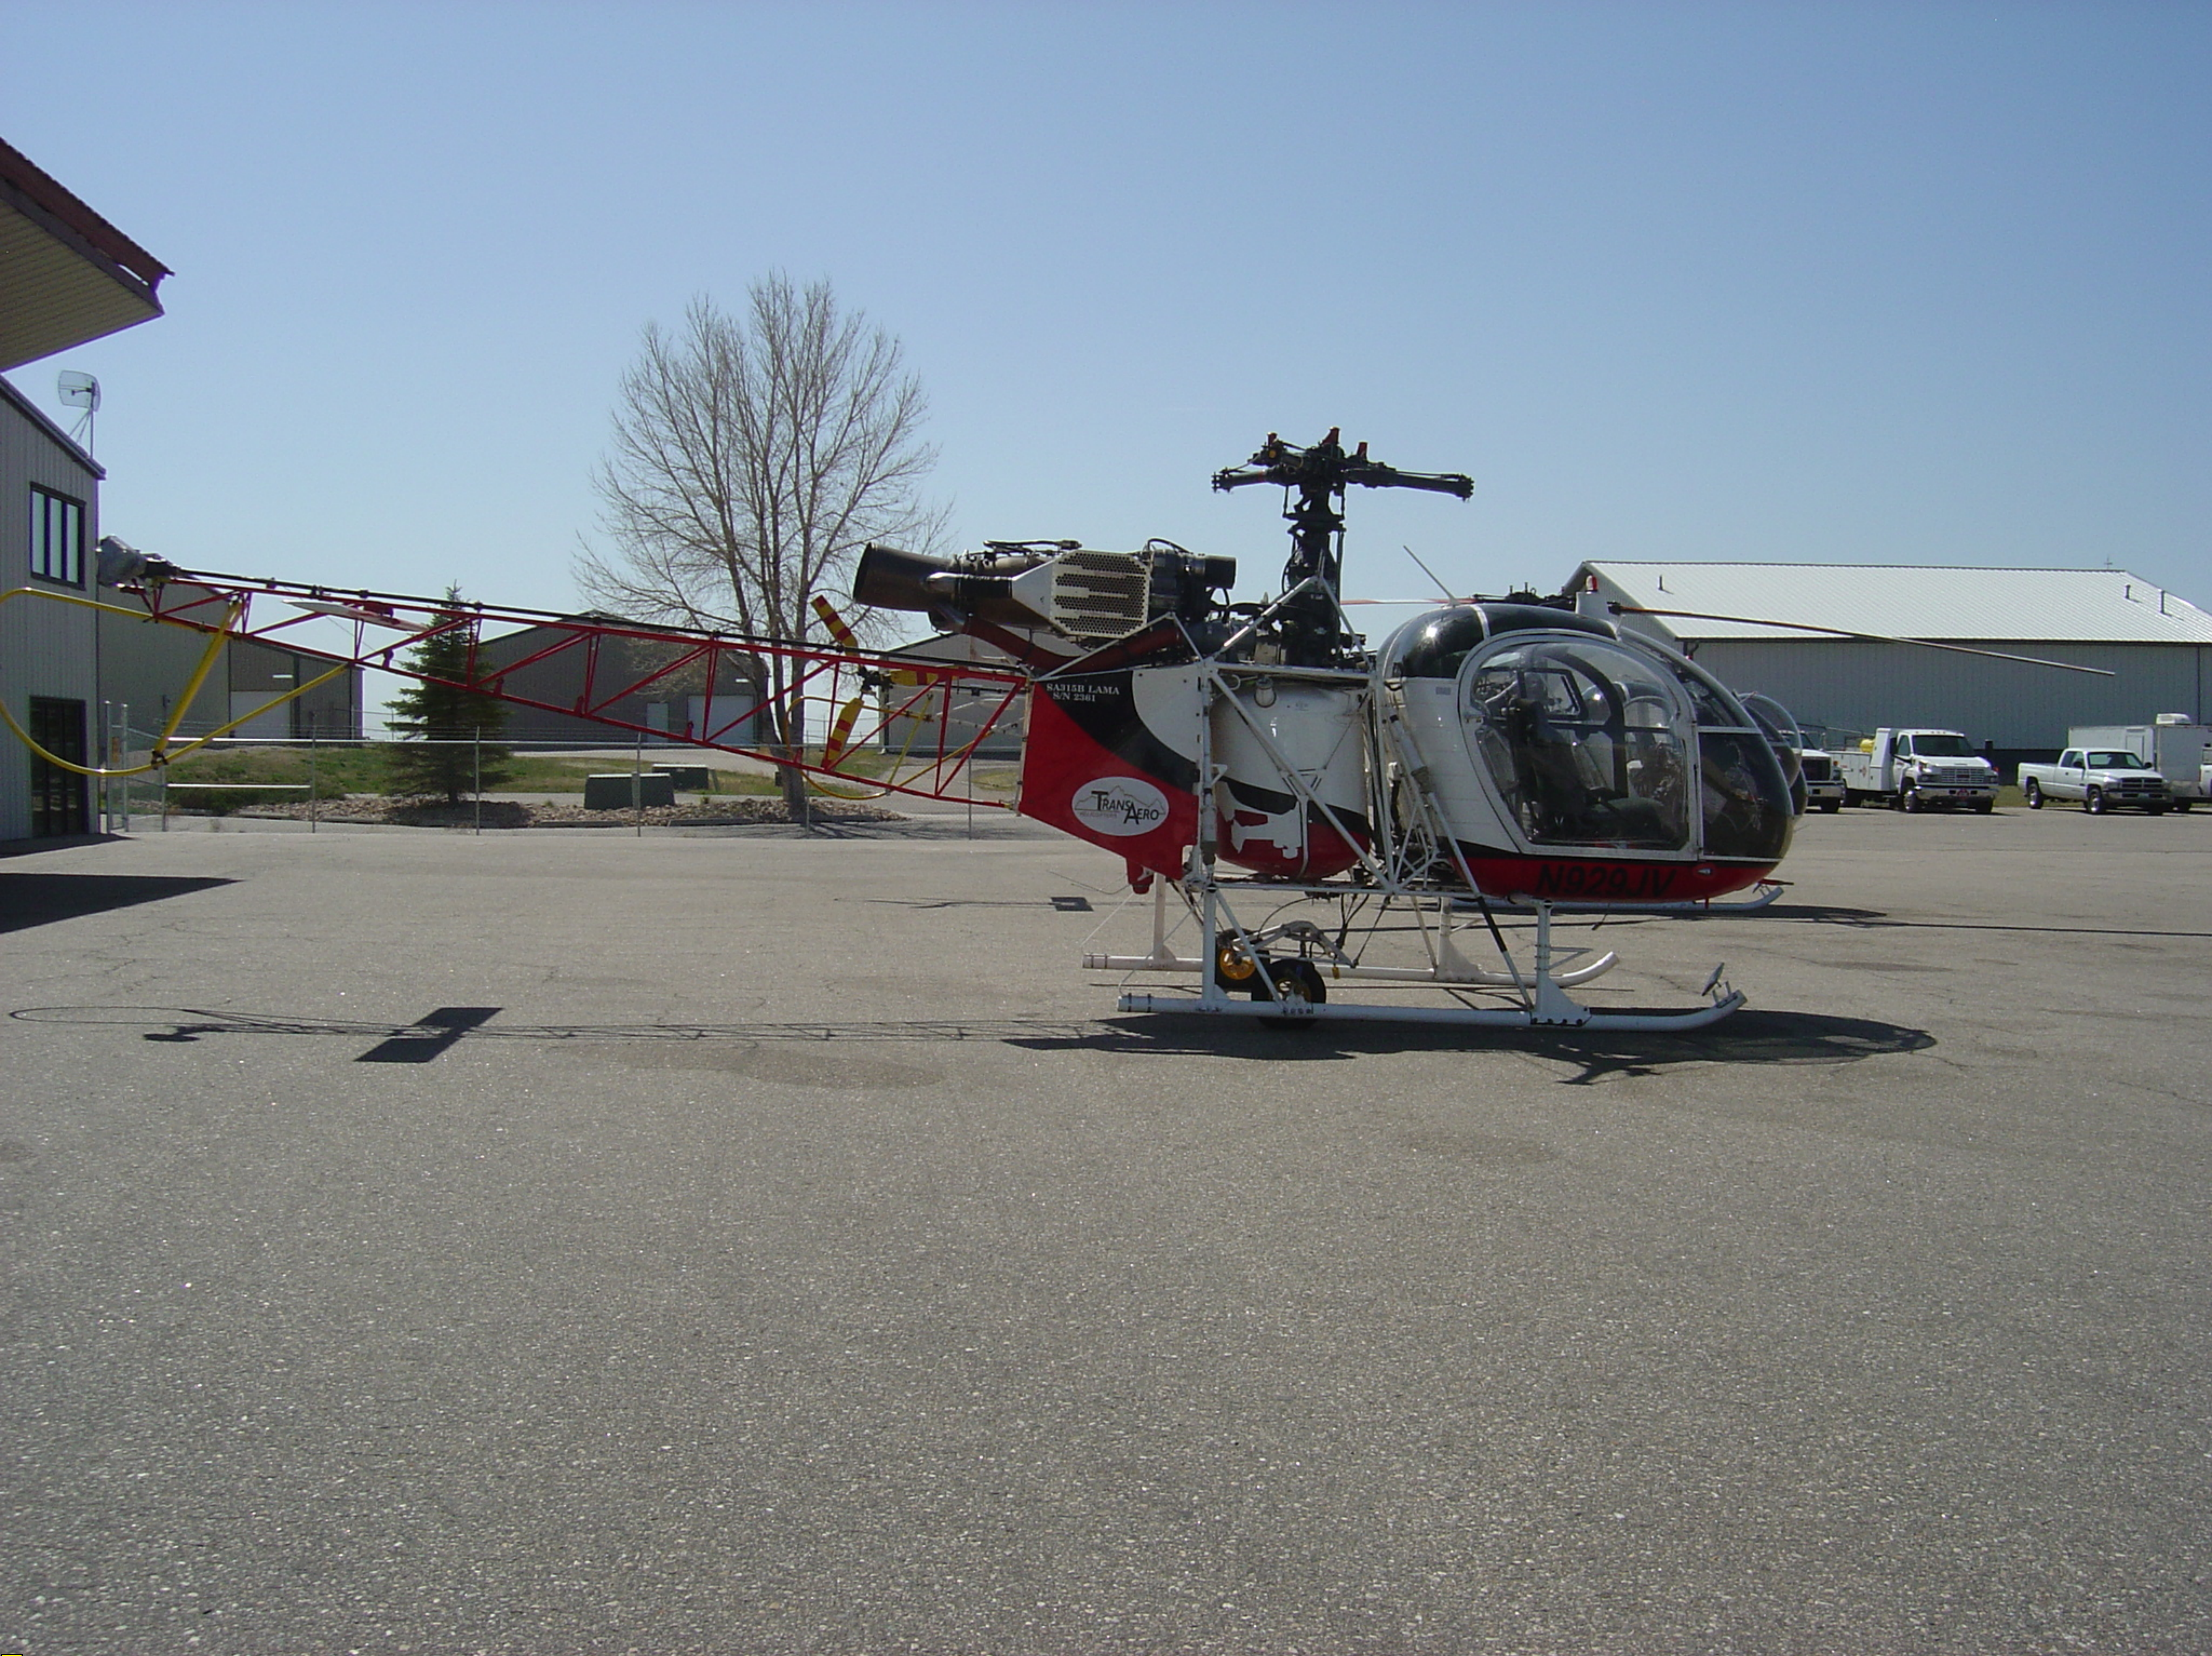
Photo 2 - Right side of helicopter. Tail rotor drive shaft is bent and some hangers are damaged.
