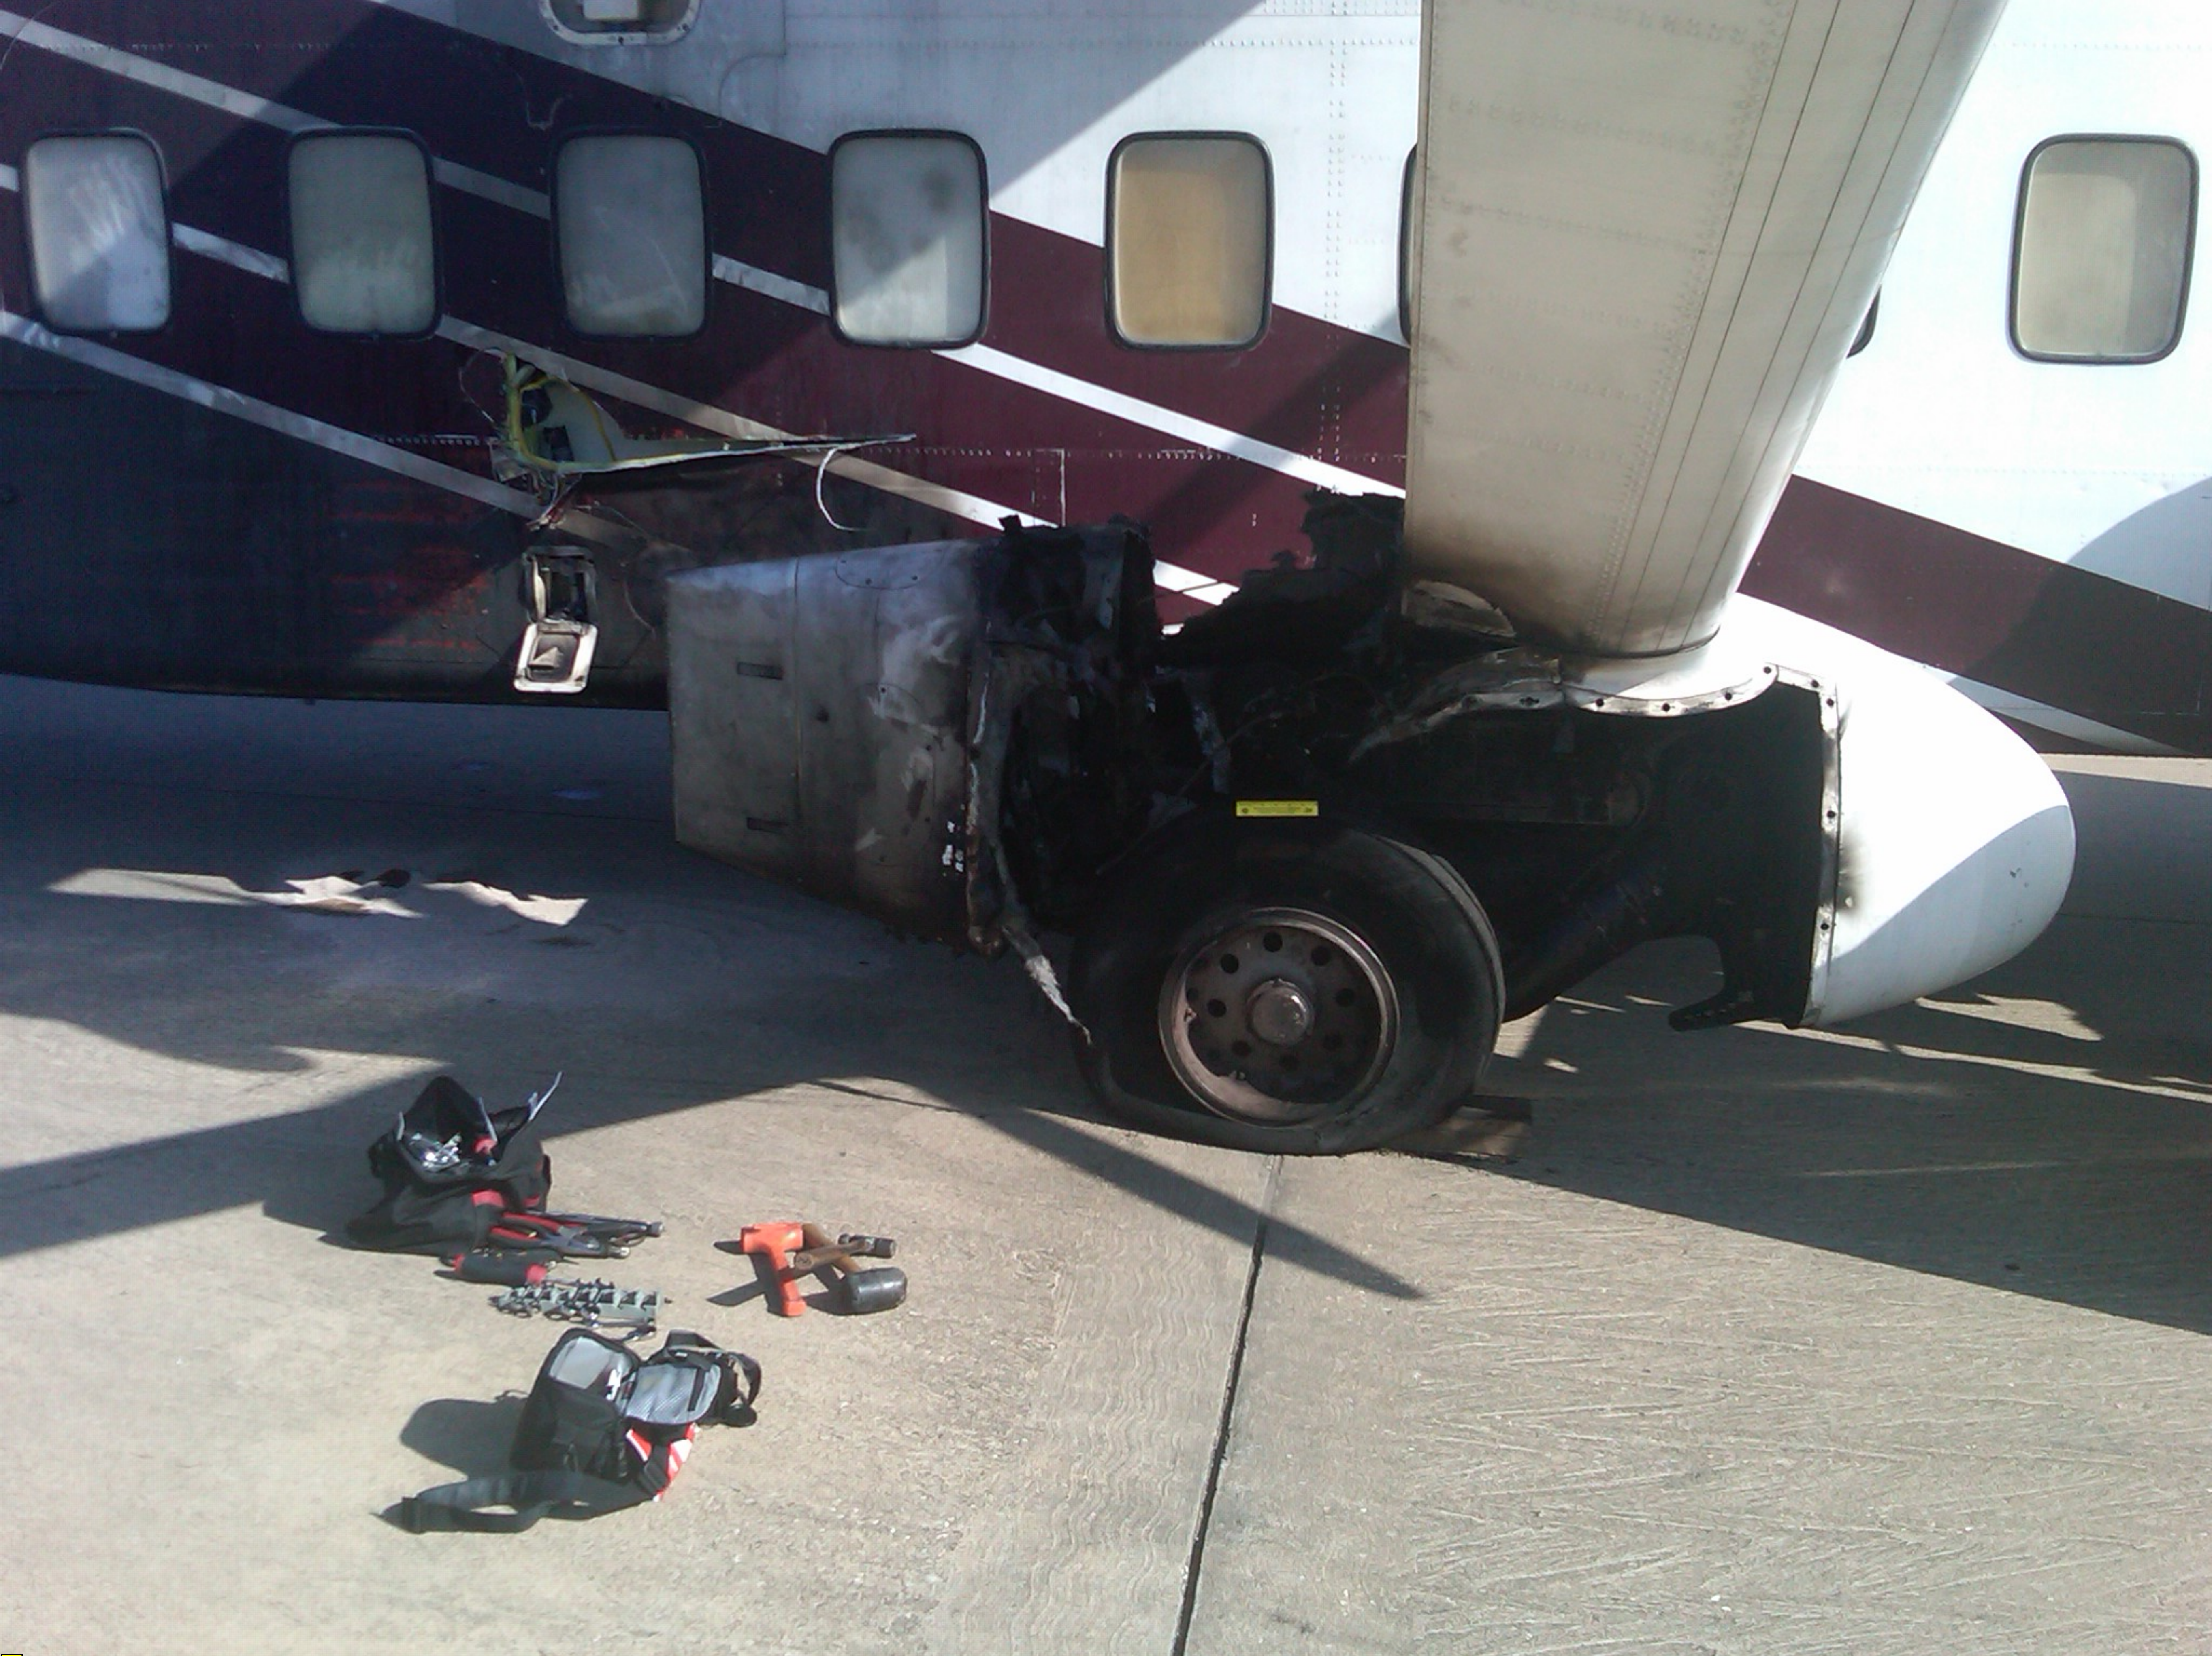
Photo 2 Closeup of Fire Damage to Right Stub Wing Assembly
