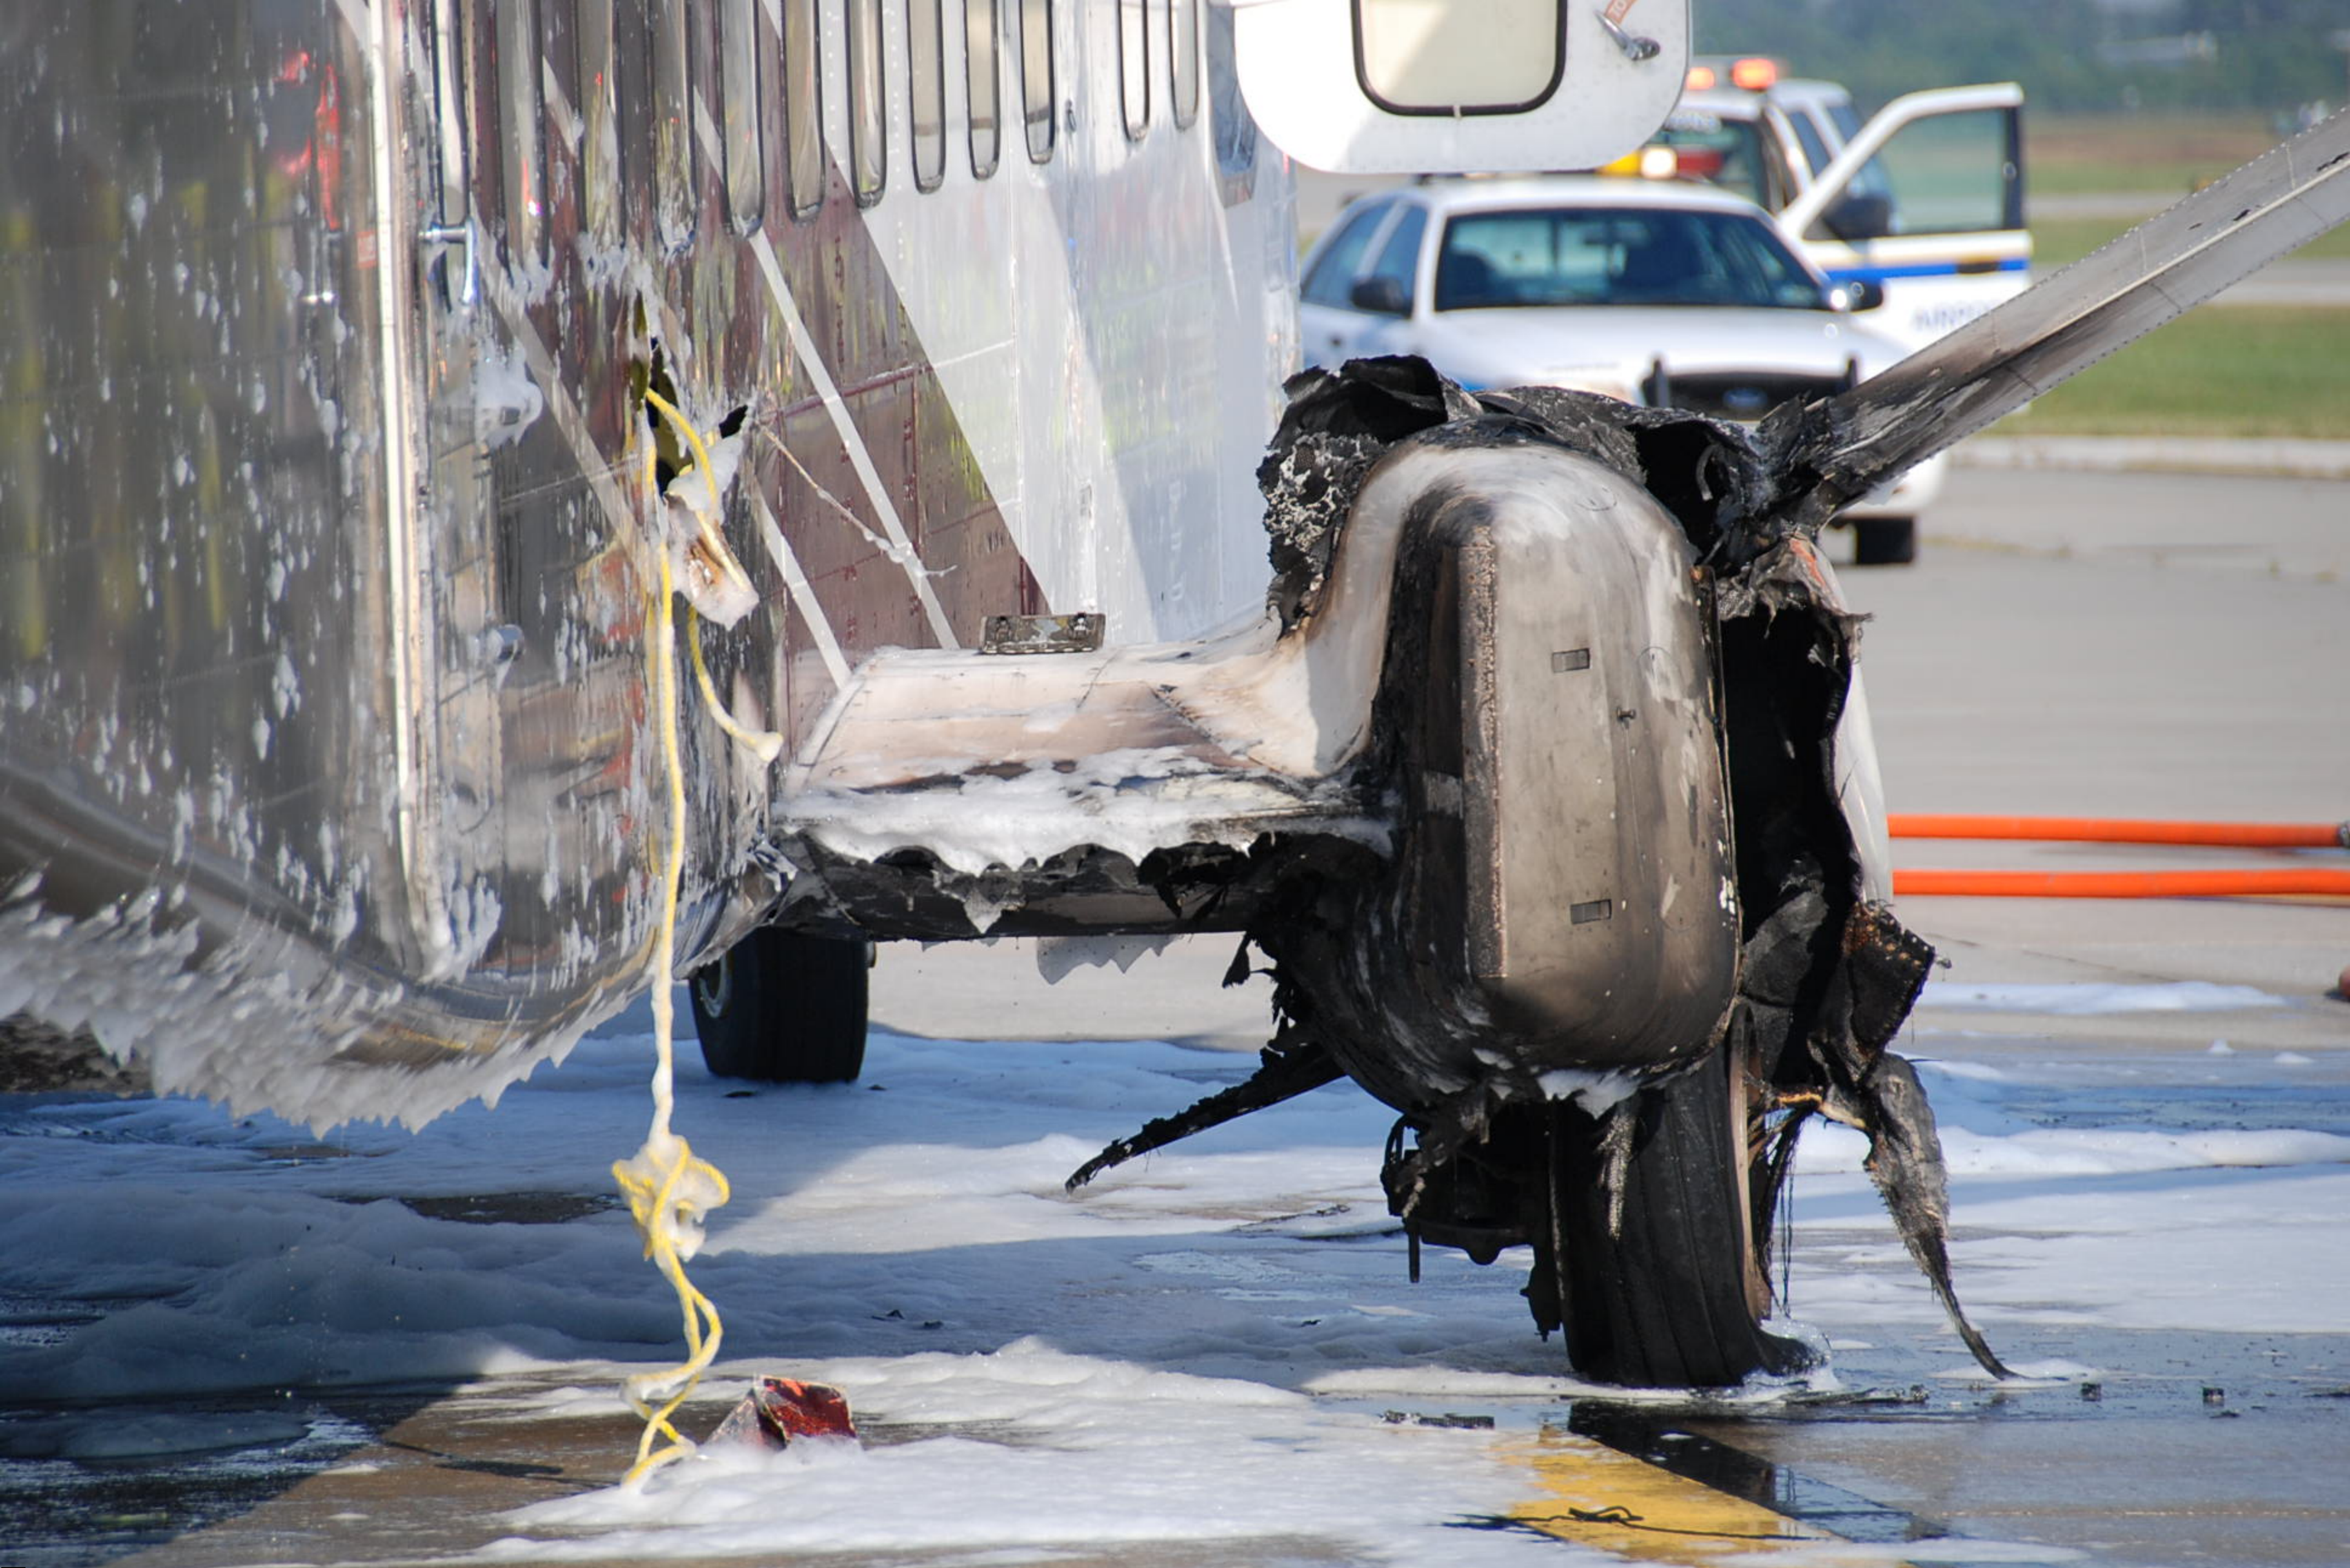
Photo 5 Rear Aspect of Fire Damage to Right Stub Wing Assembly
