NATIONAL TRANSPORTATION SAFETY BOARD  
OFFICE OF AVIATION SAFETY  
WASHINGTON, D.C. 20594

POWERPLANTS GROUP CHAIRMAN'S FACTUAL REPORT

NTSB ID: CEN13FA049

Aircraft: Cessna 208B, Registration No. N793FE, operated by Baron Aviation Services/Federal Express

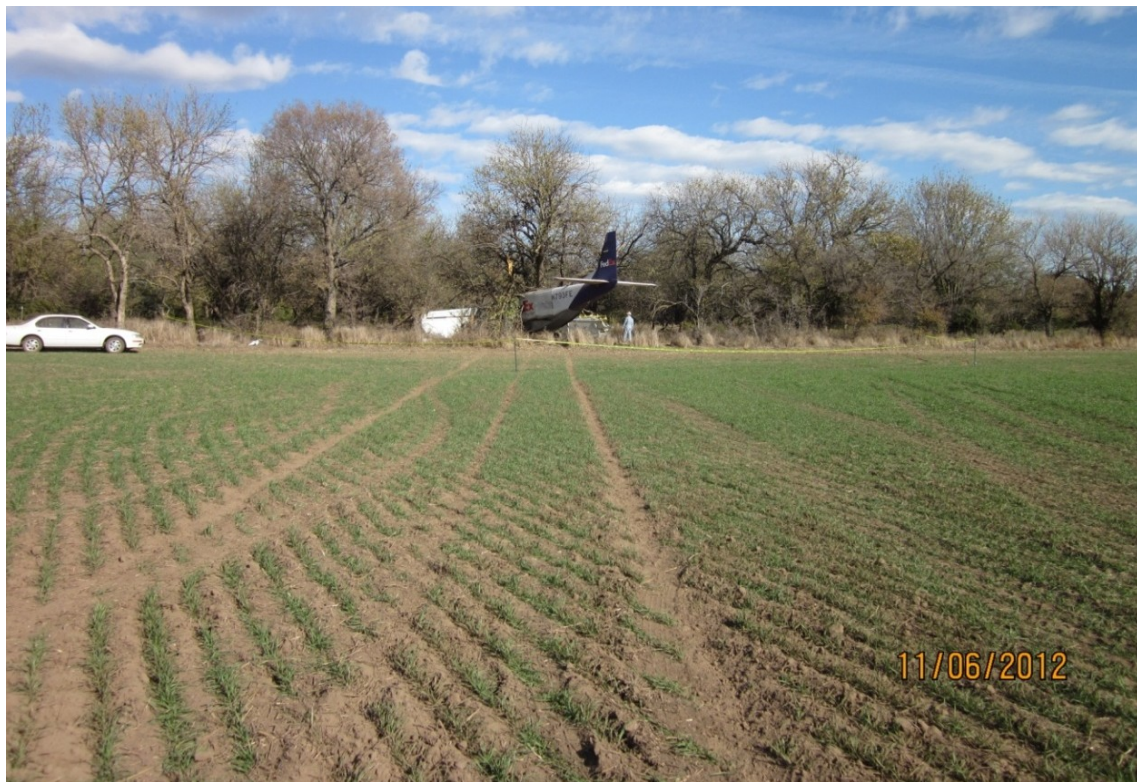
On November 6, 2012, about 0745 CST, a Cessna model 208B airplane, N793FE, was substantially damaged when it collided with a hedgerow during a forced landing following a loss of engine power near Wichita, Kansas. The loss of engine power occurred about 4-1/2 minutes after departing Wichita Mid-Continent Airport (KICT), Wichita, Kansas. The commercial pilot, who was the sole occupant, was fatally injured. The airplane was registered to the Federal Express Corporation and operated by Baron Aviation Services Incorporated, under the provisions of 14 Code of Federal Regulations Part 135 while on an instrument flight plan. Day visual meteorological conditions prevailed for the cargo flight that had the intended destination of Garden City Regional Airport (KGCK), Garden City, Kansas. Radar data indicated that the airplane departed runway 19R at approximately 0737. The airplane climbed on a westerly heading until 0742, when the pilot transmitted that his airplane had experienced a loss of engine power and that he was attempting to return to the departure airport. The pilot then asked if there were any nearby airports because he was unable to reach KICT. The departure controller provided vectors toward an airstrip that was approximately 2.5 miles southeast of the airplane's position. At 0743 the pilot advised that he could not see the airstrip because the airplane's windshield was contaminated with oil. At 0744, the pilot transmitted that he was landing in a grass field. See Figure 1. Radar contact was lost at 0745, about 2.2 miles south of KICT.

Figure 1. Accident site

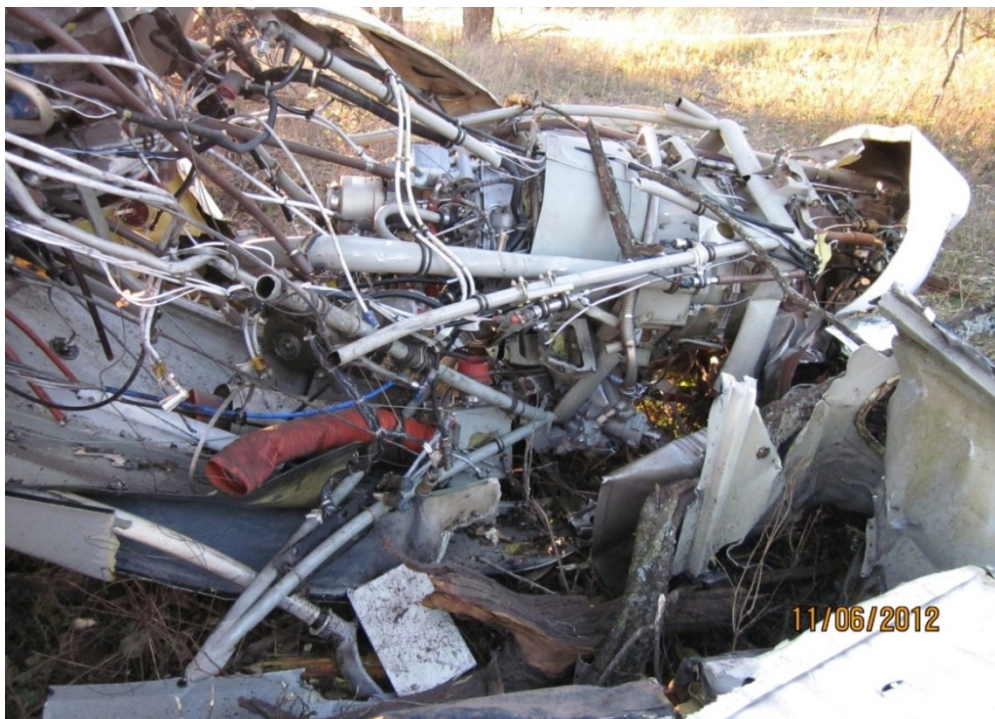
The engine remained attached to the airplane by one mount, cabling, and tubing. See Figure 2. No evidence of fire or uncontainment was found. The propeller shaft flange was twisted/deformed aftward<sup>1</sup> at 9 o'clock<sup>2</sup>; 2 bolts and 1 alignment pin were liberated. The engine serial number was confirmed from the data plate. The connecting rod for the emergency power lever was fractured at the fuel control, adjacent to the jam nut. The aircraft throttle connection rod was fractured adjacent to the jam nut. The aircraft linkage to the propeller governor was intact and in the feather position. The oil cooler was fractured.

Figure 2. Engine, right hand view

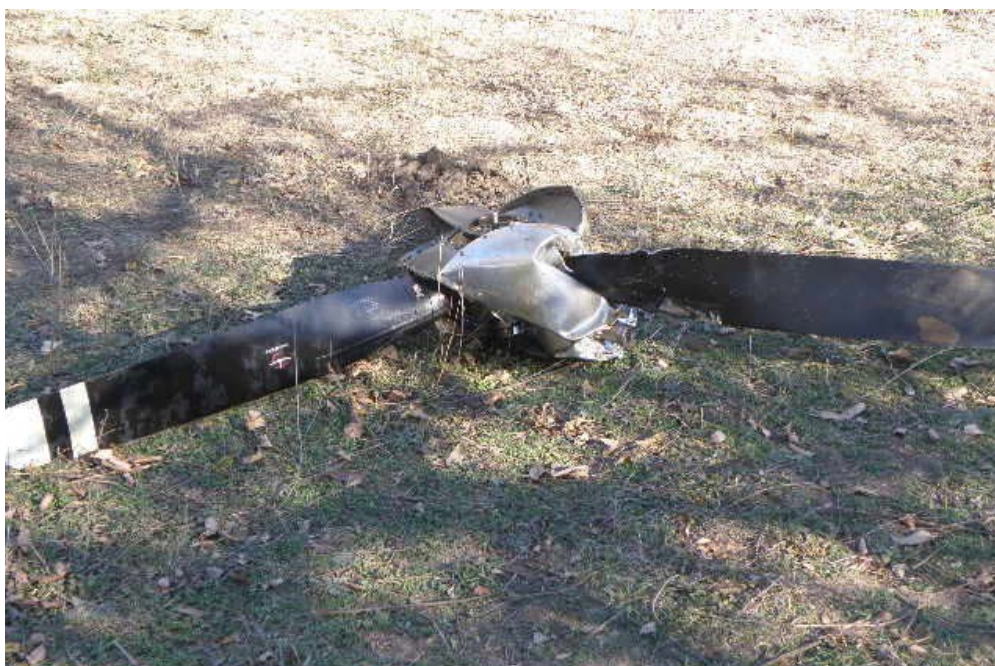
The propeller had separated from the engine, and was found approximately 80 feet northeast of the airplane.<sup>3</sup> See Figure 3.

Figure 3. Propeller

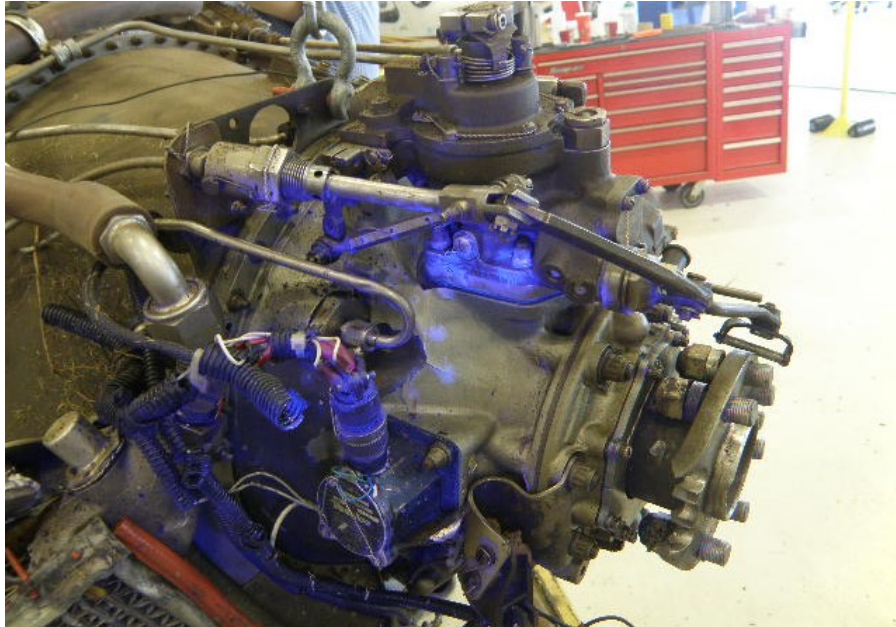
There were no case ruptures. The RGB was unremarkable. The propeller governor showed some external gouging but was otherwise intact. The overspeed governor was intact except for a fractured cannon plug. The static oil pressure tube was loose, 1 full turn plus 1 flat. The oil cooler supply and return hoses were pressurized with shop air and no leaks were noted. An ultraviolet (UV) light RGB inspection found oil residue in several locations. See Figure 8.

Figure 8. Oil residue fluorescing under UV light

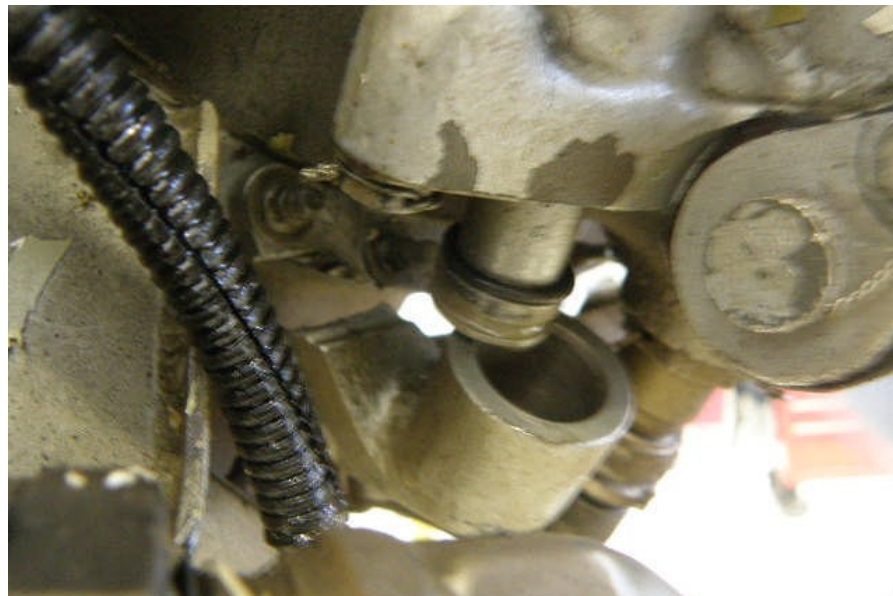
The RGB main oil pressure tube O-ring was found displaced from its groove. See Figure 9.

Figure 9. RGB pressure tube O-ring displaced

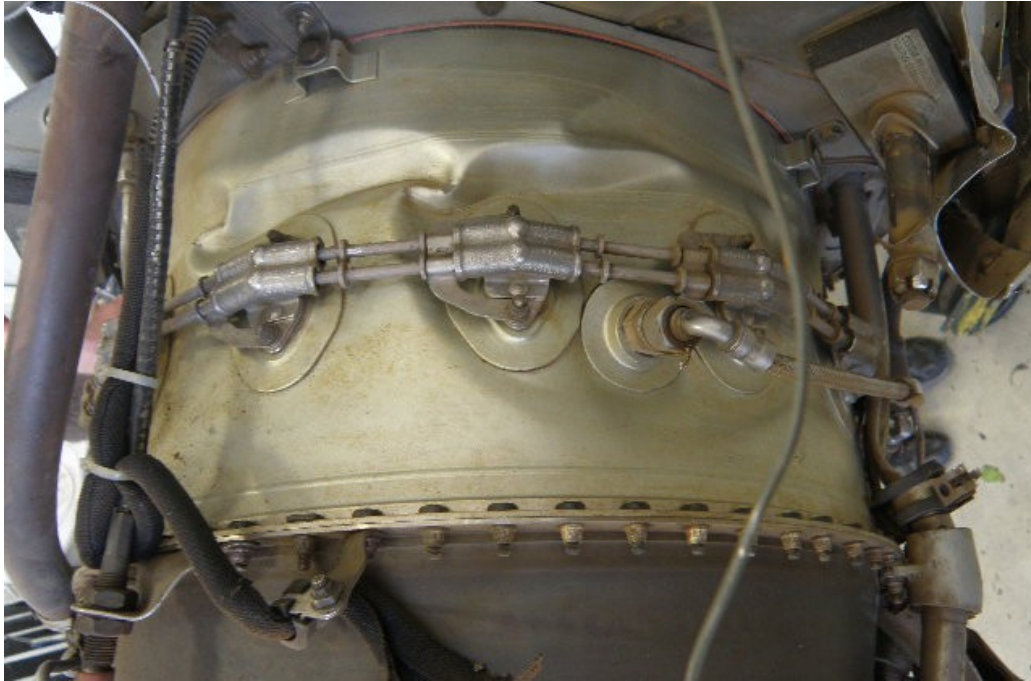
The gas generator case was buckled adjacent to the fuel nozzles, 360° around. See Figure 10. The fuel nozzles were intact and appeared in good condition.

Figure 10. Gas generator case buckling damage

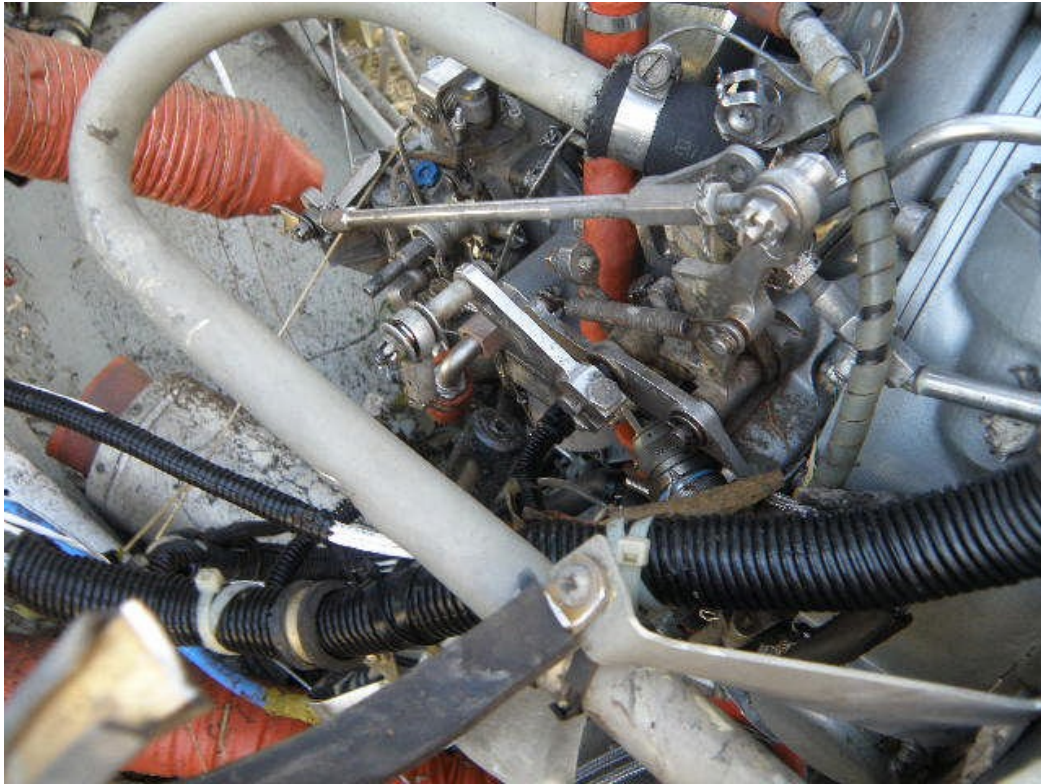
The rod between the fuel control unit and the cam box was intact and lock wired. See Figure 11. The connection cable between the cam box and the propeller governor was bent on both ends, but was intact and lock wired. The rod between the reset arm and the beta arm was bent but intact. The beta arm was intact. See Figure 12.

Figure 11. Fuel control unit-to-cambox linkage

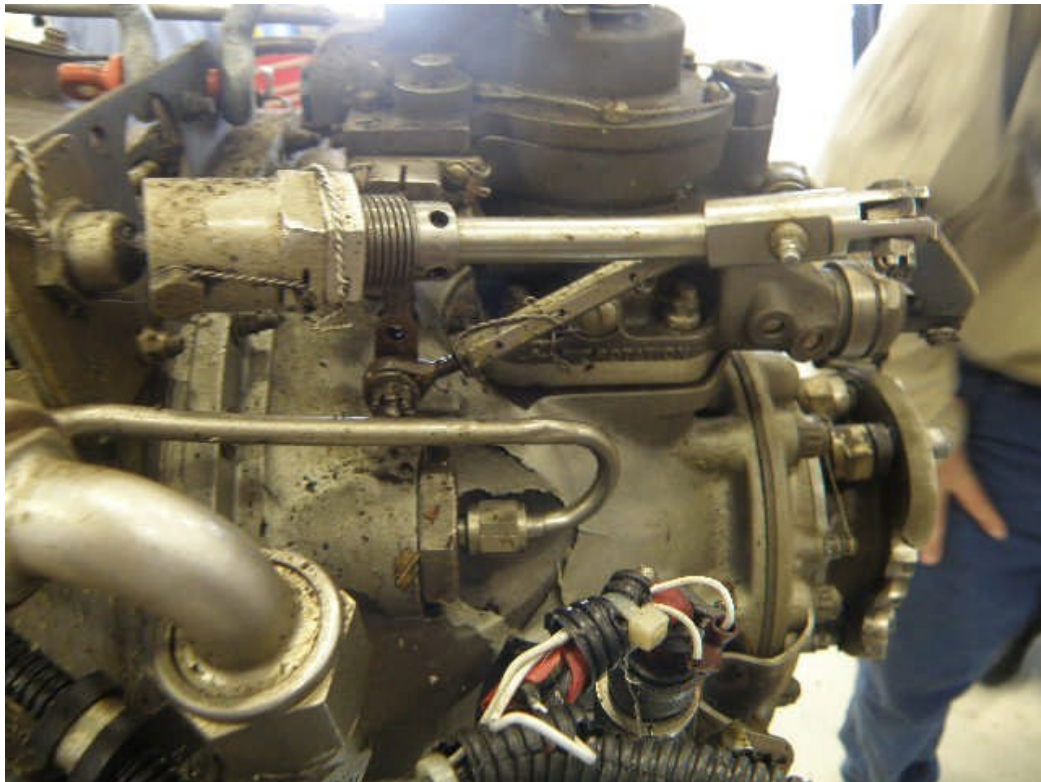
Figure 12. Reset arm-to-beta arm rod

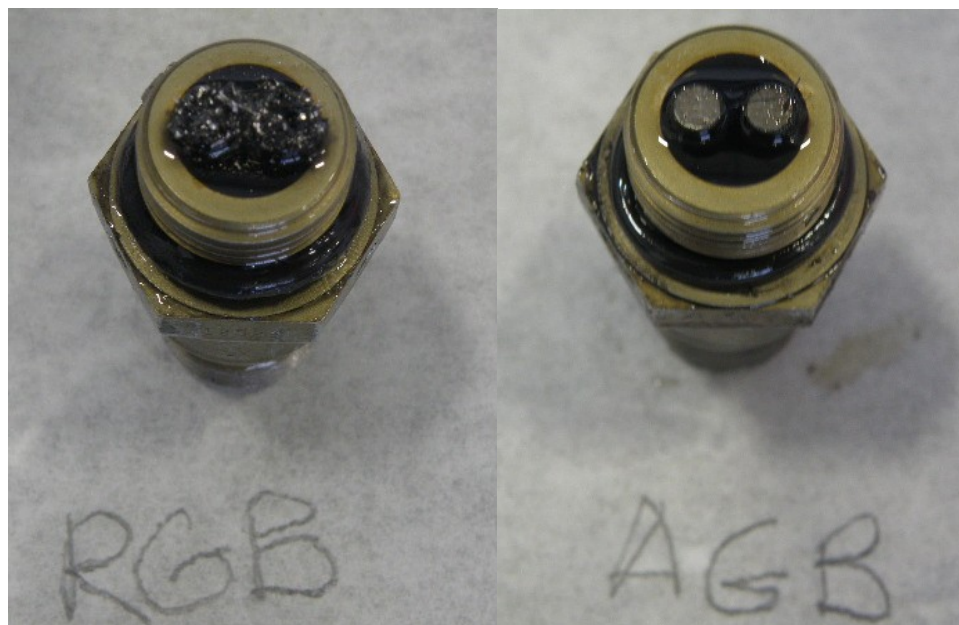
The RGB chip detector was bridged and showed a buildup of ferrous material. The AGB chip detector showed a small amount of ferrous material but was not bridged. See Figure 13. A small amount of metal particles was found in the oil filter. The main fuel filter element was clean. The fuel pump inlet filter screen/strainer showed some minor contamination.

Figure 13. RGB and AGB chip detectors

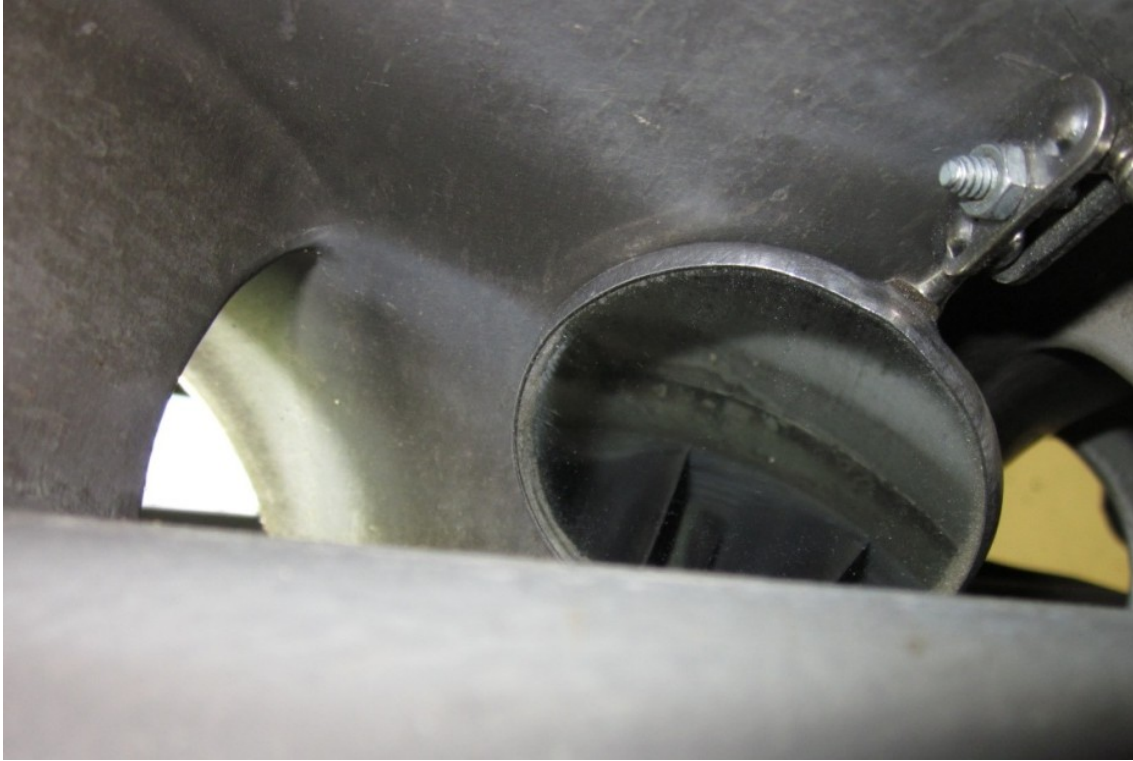
As viewed through the inlet, the 1<sup>st</sup> stage compressor blades exhibited some minor erosion and the 1<sup>st</sup> stage compressor shroud showed some circumferential scoring. No foreign object damage was noted. See Figure 14. When turned at the N1 tachometer drive pad, the compressor and the accessory drive train rotated freely, with no unusual sounds noted. The compressor section was not disassembled.

Figure 14. 1<sup>st</sup> stage of compressor viewed through the engine inlet

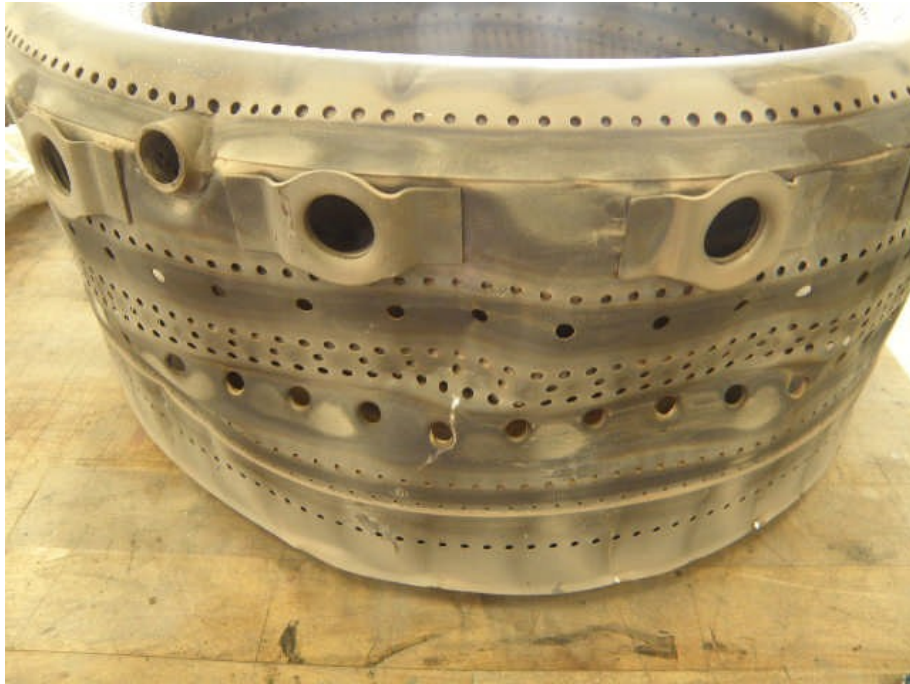
The combustor chamber liner showed minor buckling damage but was otherwise in good condition. See Figure 15. The large exit duct was unremarkable except for one localized heat deformed area at 10 o'clock. The small exit duct had some erosion at the cooling holes but was otherwise unremarkable.

Figure 15. Combustion liner

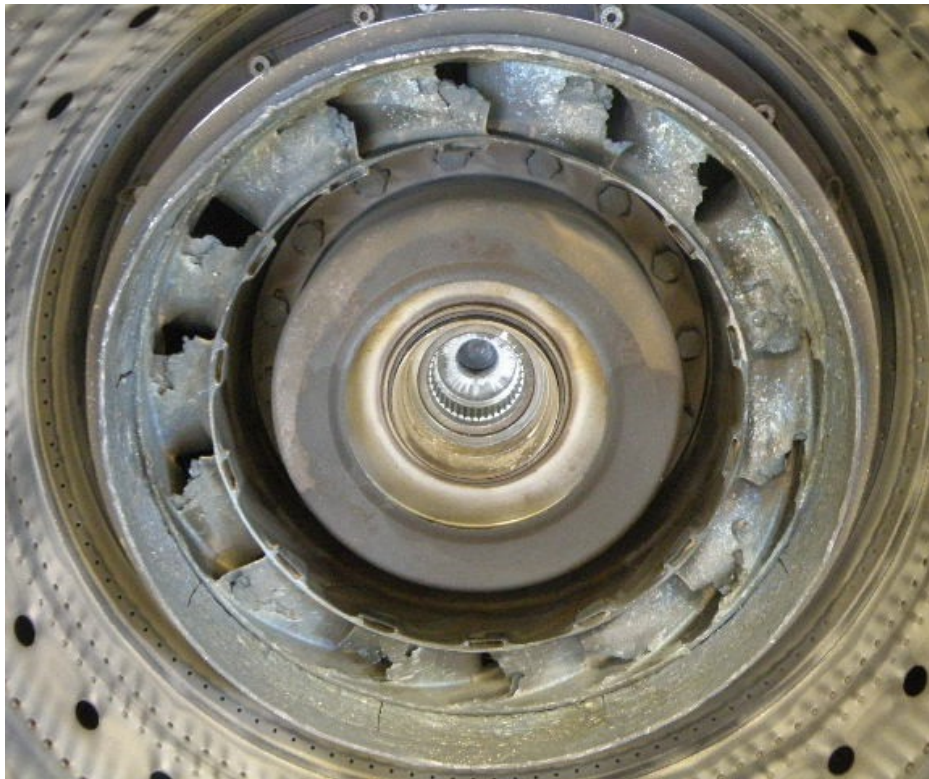
The CT guide vane ring exhibited minor erosion at the airfoil leading edges (LEs); the airfoil trailing edges (TEs) were severely battered with numerous deep impact marks and missing material. See Figure 16. The compressor turbine vane inner drum displayed a light rub between 4 and 7 o'clock.

Figure 16. Compressor turbine vane ring showing extensive airfoil TE damage

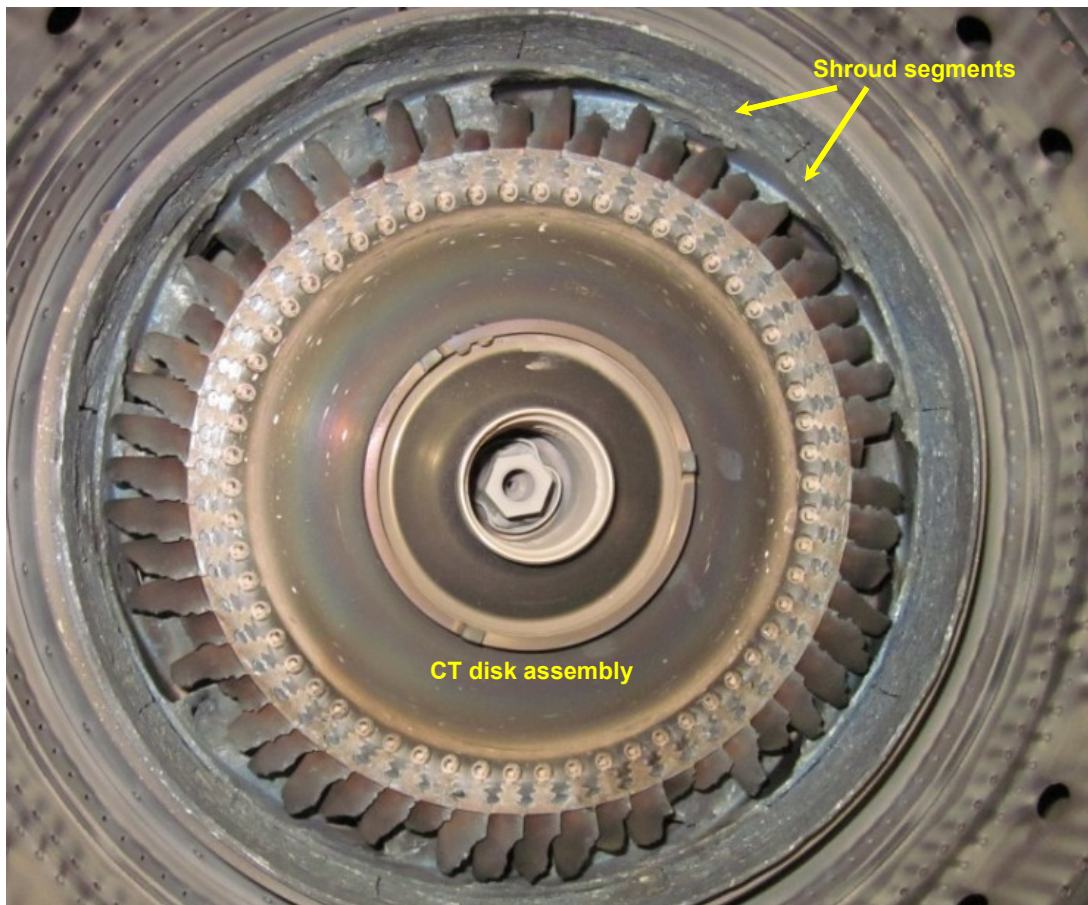
The CT shroud segments were severely battered with numerous deep impact marks. See Figure 17.

All of the CT blades were fractured at various heights, from just above the platform to approximately 75% of blade height. See Figure 17.

Figure 17. View of severe CT blade material loss and battered shroud segments

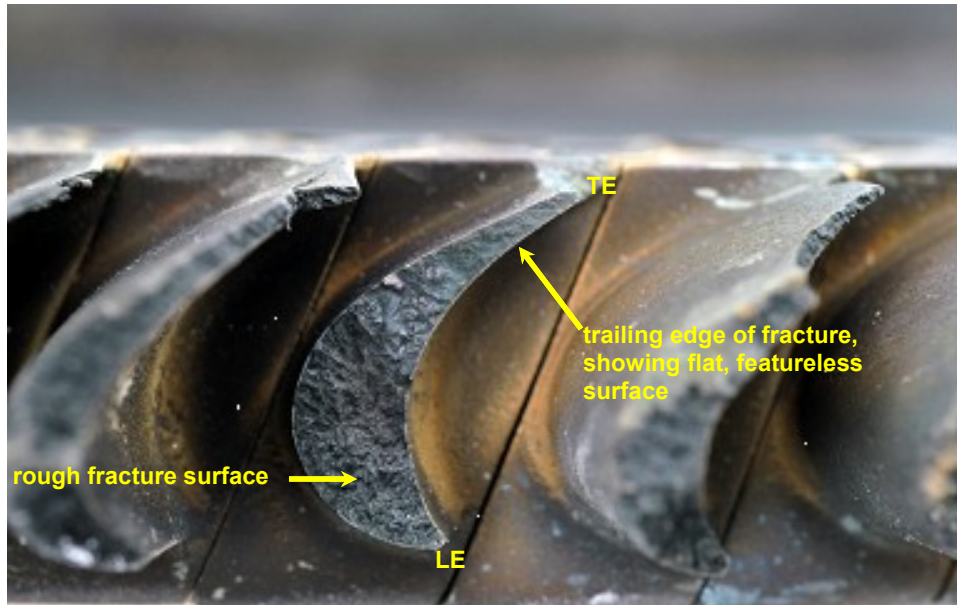
The fracture surface of one CT blade (“blade 1”) was flat and featureless from the TE to approximately mid-span, and was rough and dimpled from midspan to the LE. See Figure 18.

Figure 18. CT "blade 1" fracture surface

Metallurgical examination of CT “blade 1” revealed a fatigue fractures emanating from the TE area and progressing along the blade chord line to approximately mid-chord, where a mixture of fatigue and tensile overload fatigue cracking was observed. The remainder of the fracture was consistent with tensile overload. Scanning electron microscope (SEM) examination revealed oxidation on the fracture surface from exposure to hot gases and river lines indicating the direction of the fatigue crack propagation. The blade TE was damaged and an approximate 0.060-inch section including the fatigue initiating point was missing. However, the TE initiation suggested that the crack was most likely due to high cycle fatigue. Microscopic examination of

No material defect or evidence of creep was found. Although the TE thickness of CT “blade 1” could not be measured at 0.050” from the TE due to the secondary impact damage, the airfoil thickness was measured at the beginning of the fracture and was found to be consistent with the drawing requirements. Energy dispersive spectrometry (EDS) analysis found that its chemical composition met the drawing requirements. No evidence of hot corrosion was noted on the blades or in the disk serrations.

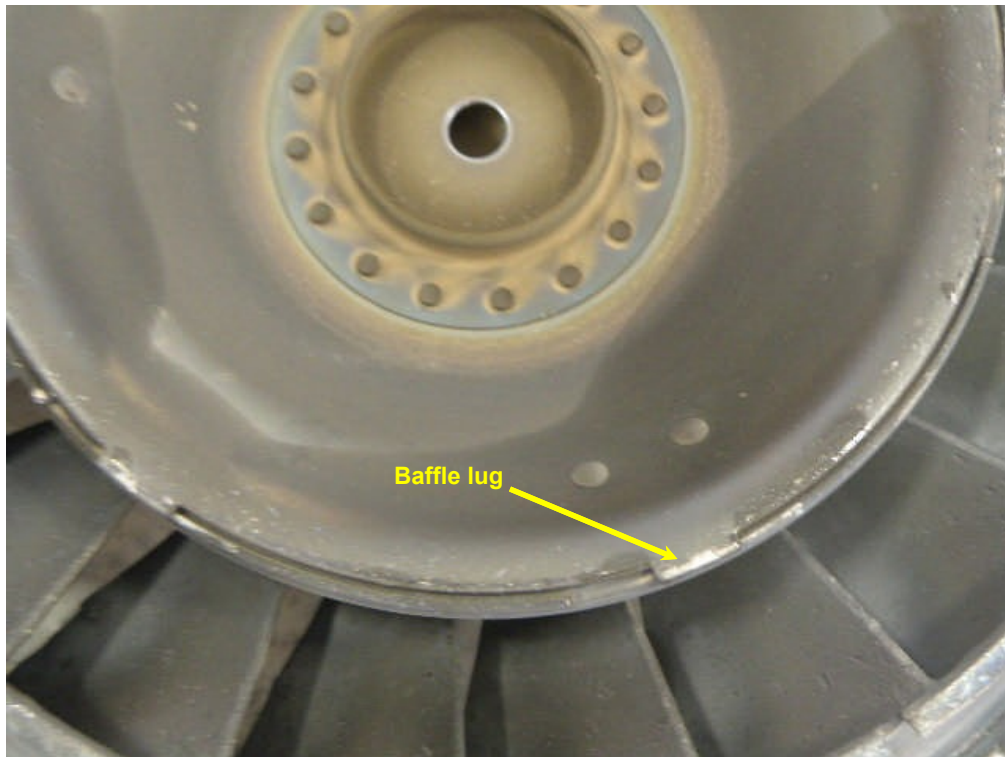
The PT vane ring airfoil LEs exhibited impact damage and erosion. The TE's were heavily battered with missing material, and coated with metal splatter. The upstream baffle lugs had rotated out of position and were scored consistent with rubbing contact with the downstream side of the CT disk and blade platforms. See Figure 19. The downstream baffle face was heavily scored with missing material consistent with rotational contact. See Figure 20.

Figure 19. Upstream side of the PT vane assembly showing baffle lug scoring

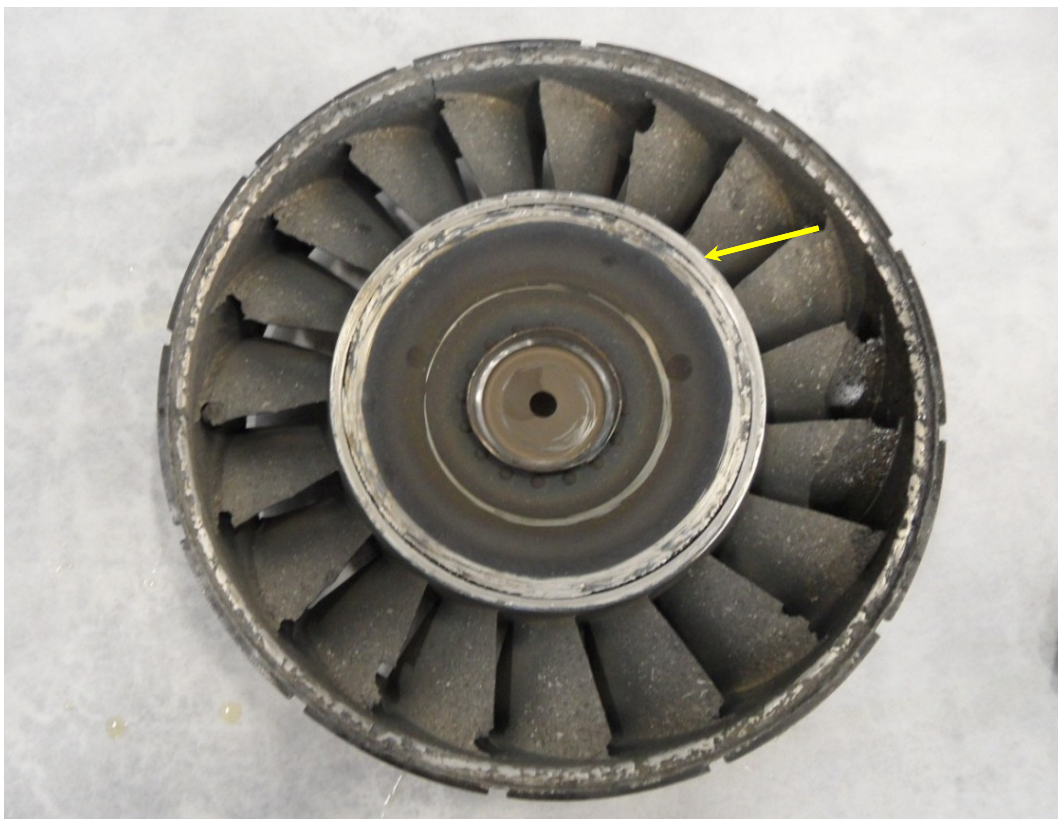
Figure 20. Power turbine vane assembly downstream side showing heavy scoring along the baffle face

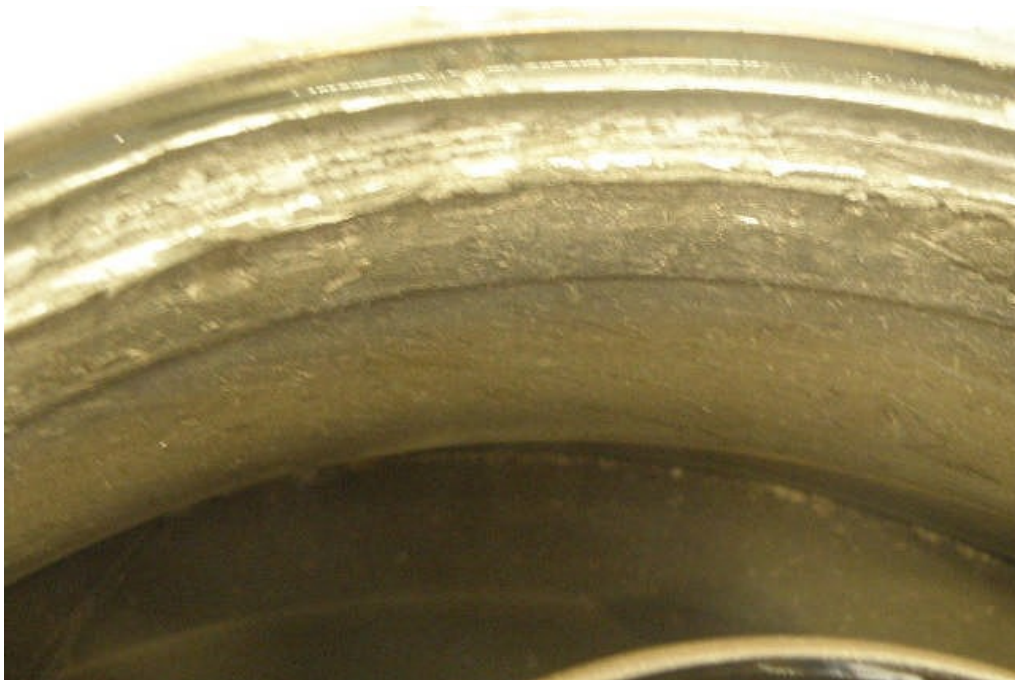
The PT shroud was heavily battered and the exhaust duct locating flange was distorted. See Figure 21.

Figure 21. PT shroud and exhaust duct

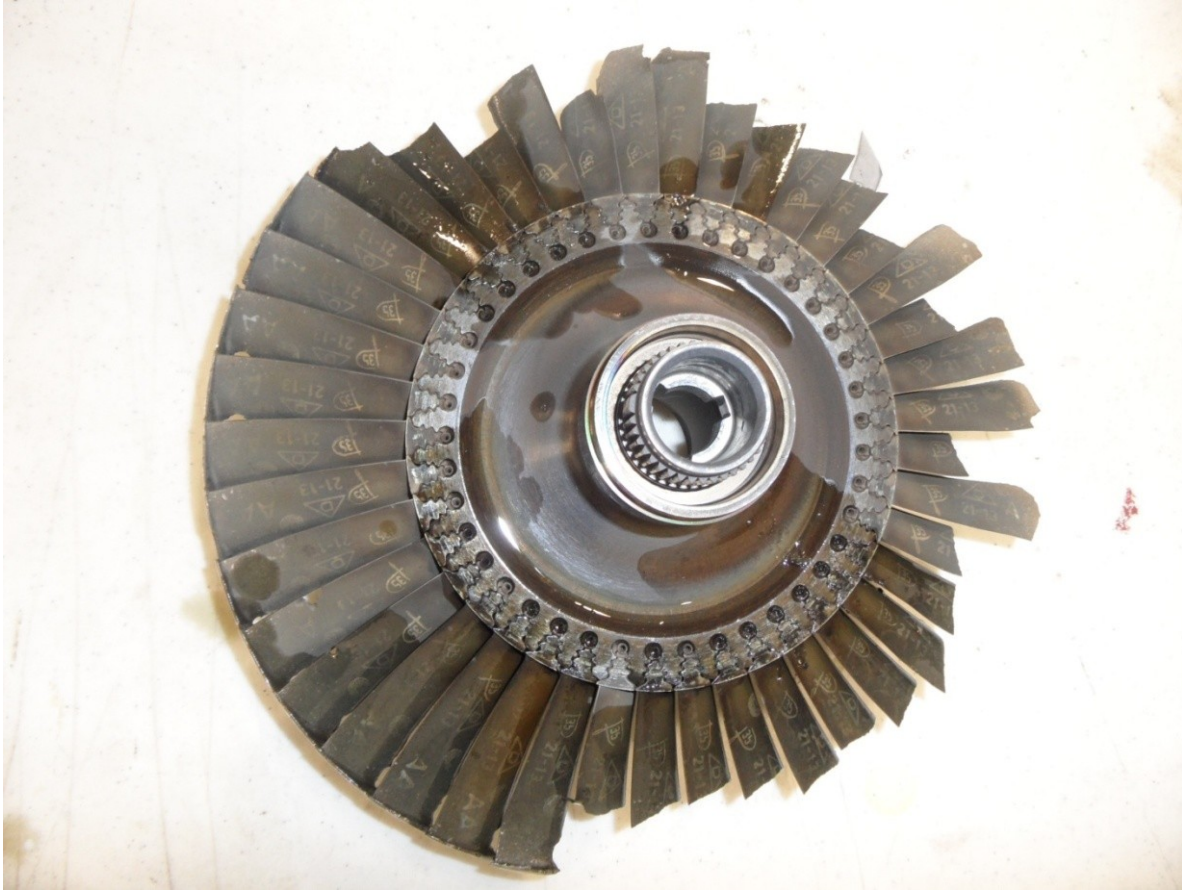
The PT disk assembly showed severe asymmetrical damage, with 28 adjacent blades fractured at varying heights and the remaining 13 consecutive blades at full height. See Figure 22. All of the blade fracture surfaces had a rough, dimpled appearance. The shrouds of the 13 full-height blades showed severe rotational scoring, consistent with contact during operation.

Figure 22. PT disk assembly showing severely localized blade loss

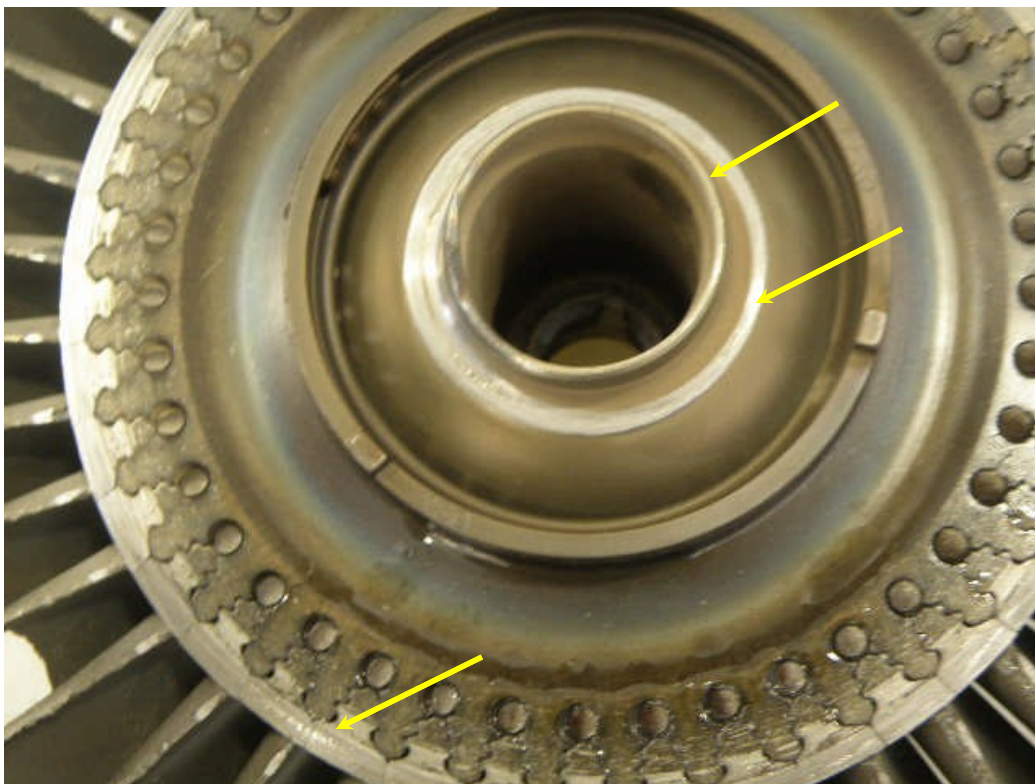
All of the PT blades were slightly loose in their rivet slots. The blade LEs, platforms and the center bore of the disk showed rotational scoring consistent with contact with the PT guide vane ring and interstage baffle. See Figure 23. The downstream side of the disk was oil-wetted. The No. 3 bearing air seal exhibited localized scoring opposite the arc of severe blade material loss. See Figure 24.

Figure 23. PT disk assembly showing rotational scoring on blades and disk

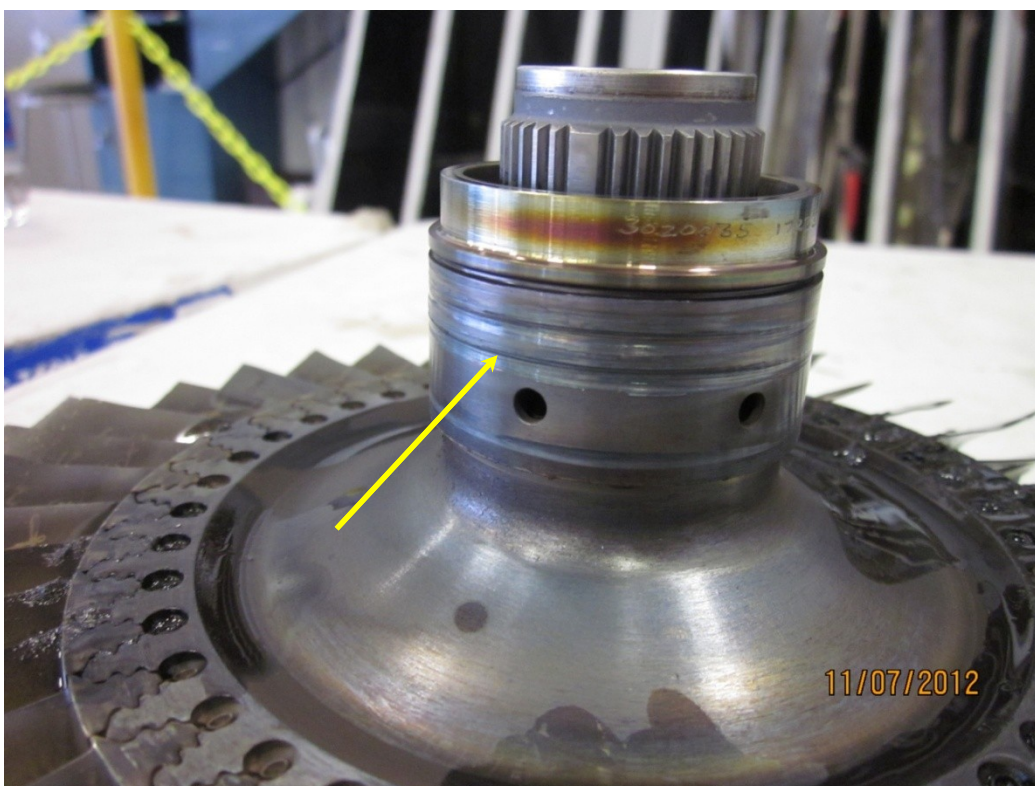
Figure 24. PT disk showing localized scoring at air seal

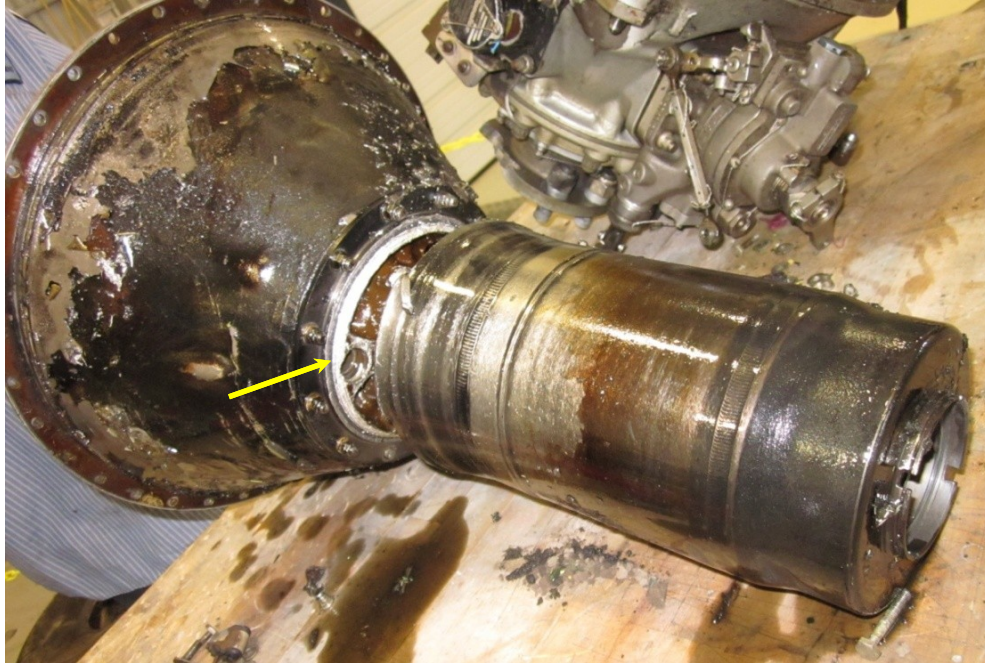
The PT shaft housing was fractured and separated adjacent to the RGB mating flange. See Figure 25.

Figure 25. PT shaft housing and rear RGB showing fracture

Most of the PT shaft housing fracture could not be analyzed, due to damage caused by relative movement between the fracture surfaces; however, a small portion of the flange section was in good condition. Metallurgical examination of this area revealed multiple fatigue cracks initiating at the outside diameter of the flange and propagating toward the inside diameter. A SEM examination of the fatigue showed striations that were not well defined, indicating the housing was subjected to low cycle fatigue. Hardness testing and EDS found that the material met the drawing requirements for chemical composition and hardness.

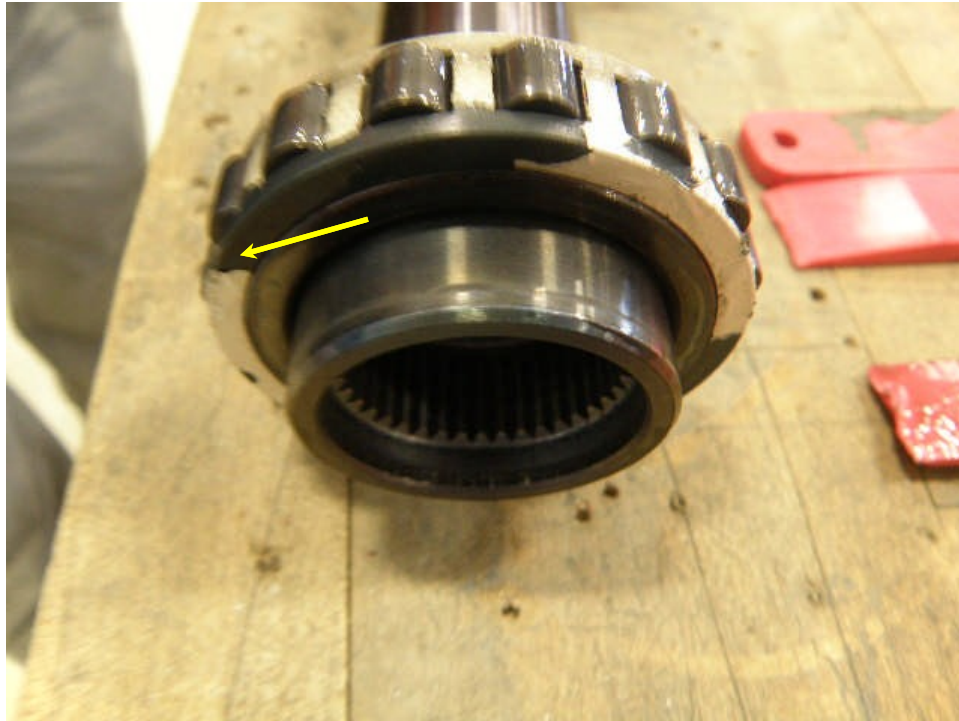
The No. 3/No. 4 bearing scavenge tube was fractured and the pressure tube was found out of position, consistent with housing rotation. Air was applied to the supply end of the pressure tube and no nozzle obstruction was noted. The PT shaft was heat discolored in the area of the No. 3 bearing. The No. 4 bearing was oil wetted and rotated freely. The No. 3 bearing was oil wetted and rotated freely but showed some cage plating delamination and local heat discoloration typical of some loss of lubrication. See Figure 26.

Figure 26. No. 3 bearing on PT shaft, showing delamination of cage plating

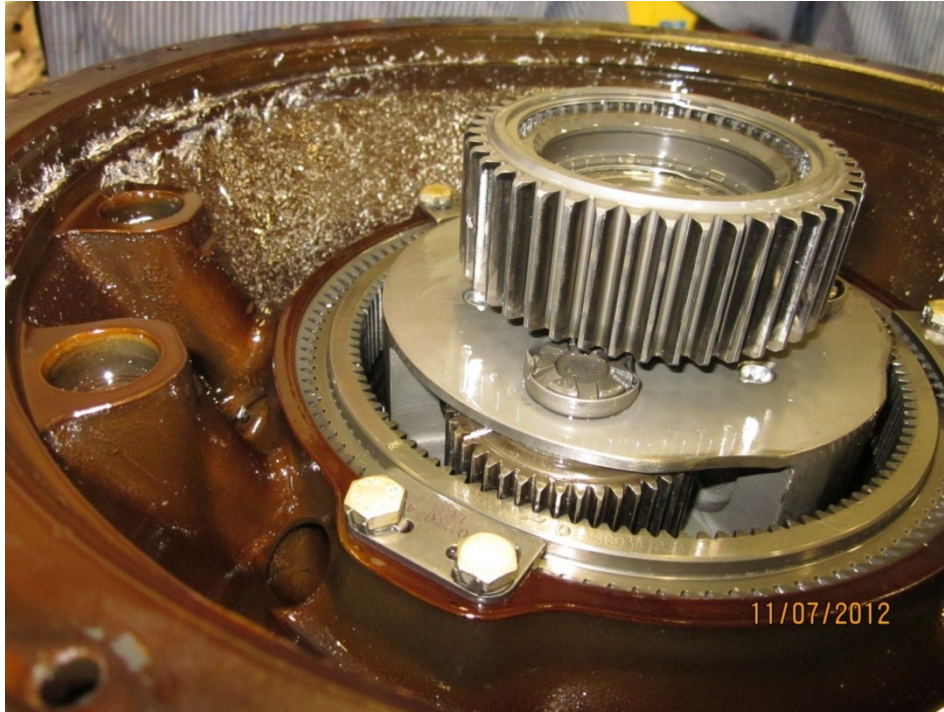
The RGB was not disassembled. The RGB housing rear face showed heavy 360° rotational scoring. The first stage sun gear was circumferentially scored and there were metal shavings on its surface. The first stage sun gear splines showed some abnormal wear. Both the 1<sup>st</sup> and 2<sup>nd</sup> stage planet gears rotated freely, with no evidence of heat tinting or oil starvation. A large amount of metal slivers and particles were found inside the rear housing. See Figure 27.

Figure 27. Metal contamination in the rear RGB housing

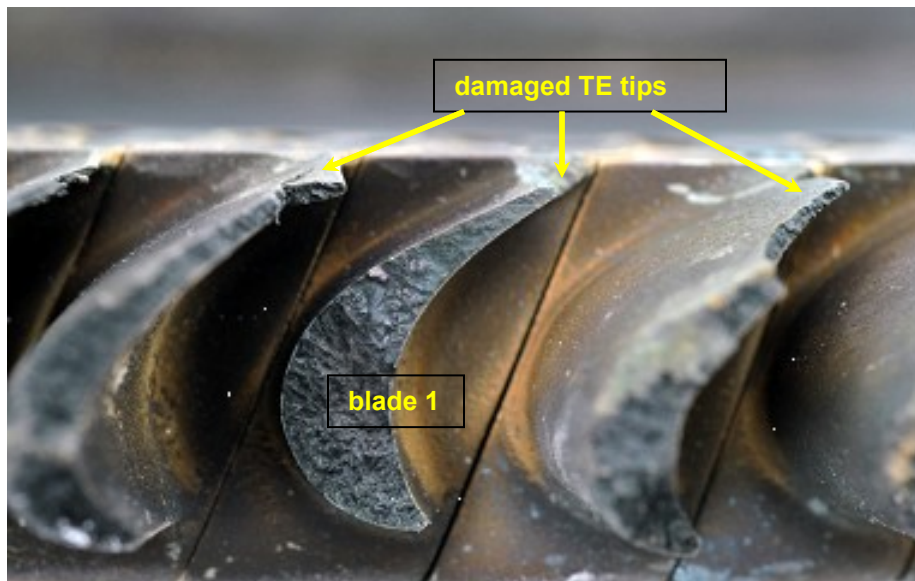
this area determined that the TE damage was caused by impact damage. Several other blades showed similar impact damage at the TE. See Figure 28.

Figure 28. CT blade TE damage. Photograph courtesy of Pratt & Whitney Canada

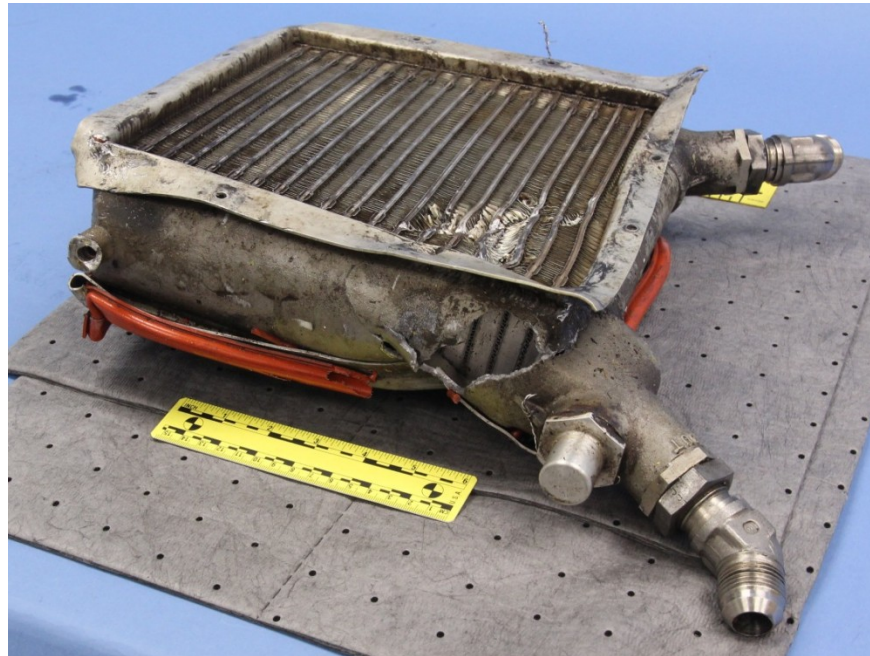
The oil cooler removed from the accident airplane was examined by the NTSB materials laboratory in Washington, DC on January 11, 2013 for evidence of fatigue at the fractures. See Figure 29. Microscopic and SEM examination of the plenum fractures found no crack arrest marks or ratchet marks that would indicate progressive cracking.<sup>4</sup>

Figure 29. Oil cooler
