# NATIONAL TRANSPORTATION SAFETY BOARD

## MATERIALS LABORATORY FACTUAL REPORT

Report 13-004

Place : Wichita, KS  
Date : November 6, 2012  
Vehicle : Cessna 208 Caravan, N793FE  
NTSB No. : CEN13FA049  
Investigator : Carol Horgan, AS-40

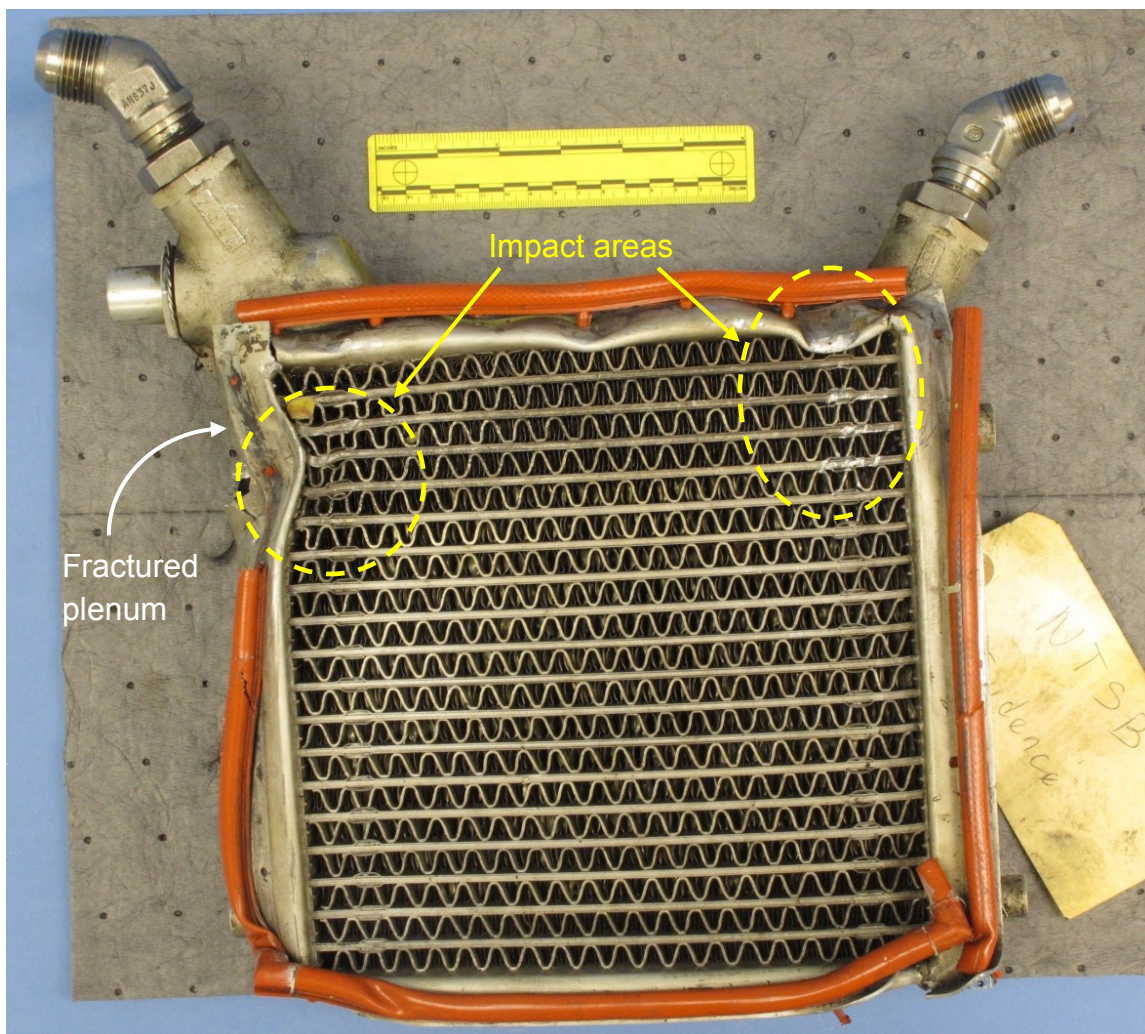
The cooler exhibited multiple impact marks on all sides of the part, particularly observed on the fins and tubes in the main body. Many of the impressions in the impacted areas are consistent with those typical of collisions with adjacent metallic parts. The most substantial damage in Figure 2 exhibited impressions on the crushed fins consistent with a threaded bolt. Also shown in Figure 2 is an area where the attachment flange was bent over the welded plenum.

Figure 1 – The oil cooler, as received. The location of the fractured plenum on the side is identified, and the areas where the cooler collided with adjacent parts are circled.

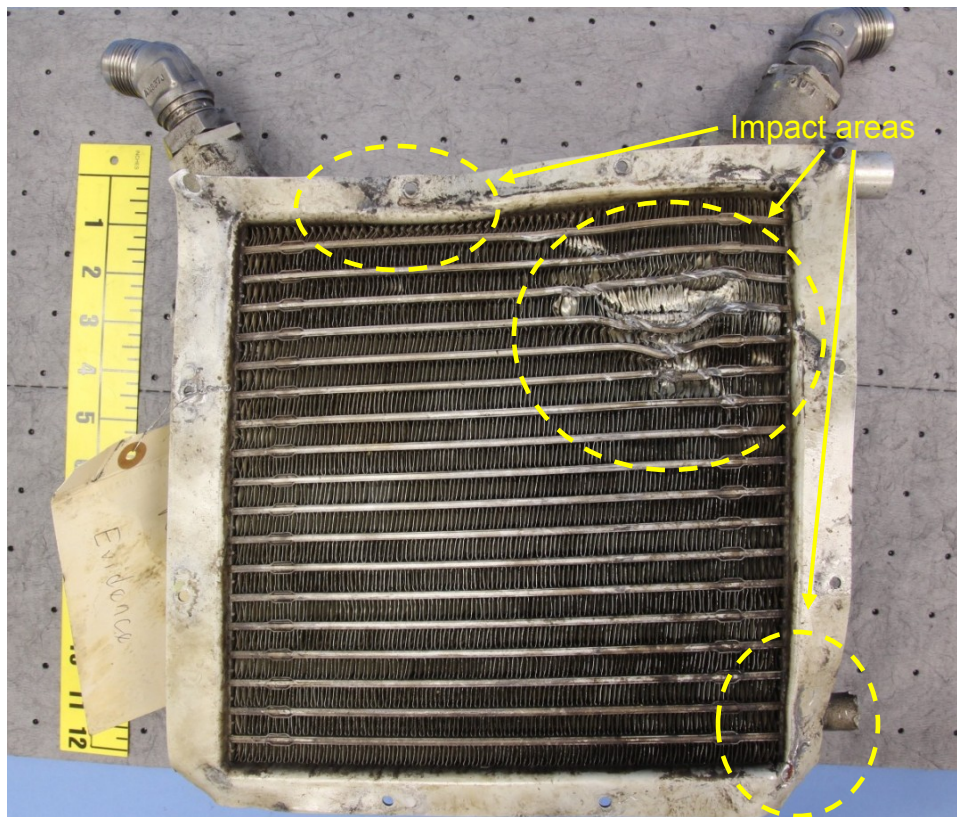
Figure 2 – The oil cooler, from the reverse side shown in Figure 1. The impact areas on the tubes are circled.

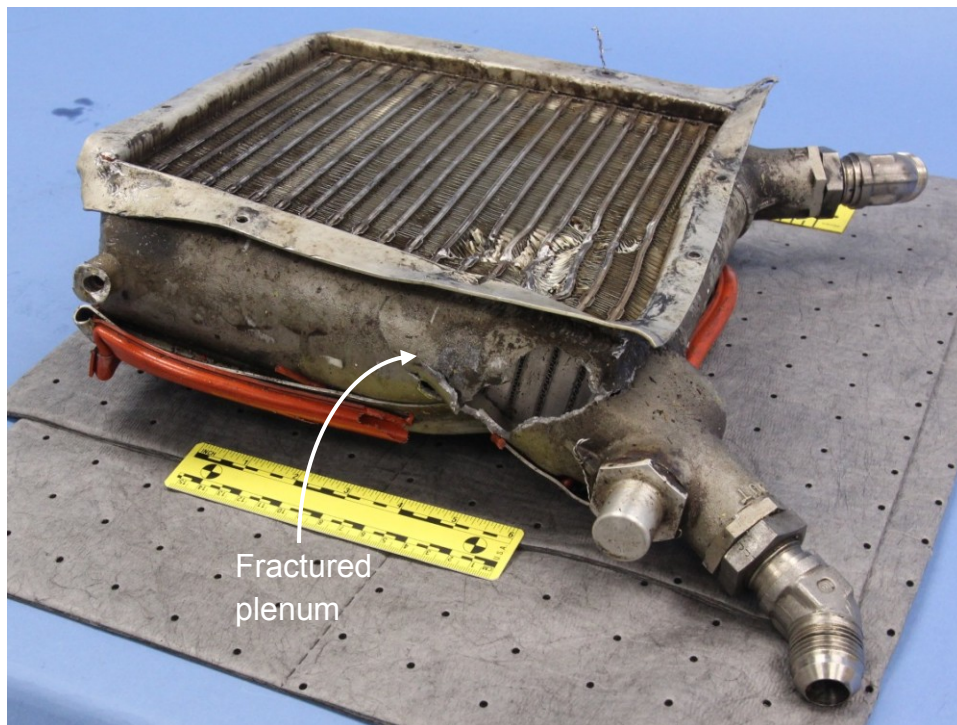
Of primary concern was the fractured plenum on the side of the cooler, depicted in Figures 3 and 4. An approximately 2" x 1" segment of the plenum housing was missing from the cooler, and three cracks appeared to emanate outward from this area. The largest crack ran along the plenum housing corresponded and with an indented section across the side (see Figure 4). The area near the fracture exhibited a slight outward bulge from the body of the part. A third crack traversed around the part along the weld between the plenum and the forward flange (Figure 5). This crack ran approximately 1.5 in along the weld on the flange side (see Figure 6).

Figure 3 – The oil cooler, from the side showing the fractured plenum.

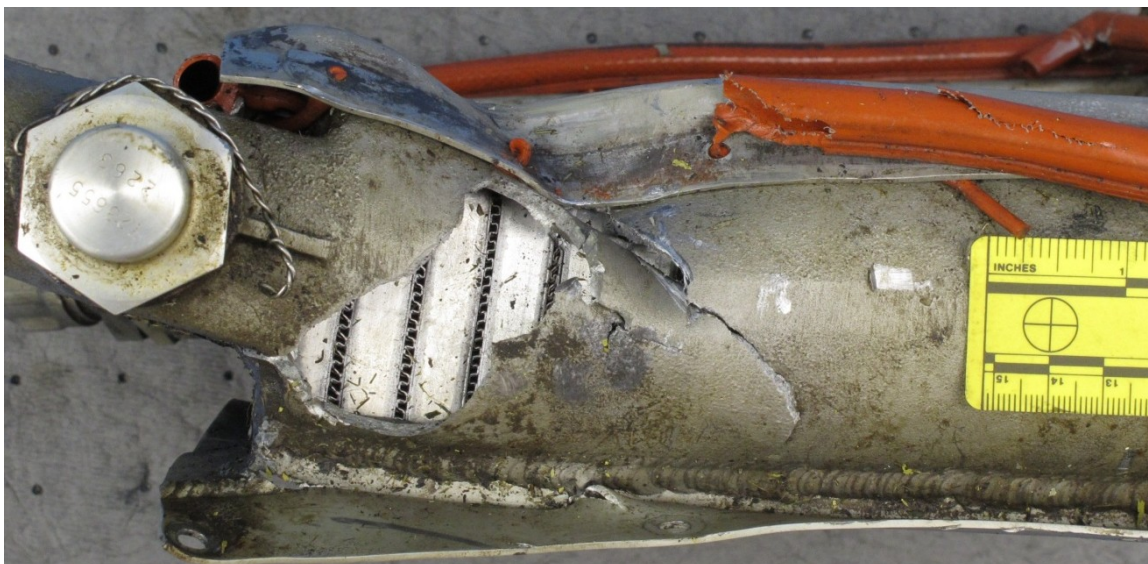
Figure 4 – The fractured plenum on the side of the cooler, showing a longitudinal impact mark and the exposed interior from the missing segment.

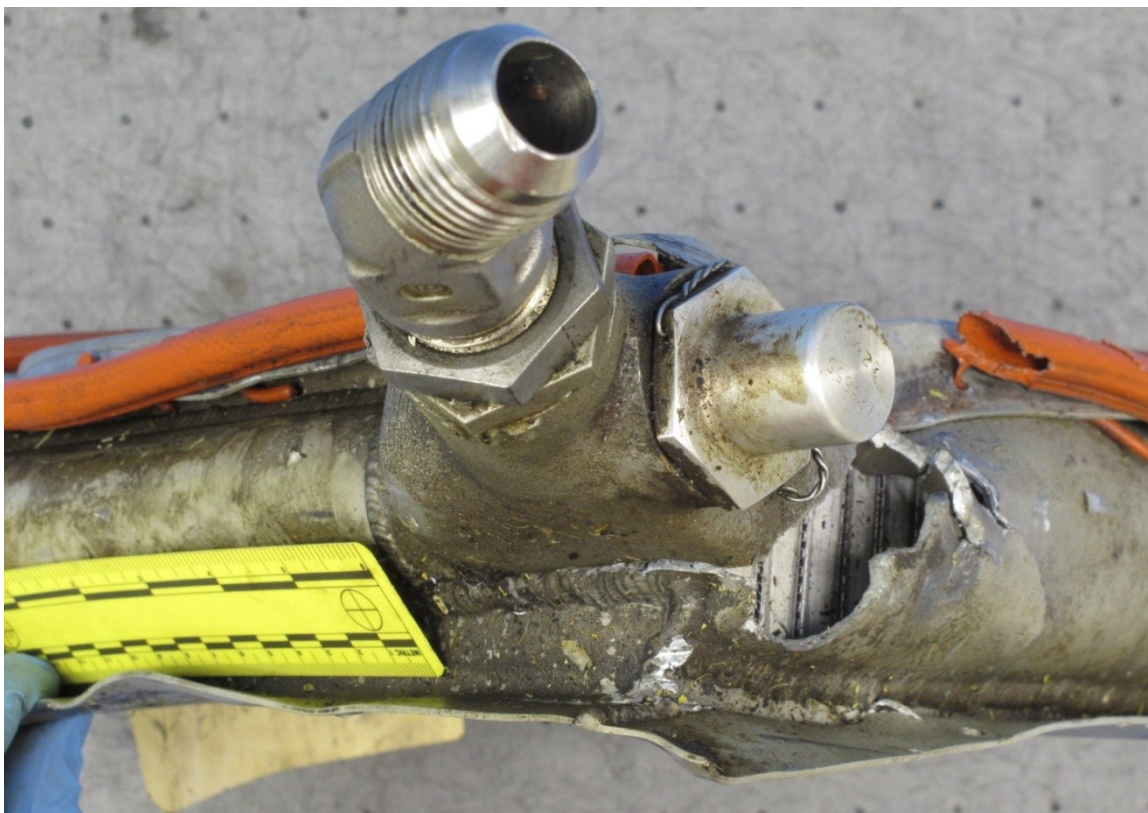
Figure 5 – The fractured plenum, rotated 45° from Figure 4, showing the crack along the weld.

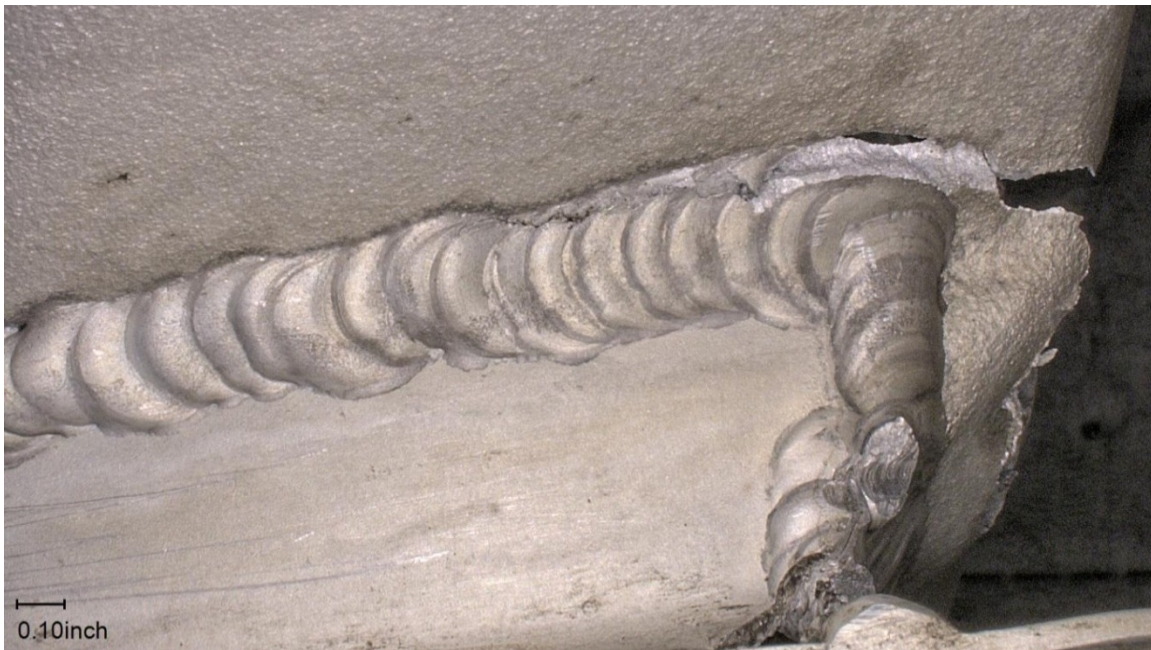
Figure 6 – The cracked weld from Figure 5, after cleaning with ethyl alcohol.

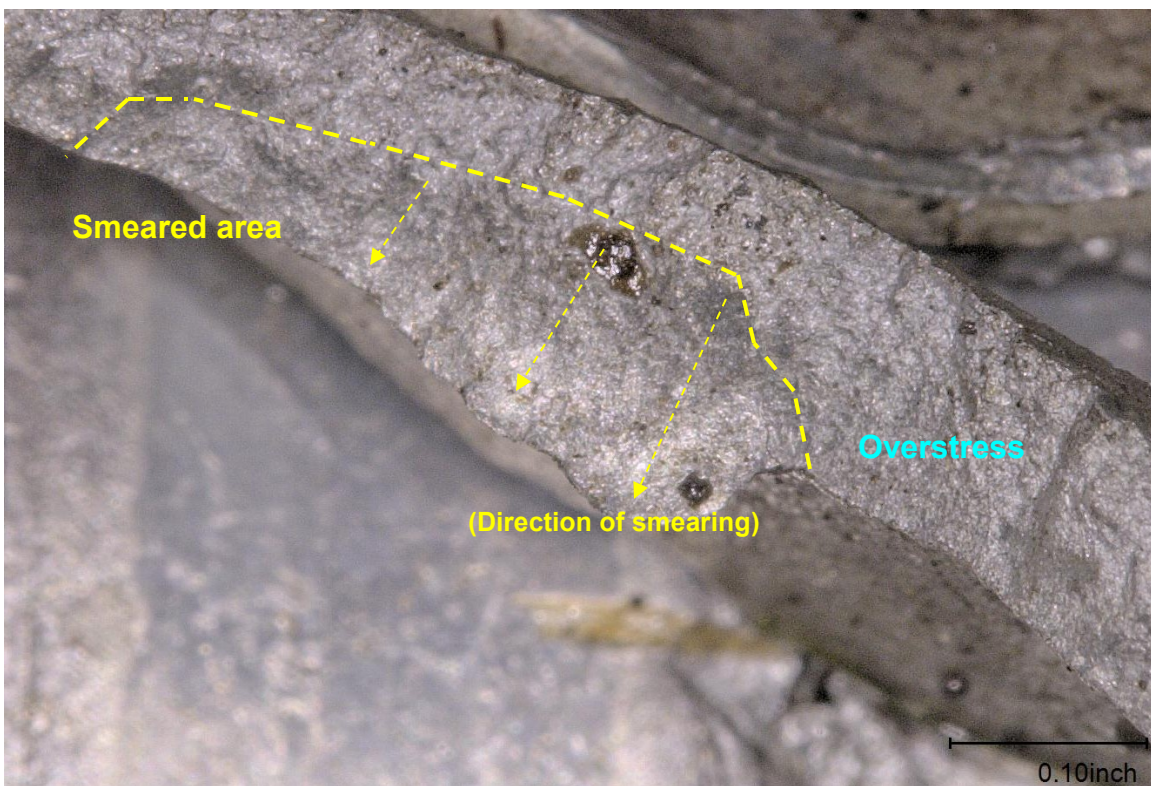
Almost all of the crack faces and fracture surfaces exhibited a dull luster and tortuous morphology. Isolated flat shiny areas were observed along the fracture surface. However, as illustrated in Figure 7, these areas contained deep irregular streaks consistent with smearing. In addition, these areas were adjacent to deformed protrusions inward, which are consistent with collisions with other metallic parts. There was no visible evidence of crack arrest marks or ratchet marks that would indicate progressive cracking.

Figure 7 – An area of smearing along the fracture surface. Material in the smeared area had been deformed inward.

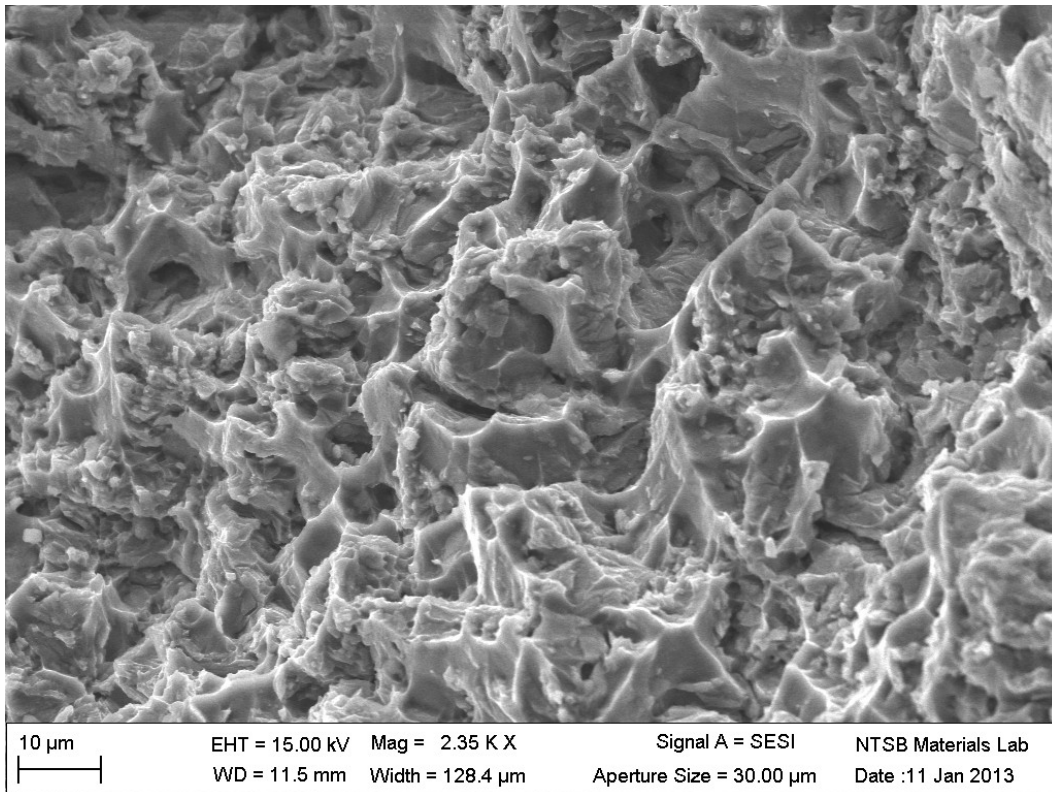
Closer examination of large sections of the fracture surface using a scanning electron microscope revealed dimple rupture, as displayed in Figure 8. This fracture morphology is indicative of overstress. The crack along the weld was backcut and opened in order to examine the crack faces. Dimple rupture was the only fracture morphology found along the weld. A small pore (approximately 0.015" diameter) was located at the end of the crack tip along the weld. However, no indication of fatigue or other progressive cracking was found emanating from the defect, and the location of the defect is not consistent with one that might lead to the fracture observed on the cooler plenum. No indications of other defects were found along the weld crack. In addition, there were no signs of other failure modes on the other fracture surfaces away from the weld.

Figure 8 – Secondary electron (SE) micrograph of a typical area along the cooler fracture surface, revealing dimple rupture indicative of overstress.

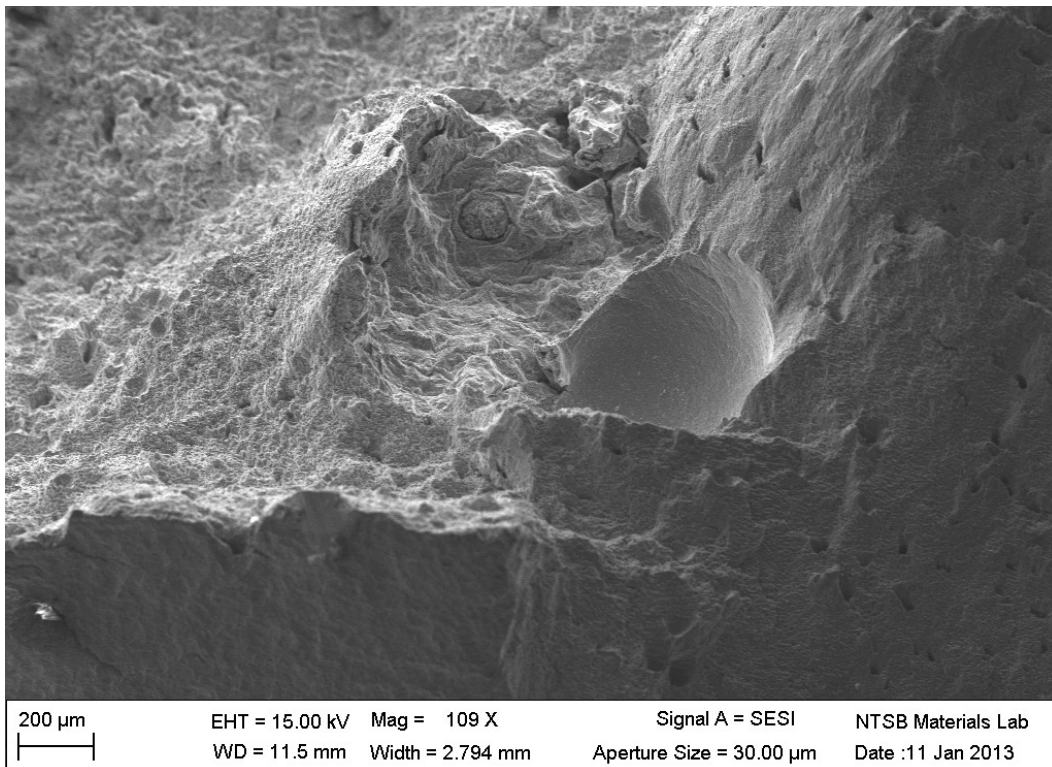
Figure 9 – SE micrograph of a small pore in the cracked weld, at the end of the crack tip.
