# NATIONAL TRANSPORTATION SAFETY BOARD

## MATERIALS LABORATORY FACTUAL REPORT

Report No. 14-032

Place : Paragould, Arkansas  
Date : June 28, 2013  
Vehicle : Zenith CH750, N699TX  
NTSB No. : CEN13IA387  
Investigator : Tim Sorensen, AS-CEN

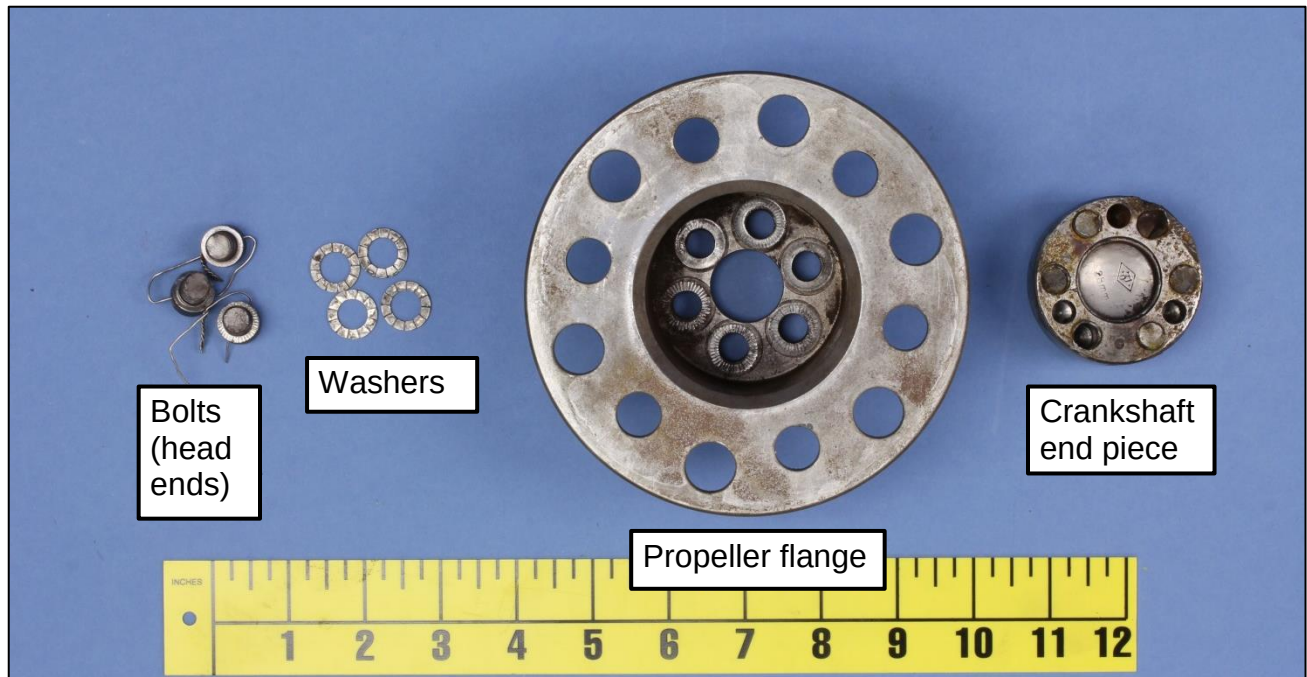
An overall view of the submitted components is shown in figure 1, where the forward faces of the propeller flange and the crankshaft piece are viewed in the image. Fractured ends of 5 of the 6 attachment bolts were retained in the propeller flange, and one of the bolts was missing completely. The head ends of 3 of the fractured bolts and 4 of the washers were recovered as shown in figure 1. According to information provided by the investigator-in-charge, the engine had 32 hours time in service since new.

Bolts 2, 5 and 6 had smeared features or features on slant planes consistent with ductile overstress fracture. The bolt head ends shown on figure 1 had fracture features that mated to bolts 2, 5, and 6. Bolt heads 5 and 6 were joined by lockwire, and a fractured piece of lockwire was attached to bolt head 2. Bolt 4 was missing in its entirety.

Figure 1. Overall view of the submitted components.

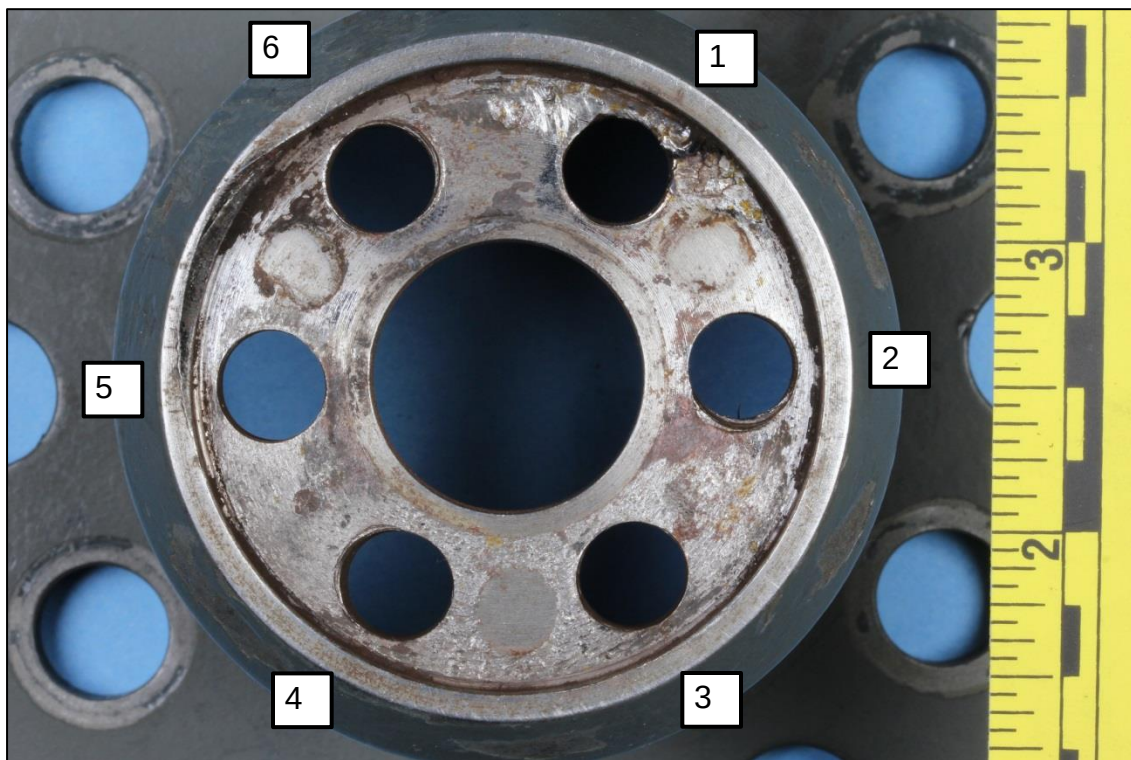
A view of the aft face of the propeller flange at the crankshaft attachment area is shown in figure 2. The 6 holes for the propeller attachment bolts were arbitrarily numbered as shown in figure 2 for reference in this report. Heavy fretting damage was observed on the face that mated to the crankshaft flange. Fretting was most severe from hole 2 clockwise<sup>1</sup> to hole 5 and in the vicinity of hole 1.

Figure 2. View of the aft face of the propeller flange where it mated to the crankshaft. Attachment bolt holes are numbered for reference.

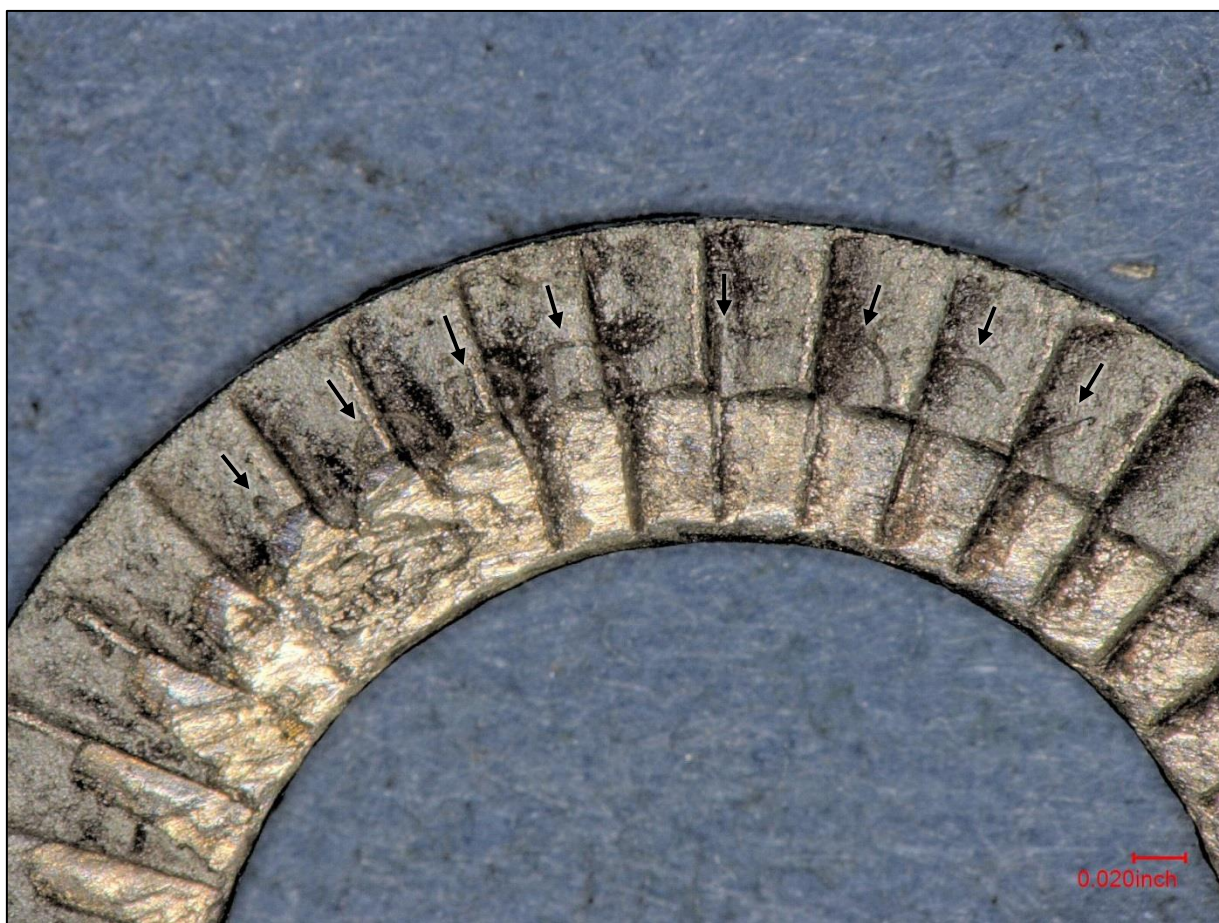
The washers, shown in figure 1, had 12 radially-oriented step features on one of the faces and 40 radially-oriented step features on the opposite face consistent with a disk-type lock washer. Partial characters were marked on one side of one of the washers as shown in the close view in figure 3. The lower portions of the characters were obliterated by rubbing contact. However, the remaining upper portions of the characters were consistent with NORD LOCK. Impressions were observed on the clamping surfaces around the attachment holes on the forward face of the propeller flange corresponding to contact with the 40-step faces of the washers. Similar step

Figure 3. Close view of one of the washers showing the upper portions of characters consistent with NORD LOCK as indicated with arrows.

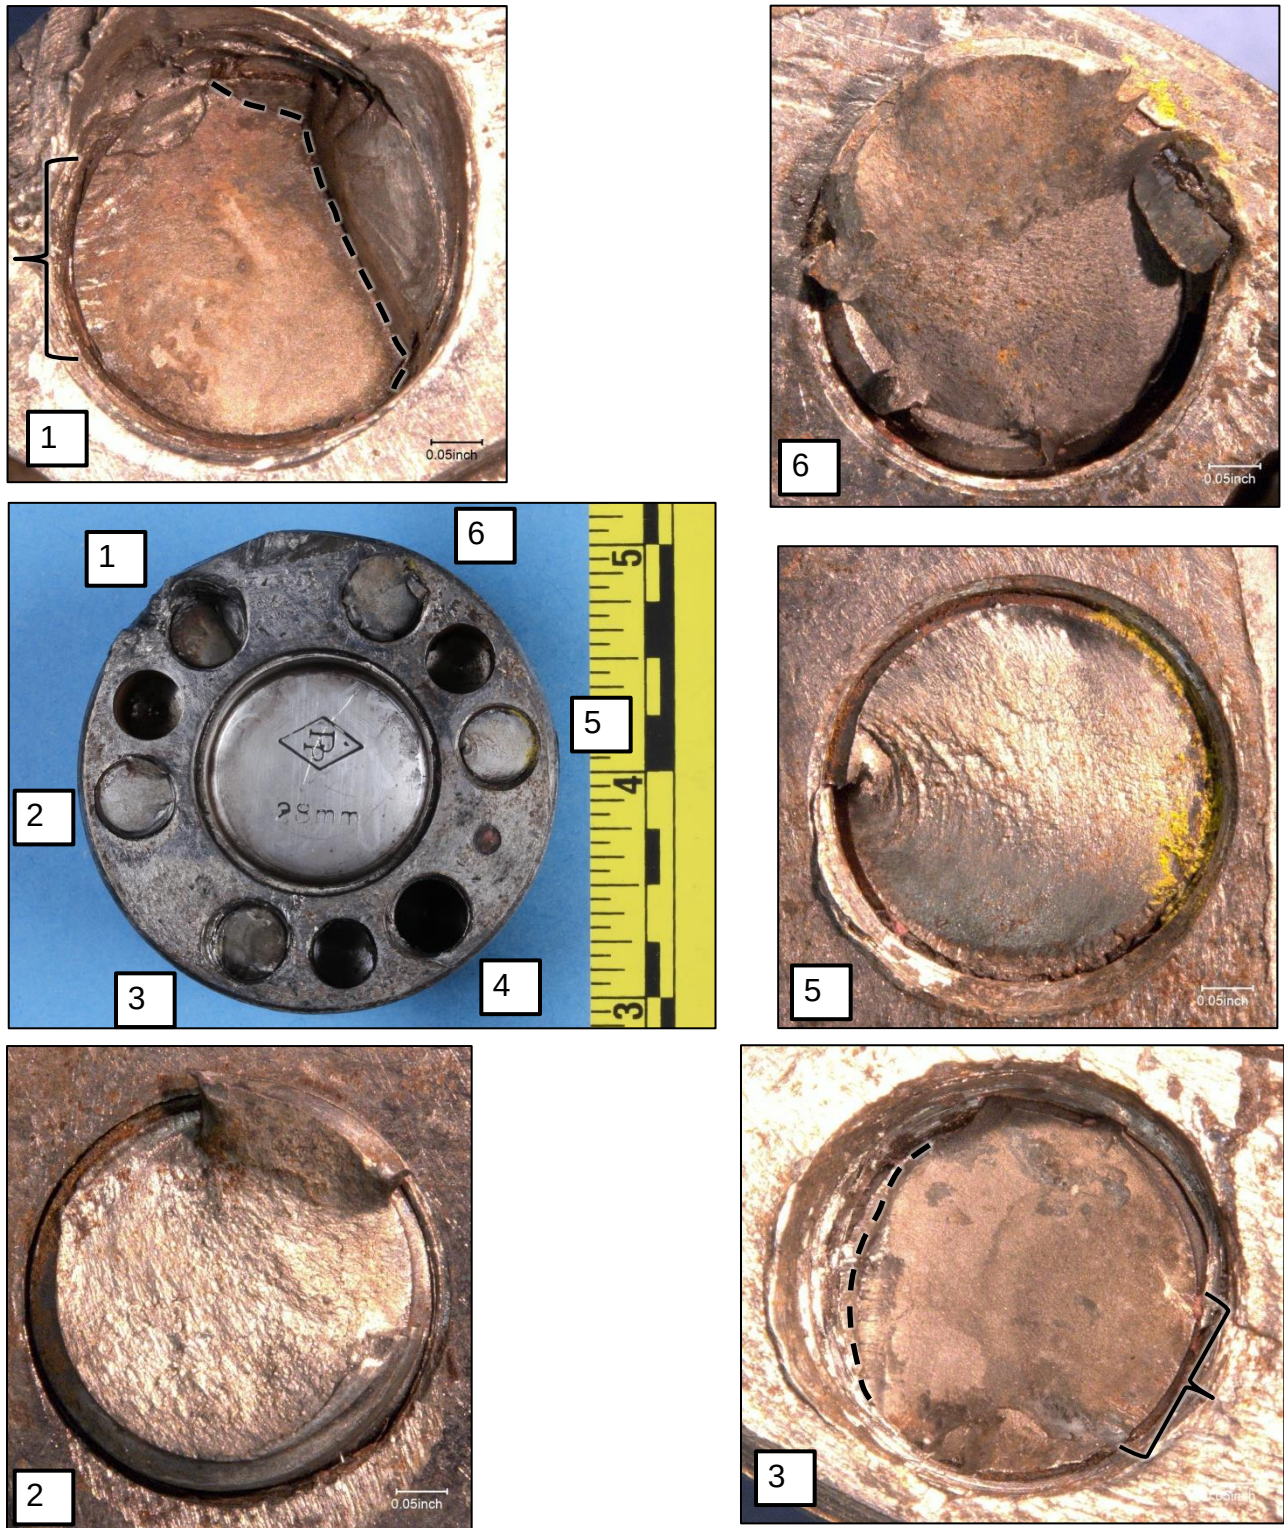
An overall view of the forward face of the crankshaft piece is shown in figure 4. Attachment bolt holes are numbered for reference. Fretting damage was observed on the end face of the crankshaft corresponding to the damage observed on the flange. Based on feature matching between the crankshaft face and the mating face of the propeller flange, the bolt numbers shown in figure 4 correspond to the hole numbers on the flange as shown in figure 2.

Close views of the fracture surfaces of the attachment bolts are shown in figure 4. Two of the bolts had relatively smooth fracture features in a plane nearly perpendicular to the bolt axis, features consistent with fatigue. Brackets in figure 4 indicate the fatigue origin area. The fatigue origin areas were located on the side of the bolt clockwise from the bolt center. Ratchet marks<sup>2</sup> were observed at the origin area, consistent with multiple fatigue origins. Dashed lines indicate the fatigue boundaries. Fatigue cracks progressed through nearly the entire cross-section of bolt 3 and approximately 80 percent of bolt 1.

Figure 4. Overall view of the crankshaft end piece with close views of attachment bolt fracture features. Brackets indicate fatigue origin areas and dashed lines indicate fatigue boundaries in bolts 1 and 3.

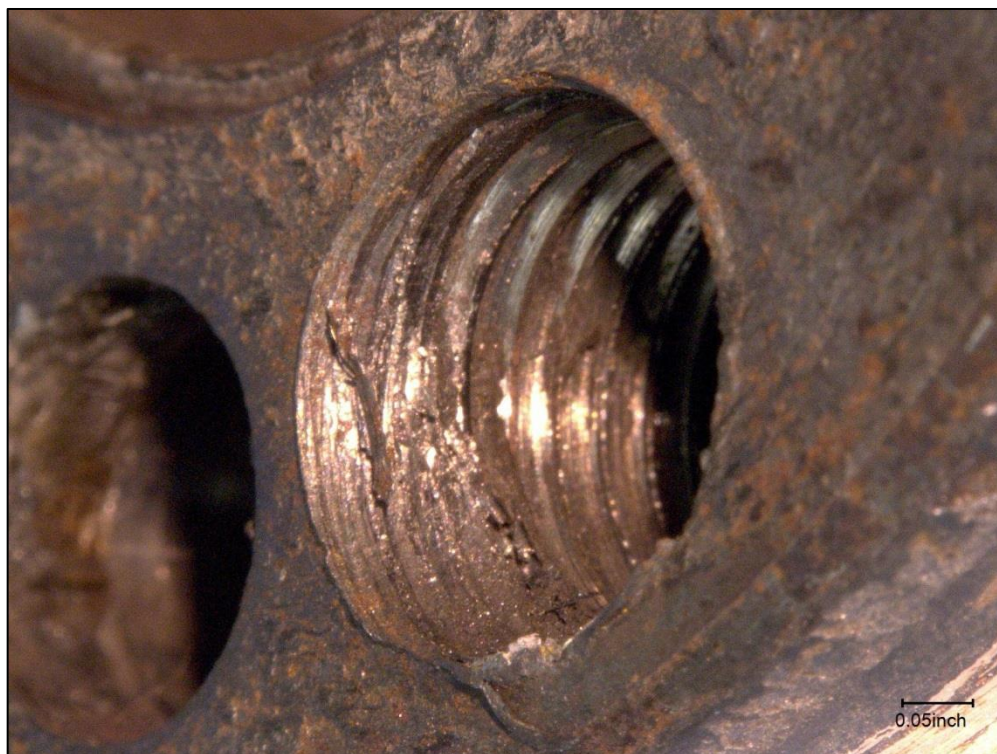
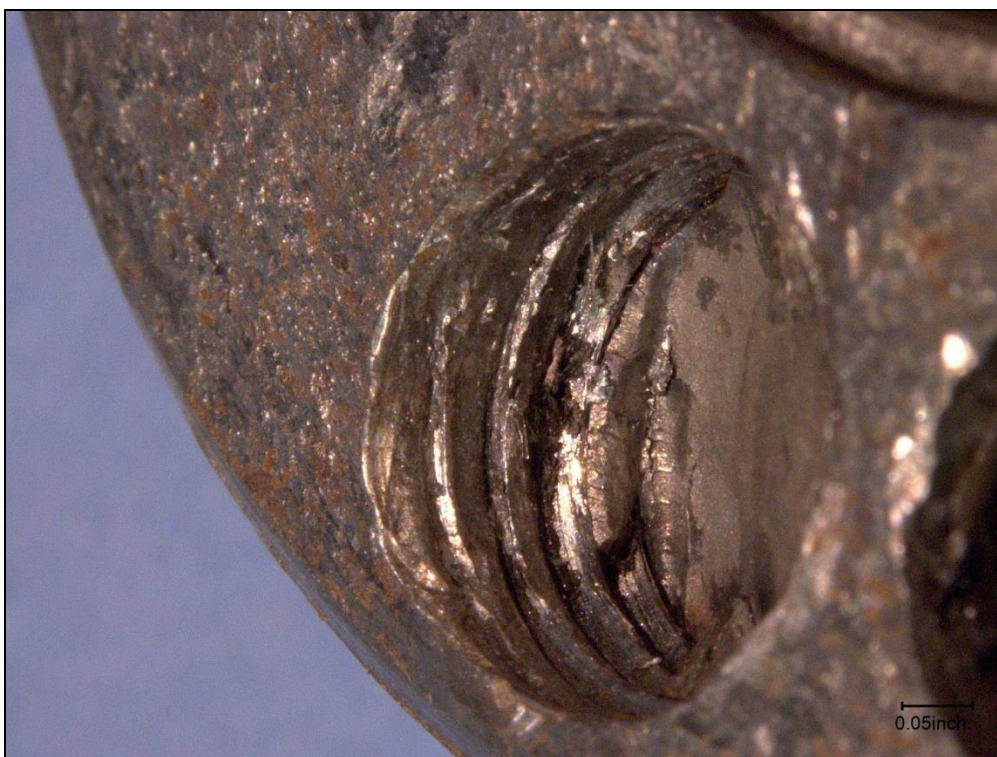
Thread damage was observed in bolt holes 1, 3, and 4 in the crankshaft piece. The thread damage was located at the side of the hole that was counterclockwise from the bolt center (opposite the fatigue origin areas in bolts 1 and 3). Close views of the thread damage in holes 3 and 4 are shown in figure 5.

Figure 5. Close view of thread damage at bolt hole 4 (upper image) and 3 (lower image) on the crankshaft piece.

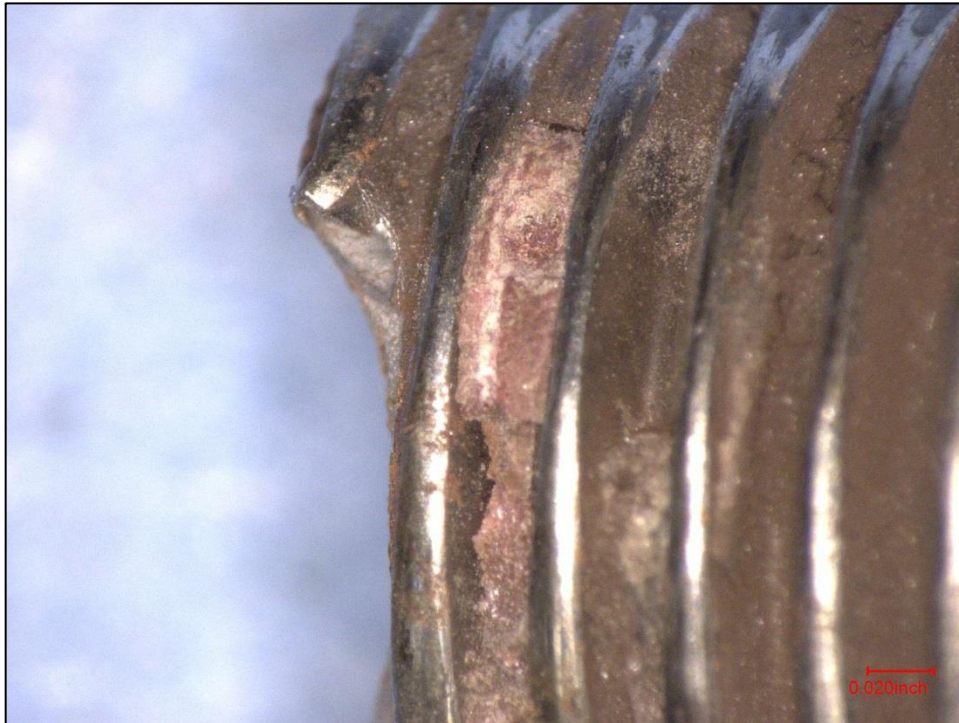
Deposits consistent with thread lock were observed in the threads of the fractured bolts and in the bolt holes in the crankshaft. A close view of thread lock in the threads of bolt number 6 is shown in figure 6. The thread lock had a red color. A close view of thread lock in the hole for bolt number 1 is shown in figure 7. Red thread lock was observed in this location as indicated. A yellow substance, also indicated in figure 7, was observed located between the red thread lock and the thread flank.

A sample of the red thread lock was removed from the bolt shown in figure 6 and analyzed using a Varian IR600 Fourier-transform infrared (FTIR) spectrometer with a diamond attenuated total reflectance (ATR) accessory in accordance with ASTM E1252-98 (American Society for Testing Materials E1252-98: *Standard Practice for General Techniques for Obtaining Infrared Spectra for Qualitative Analysis*). The resulting spectrum for the sample was consistent with a methacrylate ester.

Figure 6. Red-colored thread lock observed in the threads of fractured attachment bolt number 6.

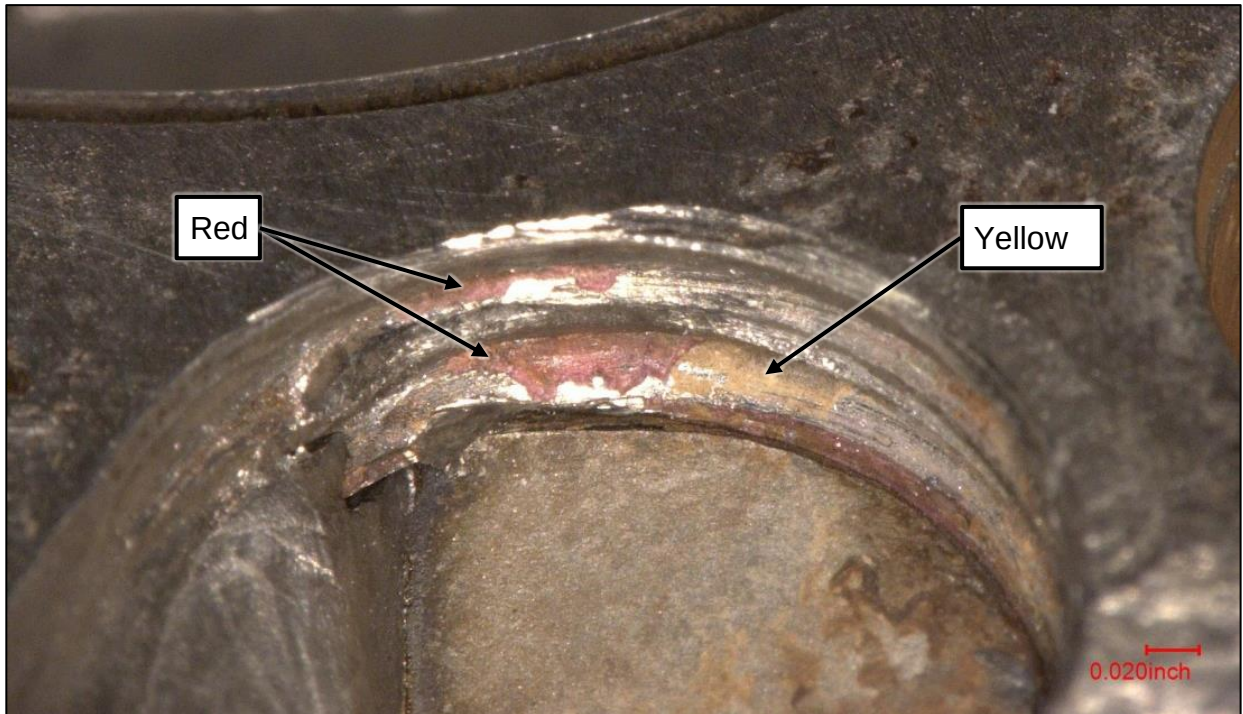
Figure 7. Red-colored thread lock over a yellow substance in the threaded hole for attachment bolt 1.
