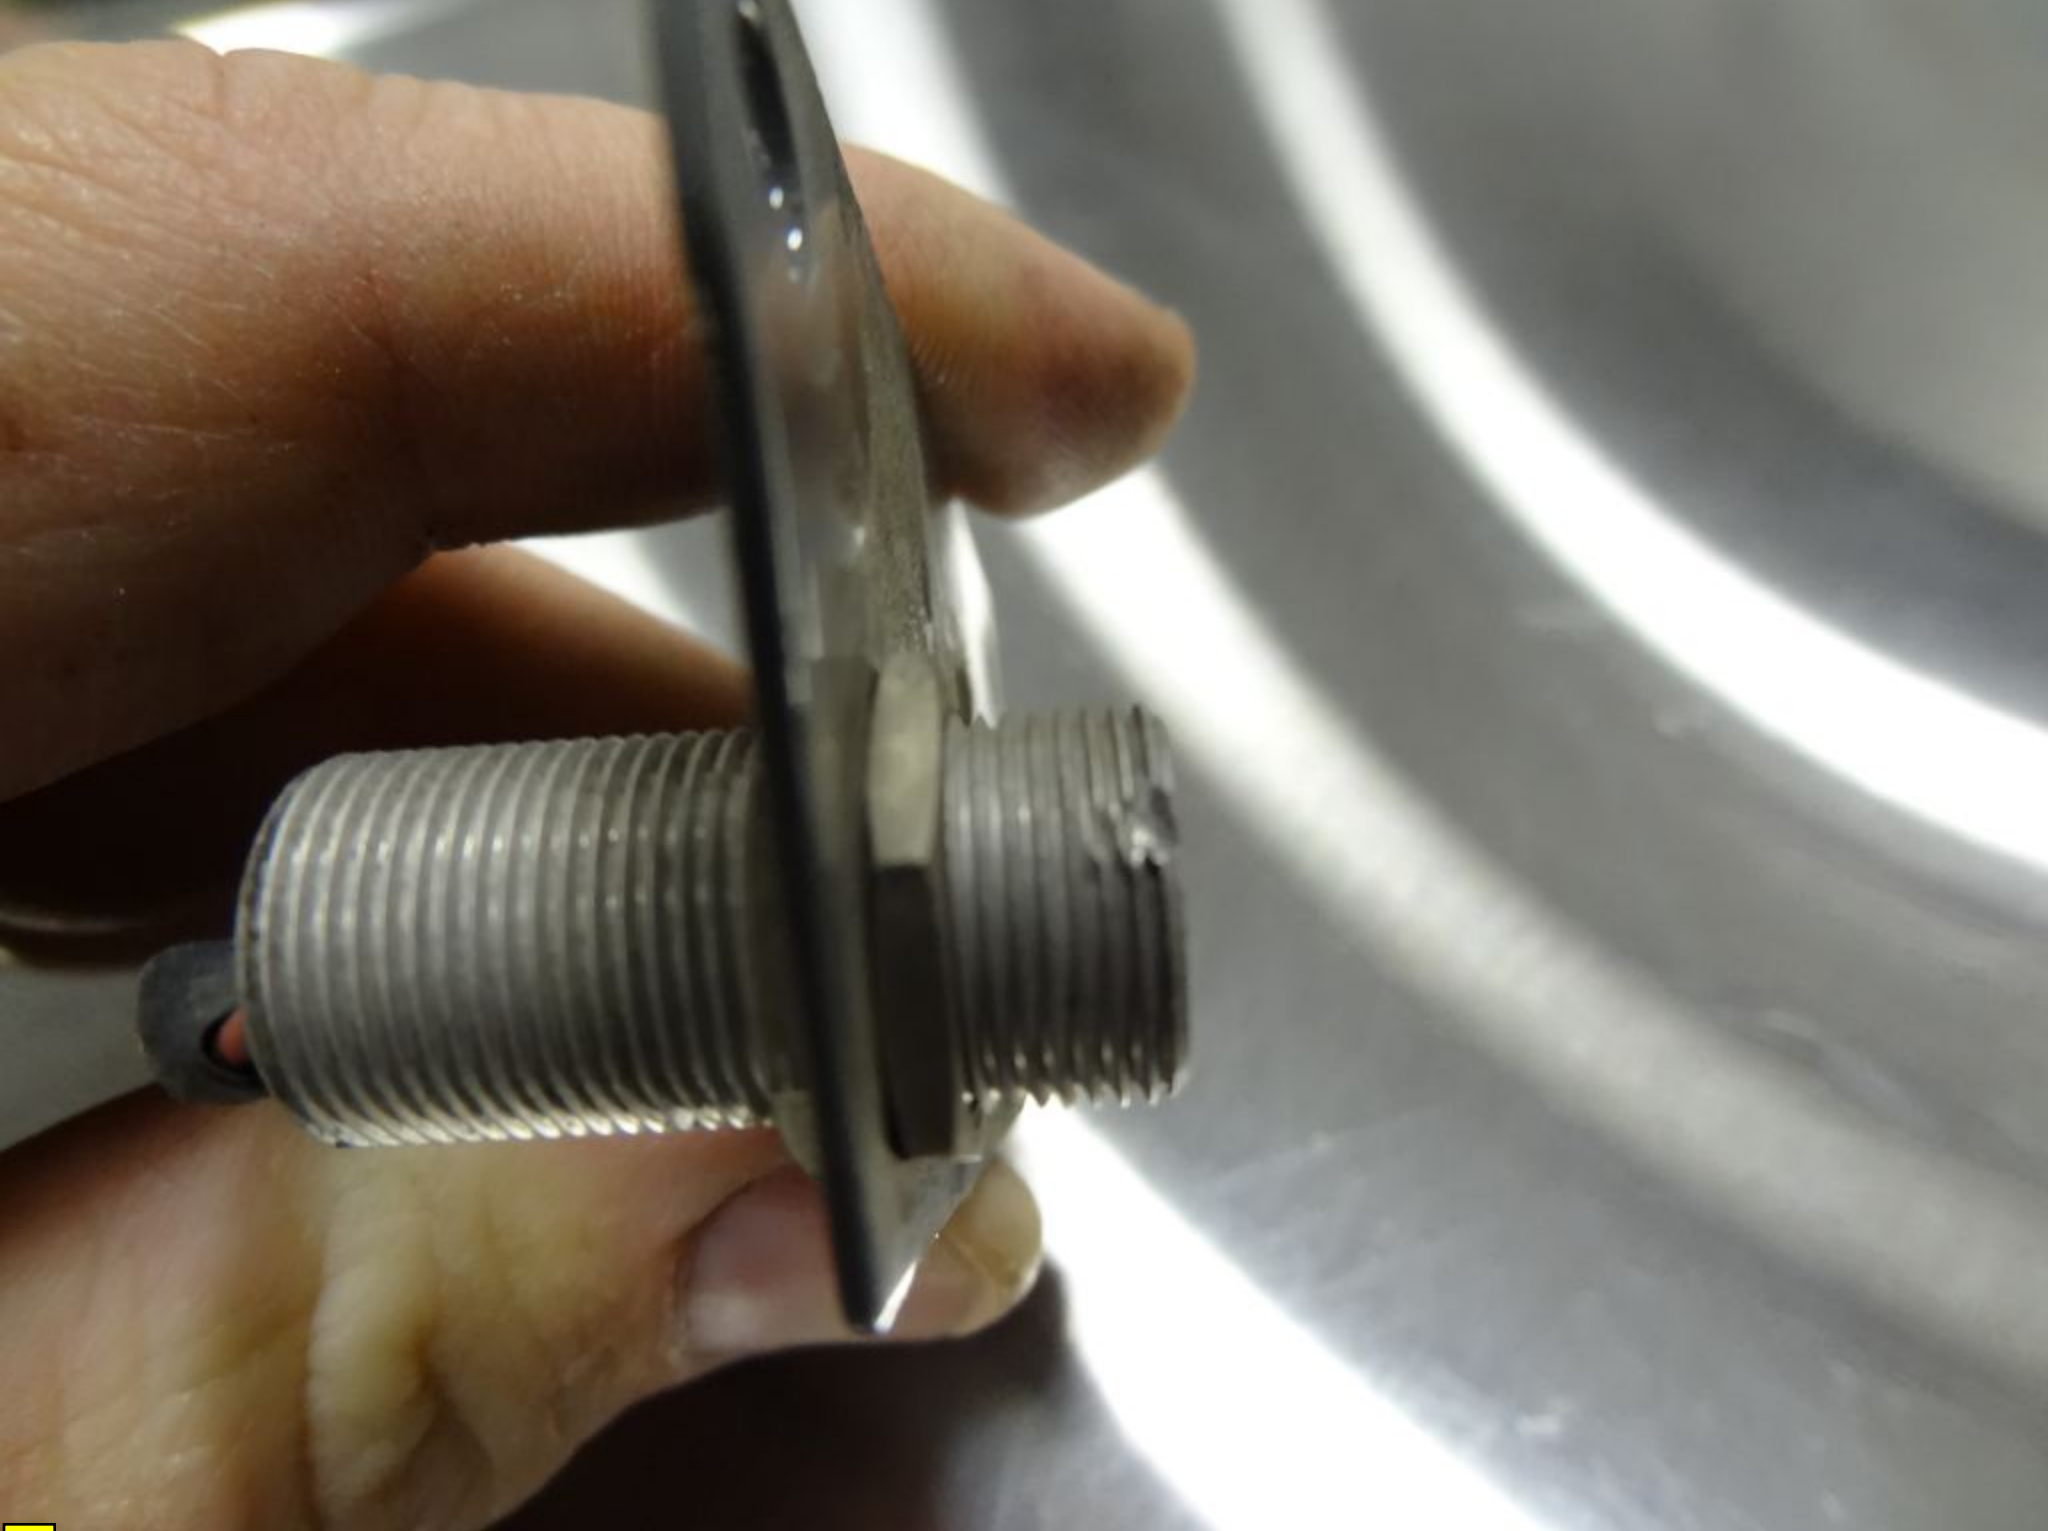
Photo 4 - Mechanical damage to the sensor, caused by the failed magnet. It was mounted oppsite the magnet.
