# NATIONAL TRANSPORTATION SAFETY BOARD

MATERIALS LABORATORY FACTUAL REPORT

Report No. 13-104

Place : Paris, Texas  
Date : April 19, 2013  
Vehicle : Piper PA-32, N82723  
NTSB No. : CEN13LA233  
Investigator : Aaron M. Sauer, AS-CEN

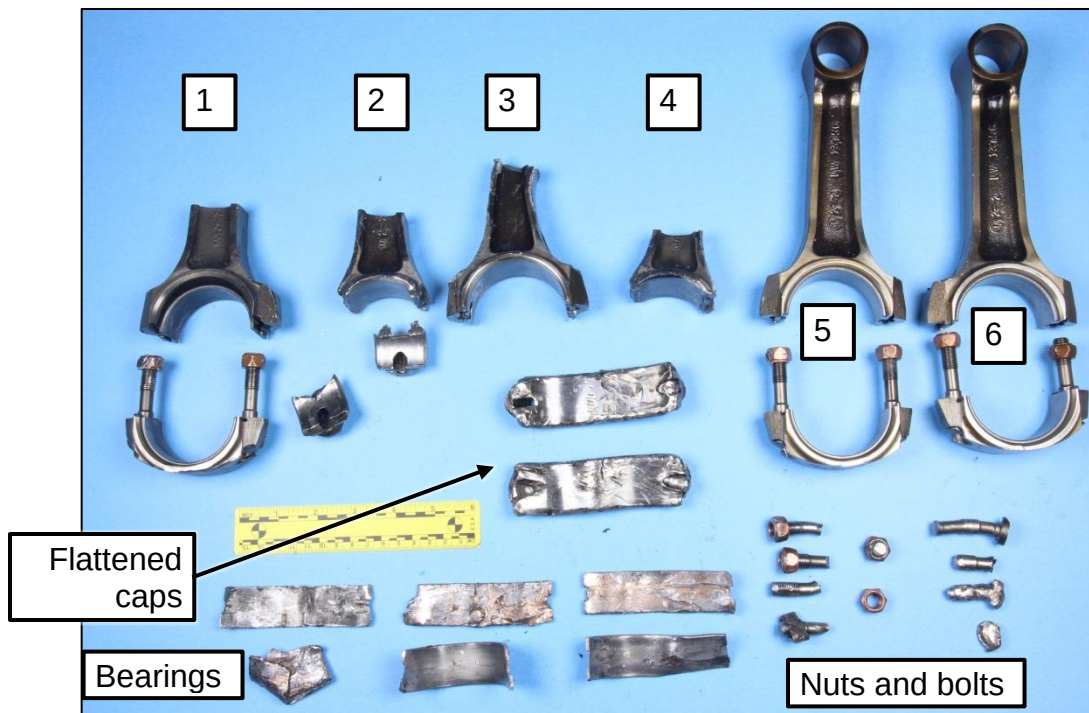
An overall view of the submitted components is shown in figure 1. The connecting rod pieces are numbered in figure 1 in accordance with cylinder number. The number 3 connecting rod was fractured in the I-beam section of the connecting rod, and connecting rods 2 and 4 were fractured through the straps on each side of the rods. Two flattened connecting rod caps were also included along with multiple connecting rod nut and bolt pieces and connecting rod journal bearings. No evidence of heat tinting was observed on the components.

Figure 1. Overall view of the submitted components. Connecting rod pieces from cylinders 1 to 6 are positioned from left to right, and bearings and connecting rod nuts and bolts are shown along the bottom of the image.

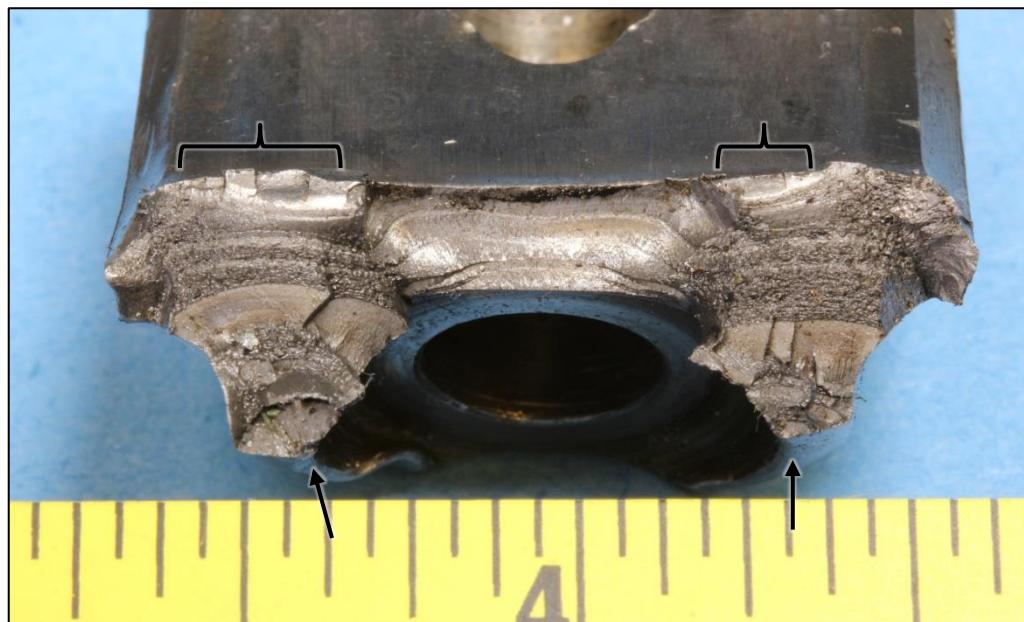
Fractures on connecting rods and bolts were examined visually and under an optical stereo microscope. The number 3 connecting rod was bent adjacent to the fracture surface, and fracture features were irregular and rough consistent with overstress fracture. A view of one of the strap fracture surfaces from connecting rod 2 is shown in figure 2. The fracture showed flat features with curving crack arrest lines, features consistent with fatigue. The fatigue features emanated from origin areas at the connecting rod bolt head cutout (arrowed locations in figure 2) and from the bearing face (bracketed areas in figure 2). The fatigue regions were relatively rough with multiple origins and step features, features consistent with low cycle (relatively high stress) fatigue.

Fracture surfaces on the opposite strap for connecting rod 2 and on one of the fractures in the strap for connecting rod 4 also showed crack arrest features consistent

with fatigue. Fatigue origins were located both at the edges of the bolt cutouts and at the bearing face. The fatigue features were relatively rough consistent with crack propagation under relatively high stress.

Figure 2. Overall view of a fracture surface on a strap piece from the number 2 connecting rod. Arrows and brackets indicate fatigue origin areas on opposite sides of the fracture surface.

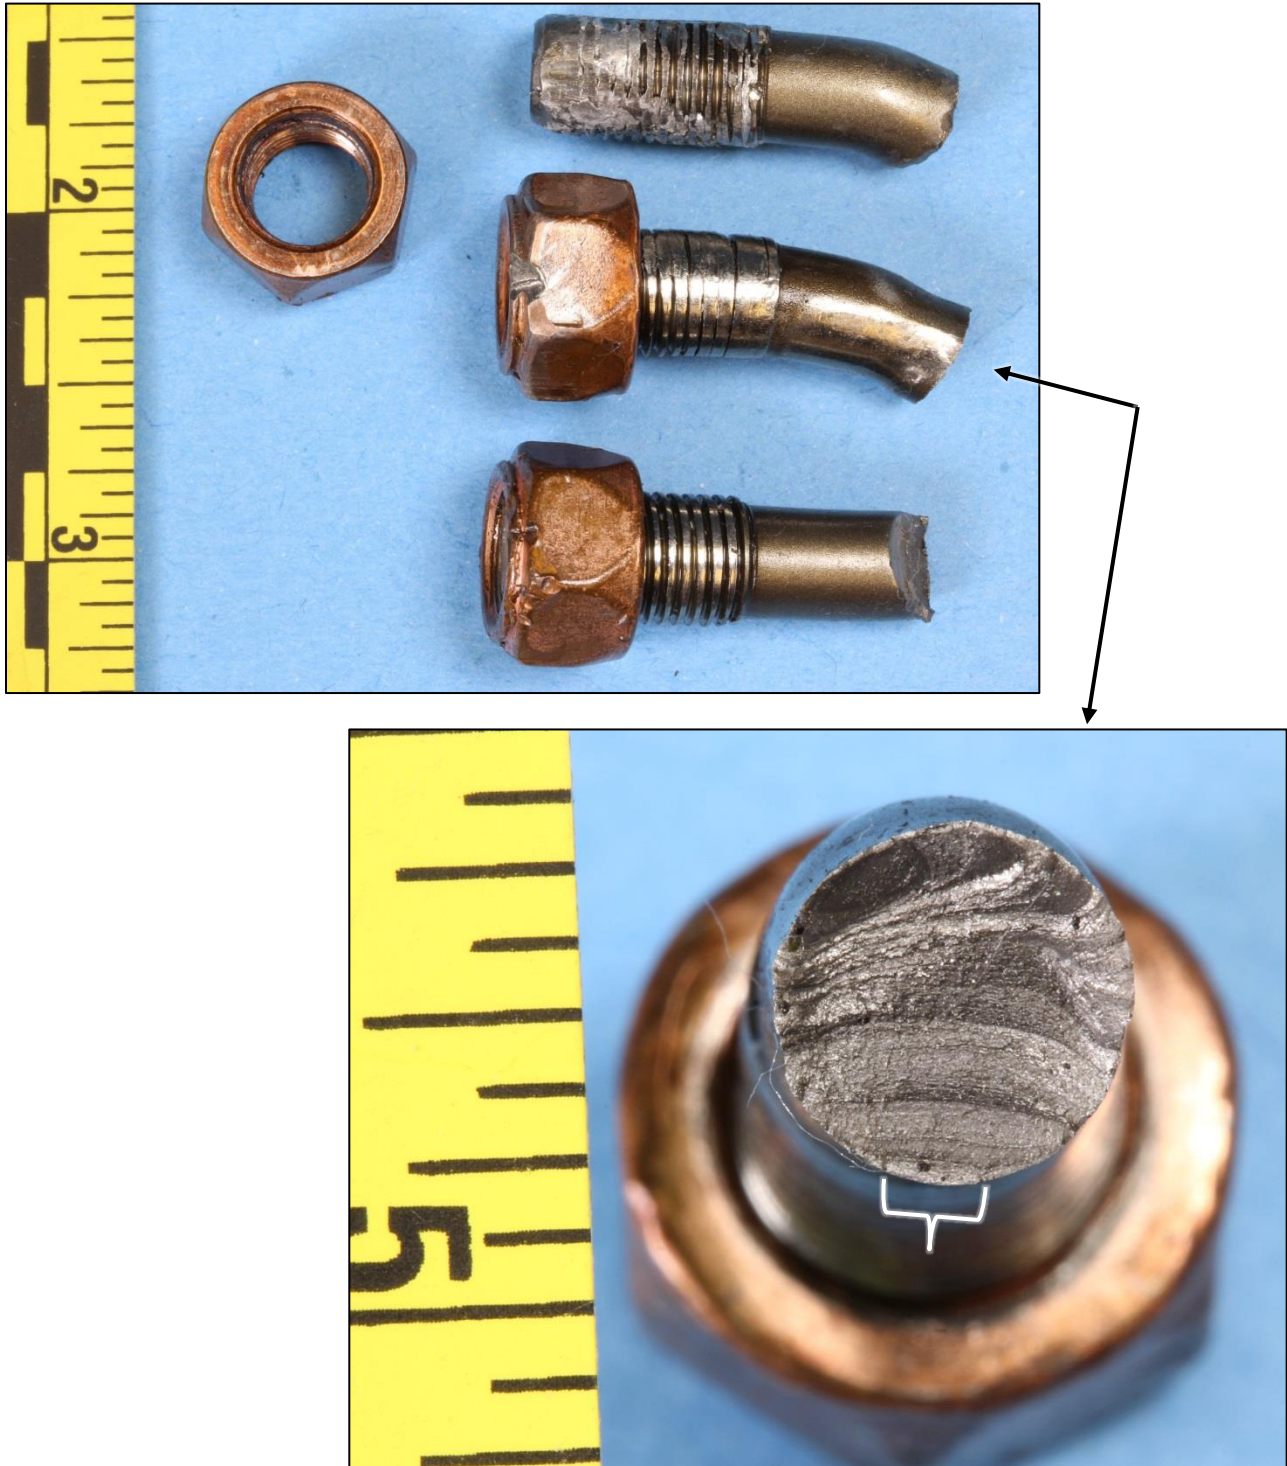
The threaded ends of several of the connecting rod bolts are shown in figure 3. The nuts on two of the bolt pieces were displaced toward the end of the bolt, and thread peaks between the nut and the grip were flattened. One nut was received separated from the bolt as shown in the upper image in figure 3. The final 2 threads on the nut were damaged consistent with bolt pullout, and the remaining threads were intact.

The fracture surface of the middle bolt in the upper image in figure 3 is shown in the lower image in figure 3. Curving crack arrest lines consistent with fatigue were observed emanating from one side of the bolt. A bracket in figure 3 indicates the approximate fatigue origin. The fracture features were relatively rough consistent with fatigue crack propagation under relatively high stress. As shown in the upper image in figure 3, the bolt with fatigue features was bent and showed necking (reduced cross-sectional area) adjacent to the fracture. Fracture in all other submitted connecting rod bolt pieces (including those not shown in figure 3) showed features and deformation consistent with overstress fracture.

Figure 3. Close view of the threaded end of 3 of the connecting rod bolts and 3 nuts. Fatigue features were observed on one of the bolt fractures as indicated with an arrow and shown in the lower image. A bracket in the lower image indicates the fatigue origin area.

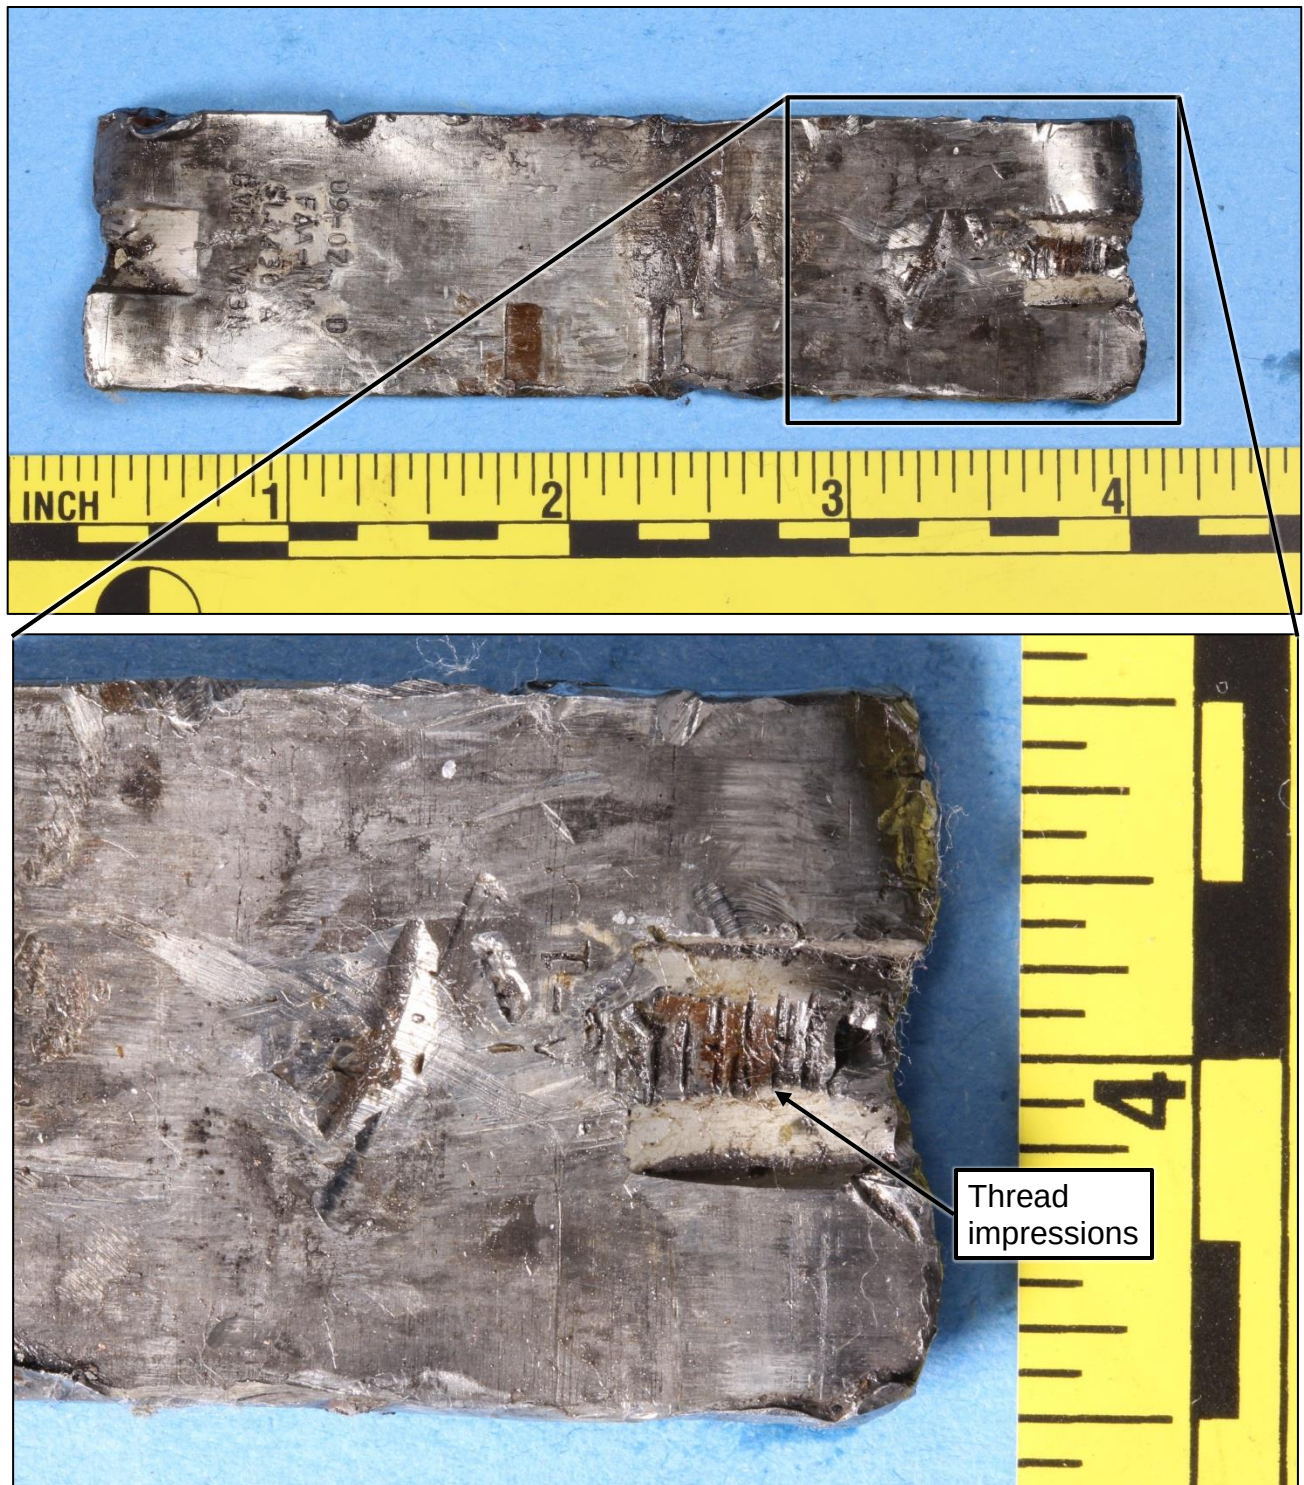
The bearings showed evidence of impact damage, and several of the bearings were flattened. Babbitt material was observed on interior surfaces of all the bearing pieces, and no evidence of abnormal or excessive wear was observed. The back side of one of the flattened bearings is shown in figure 4. Thread impressions corresponding to contact with the threads of a connecting rod bolt were observed in the slot at one end of the bearing as indicated in figure 4. The thread impressions were oriented such that the axis of the bolt was generally aligned with the length of the slot.

Figure 4. Views of the backside of one of the bearings showing thread impressions corresponding to contact with the threads of a connecting rod bolt.
