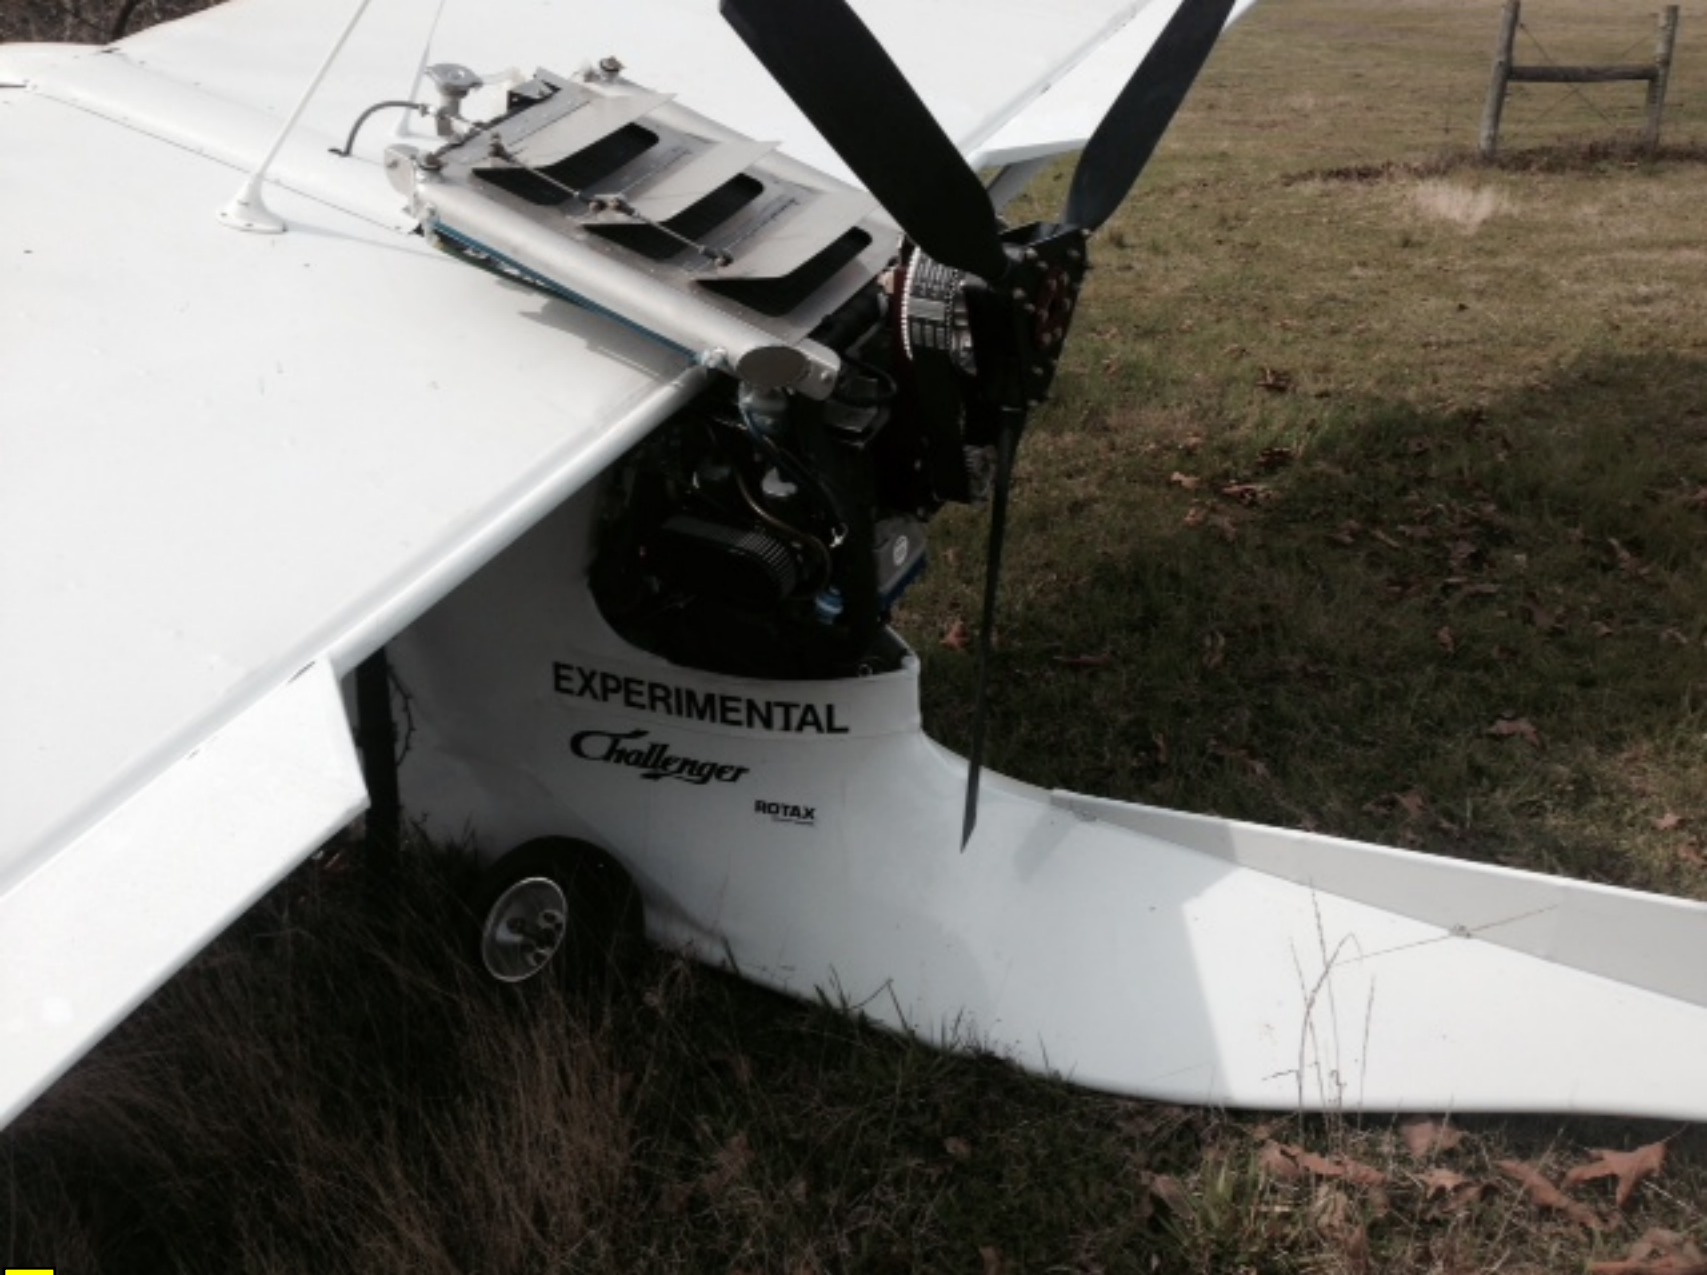
Photo 3. Collapsed Left Main Landing Gear and Buckled Fuselage
