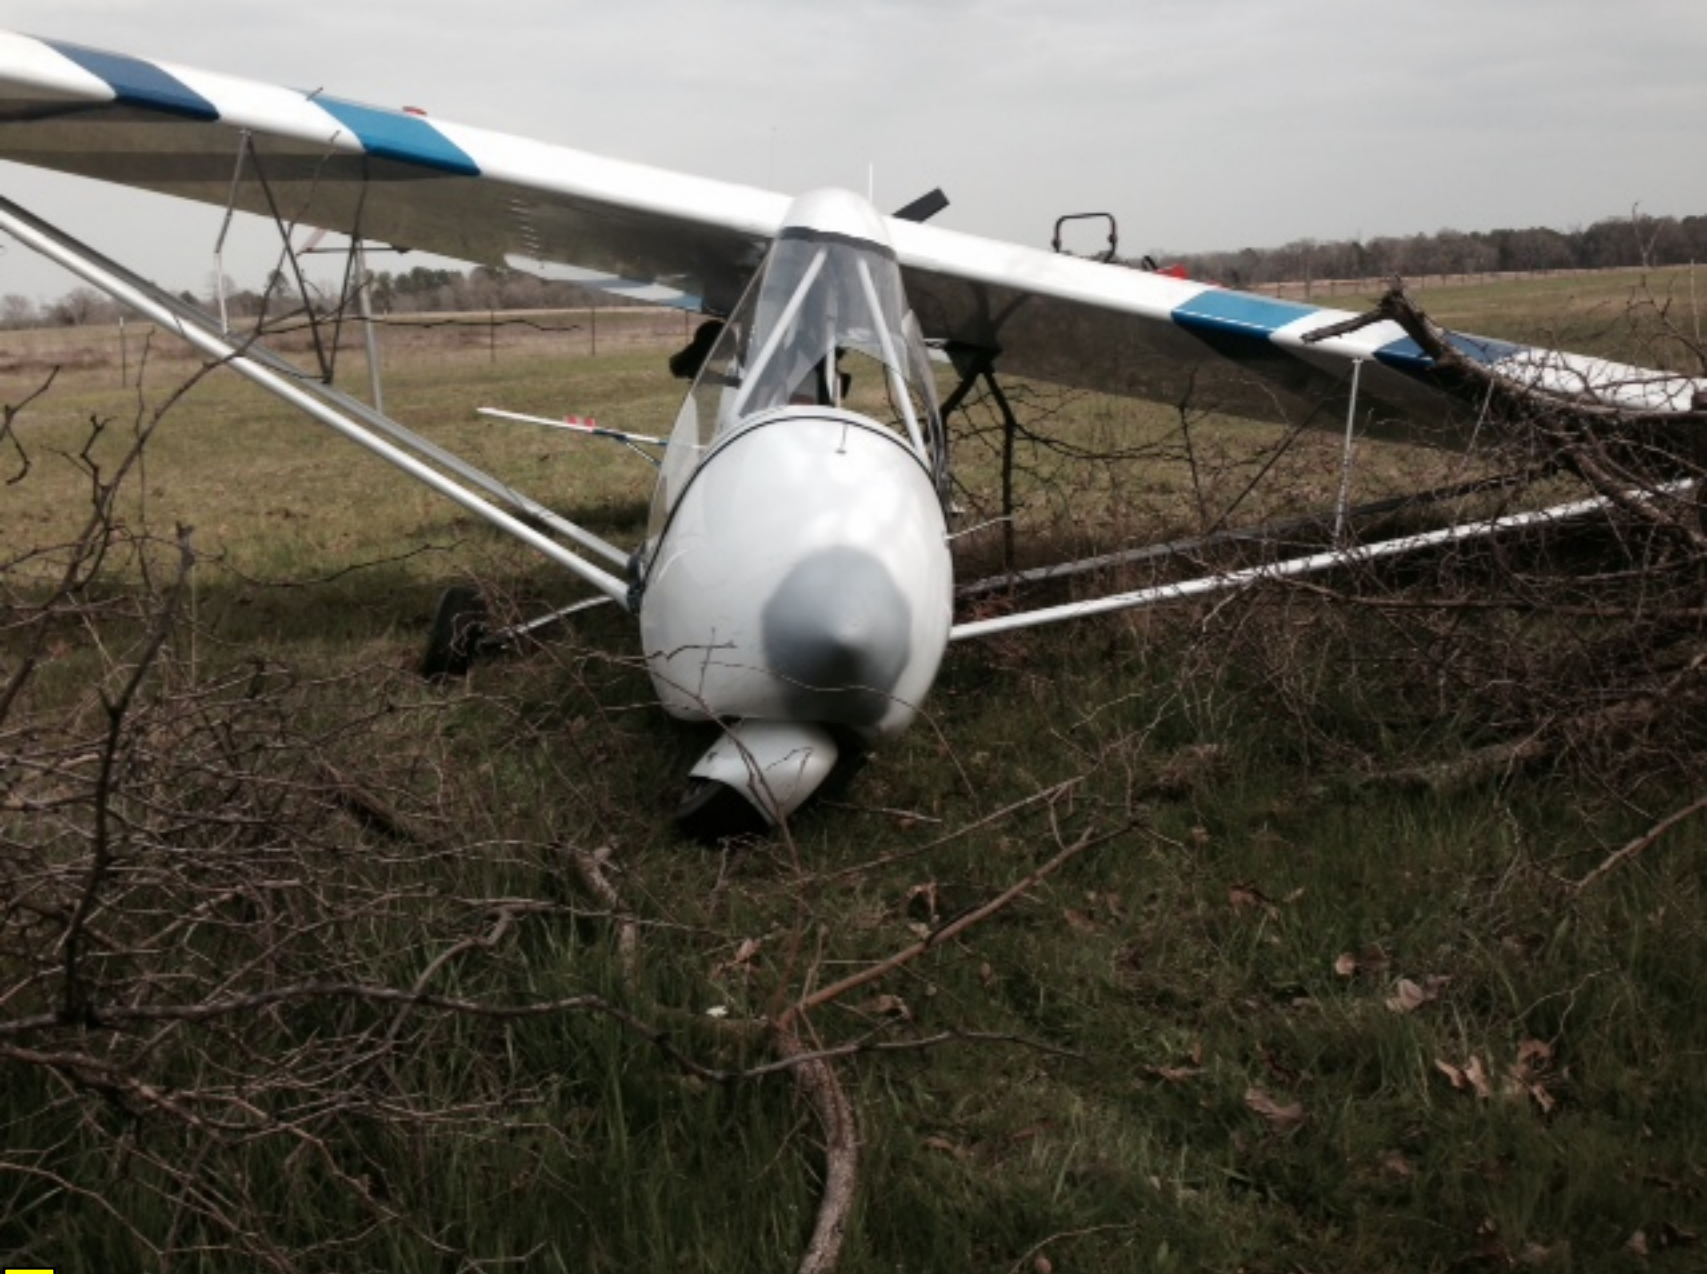
Photo 4. Collapsed Nosed and Left Main Landing Gears, Buckled Struts and Tree Branches in Left Wing
