Flight Safety Dept  
Engineering

**Factual Observations of Helicopter Mishap**  
**Bell 206L3; Serial Number 51546; N207DS**  
**Owner/Operator: Delta Bravo Sierra, Inc.**  
**Date of Accident: January 27, 2014**  
**Location of Accident: Silt, CO**

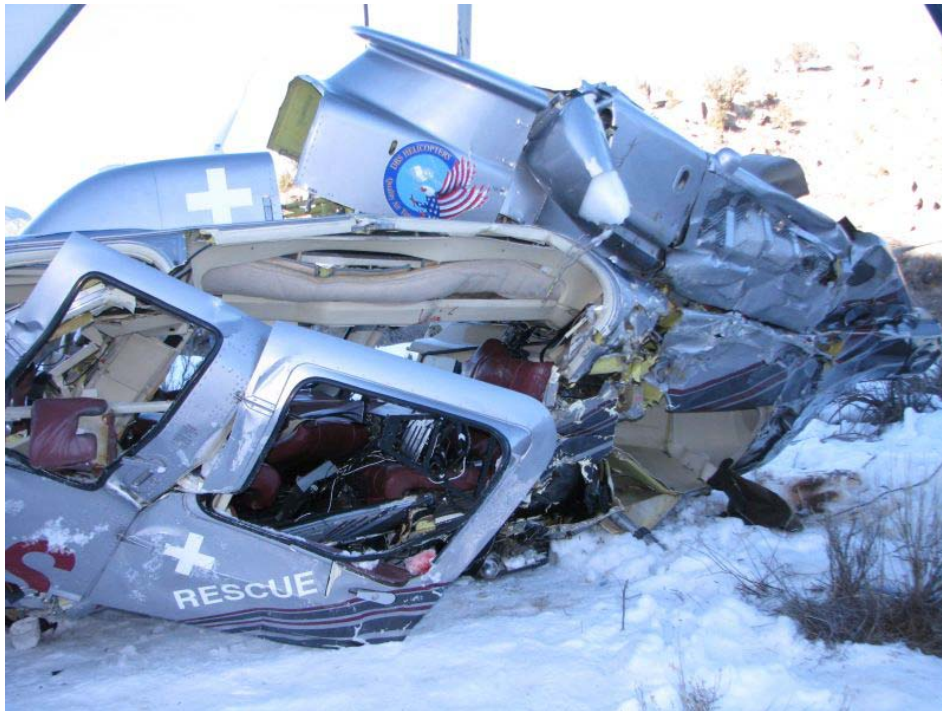
The helicopter was found resting on its left side at the accident site. The fuselage exhibited significant impact damage on the left side (See Photo 1). The forward cabin exhibited crushing on the left side. Neither the upper (See Photo 2) or the lower wirestrike cutters showed evidence of wire contact.

Photo 1  
Crushing on left side of fuselage

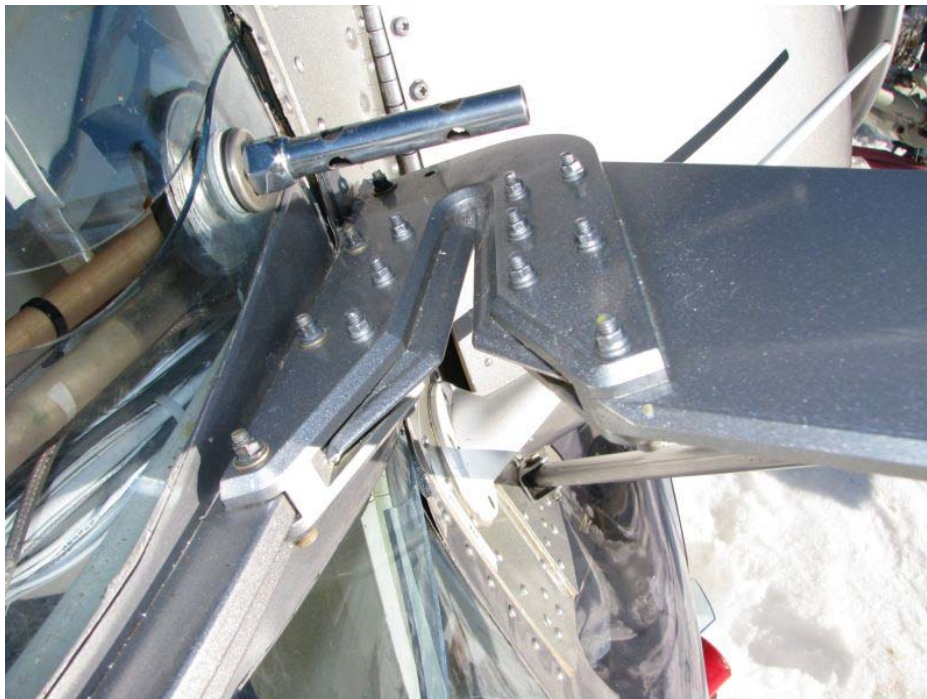
Photo 2  
Upper wirestrike cutter showed no evidence of wire contact

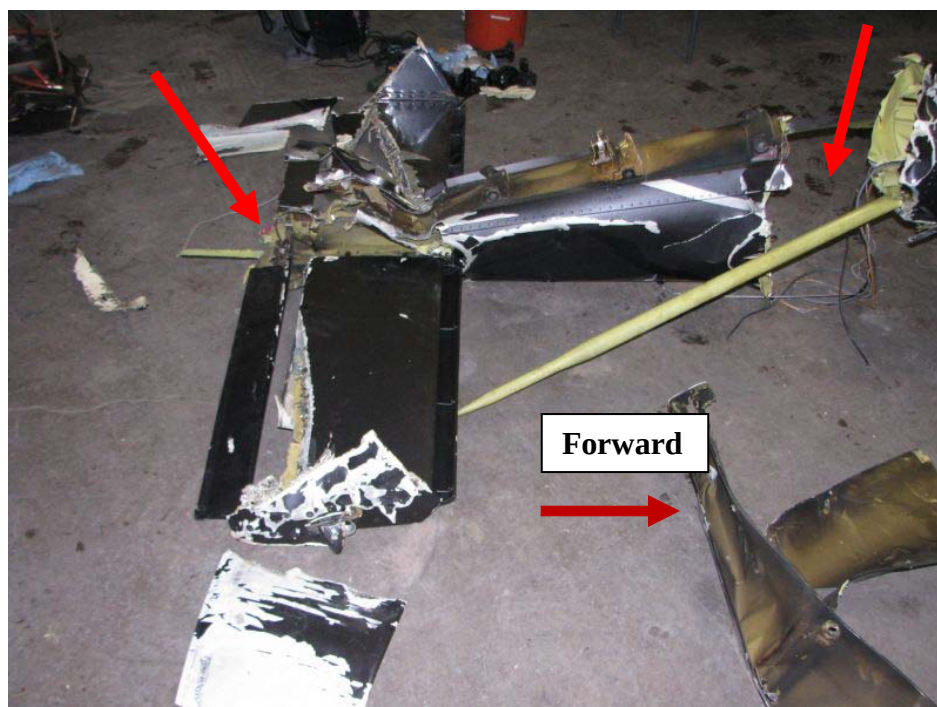
The tailboom was fractured consistent with overload forces in two locations (See Photo 3), just aft of the intercostal support on the tailboom's forward surface and just aft of the horizontal stabilizer. At the aft tailboom fracture near the horizontal stabilizer, evidence of main rotor strikes was observed. The aft tailboom section was found near the main wreckage. The mid-tailboom section with attached horizontal stabilizer was found approximately 50-100 feet from the main wreckage and exhibited evidence of a main rotor strike (See Photo 4). Both the left and right end plates on the horizontal stabilizer exhibited evidence of fractures from main rotor strikes (See Photo 5). The tailboom was equipped with an aftermarket strake on the left side of the tailboom.

Photo 3  
Arrows note two locations of tailboom fracture

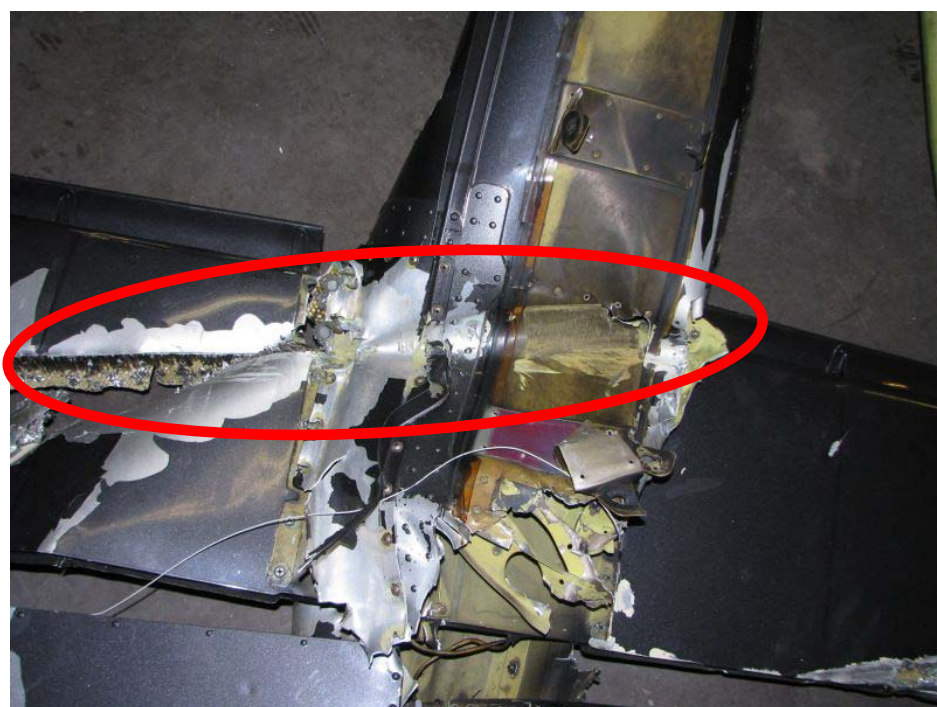
Photo 4  
Main rotor strike to mid-tailboom section

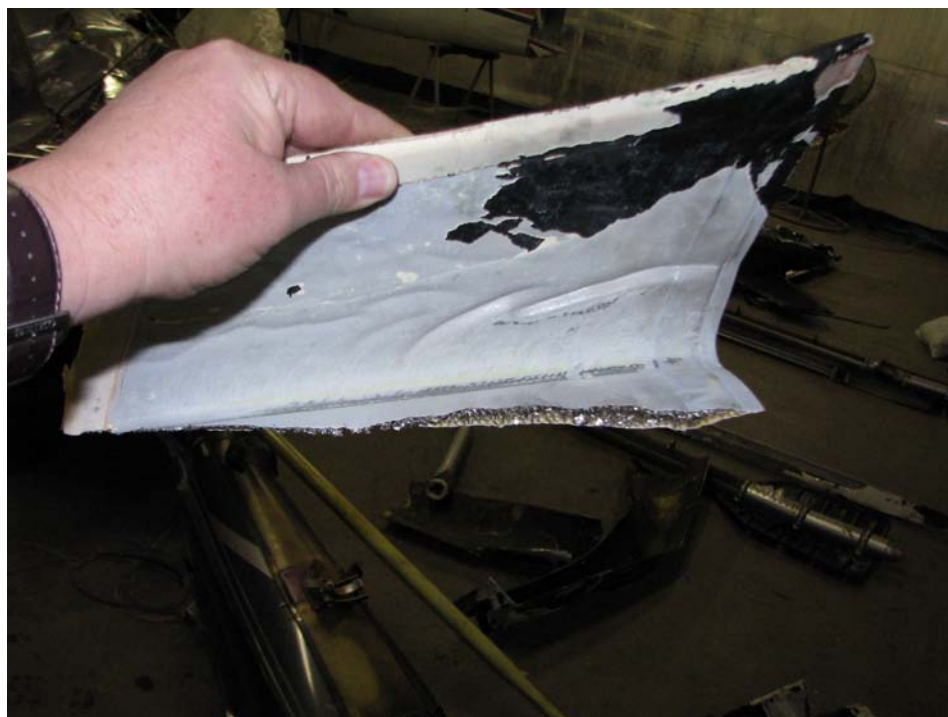
Photo 5  
End plate with main rotor blade strike

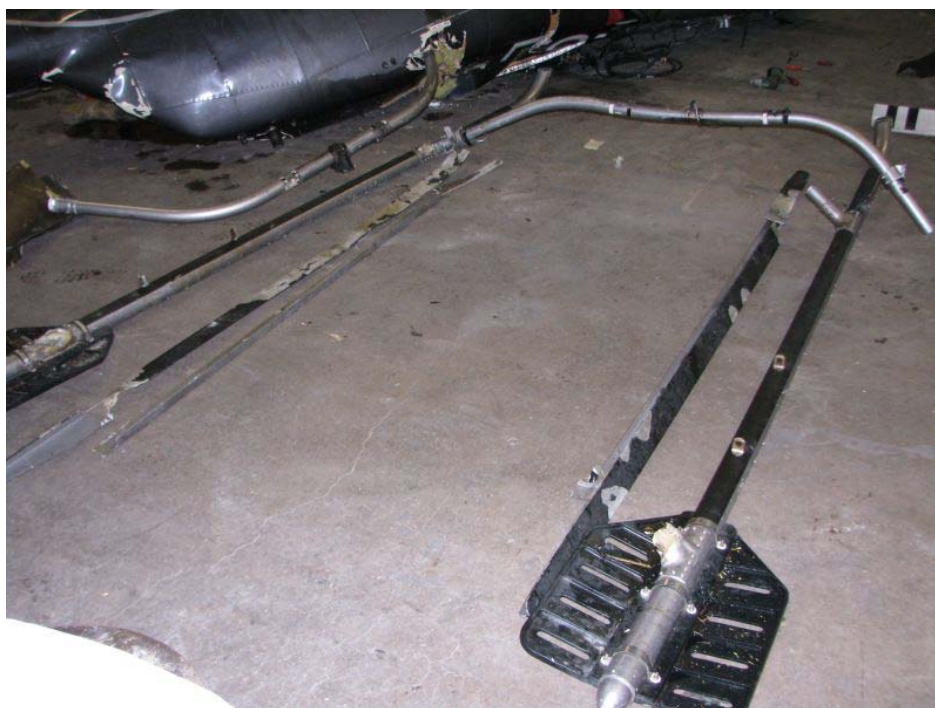
The helicopter was equipped with high skid gear, flight steps, and bear paws on the aft skids (See Photo 6). The landing gear was located with the main wreckage. The left forward crosstube was significantly flattened and the left skid was fractured at the forward crosstube saddle location. The left skid fracture and left forward crosstube flattening were both consistent with left side ground impact. The aft crosstube was separated from both the left and right skid tubes where the rear saddles had fractured consistent with overload forces.

Photo 6  
Landing gear

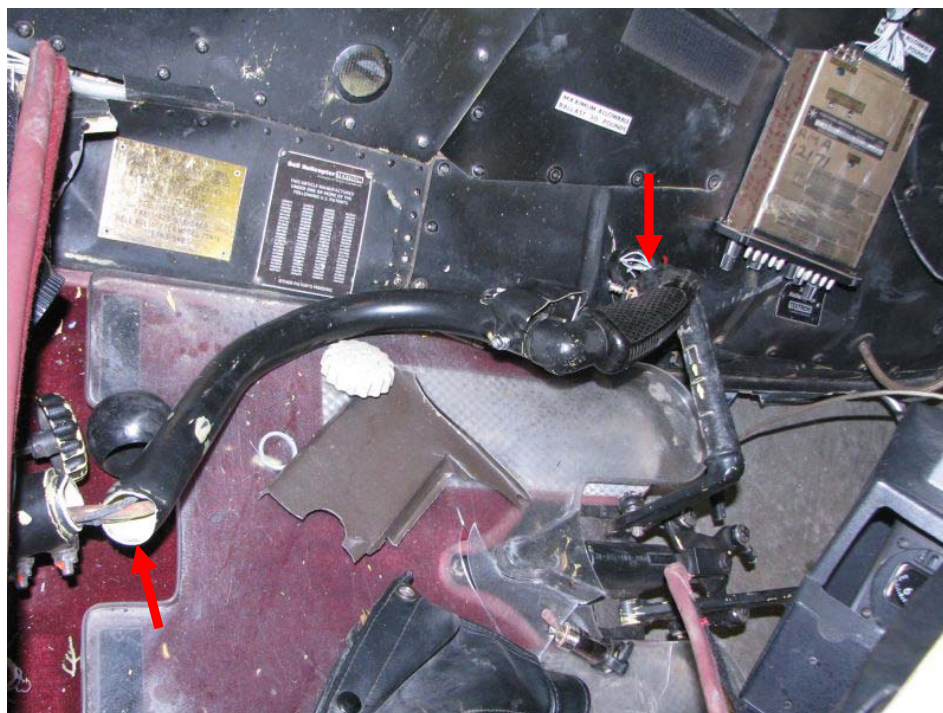
The helicopter was equipped with a single set of flight controls at the pilot right seat station. Extensive damage to the flight controls was observed and is consistent with impact forces. The cyclic stick exhibited fractures consistent with overload forces at its base and on the hand grip (See Photo 7). The left side of the cockpit exhibited significant damage to the cyclic control system (See Photo 8). The collective stick control head fractured consistent with overload forces. The collective stick remained connected to the control system. The fractured stub of the cyclic stick and the collective stick were moved by hand and corresponding movement was observed to the three main rotor servo inputs. The fixed controls from the servos to the swashplate (cyclic) and the collective lever were intact (See Photo 9).

Photo 7  
Cyclic stick fractured at base and on hand grip

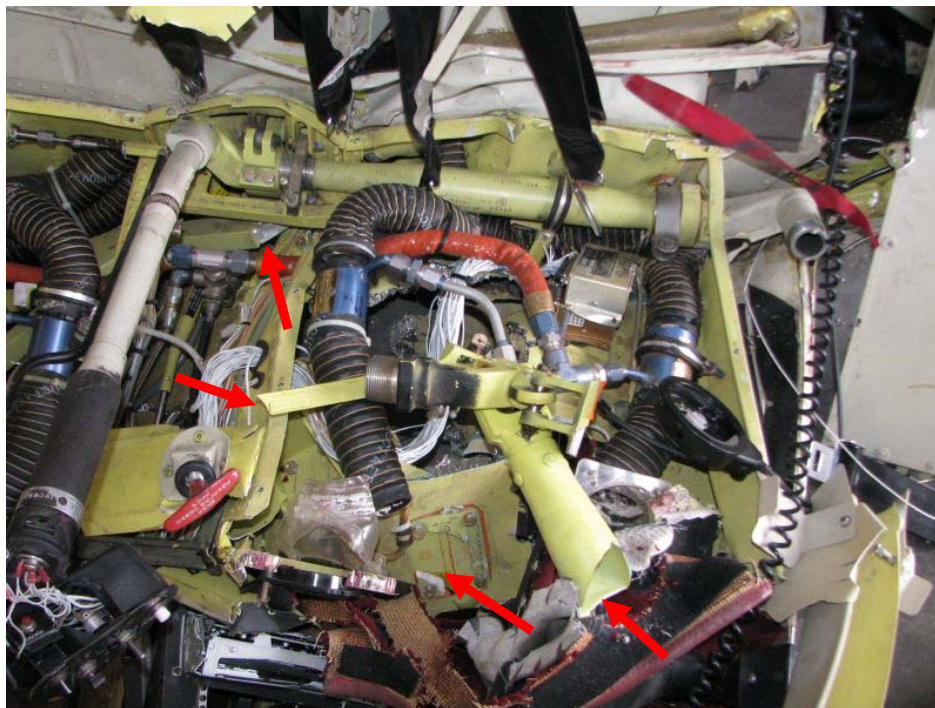
Photo 8  
Extensive damage to cyclic flight controls on left side; overload fractures at arrows

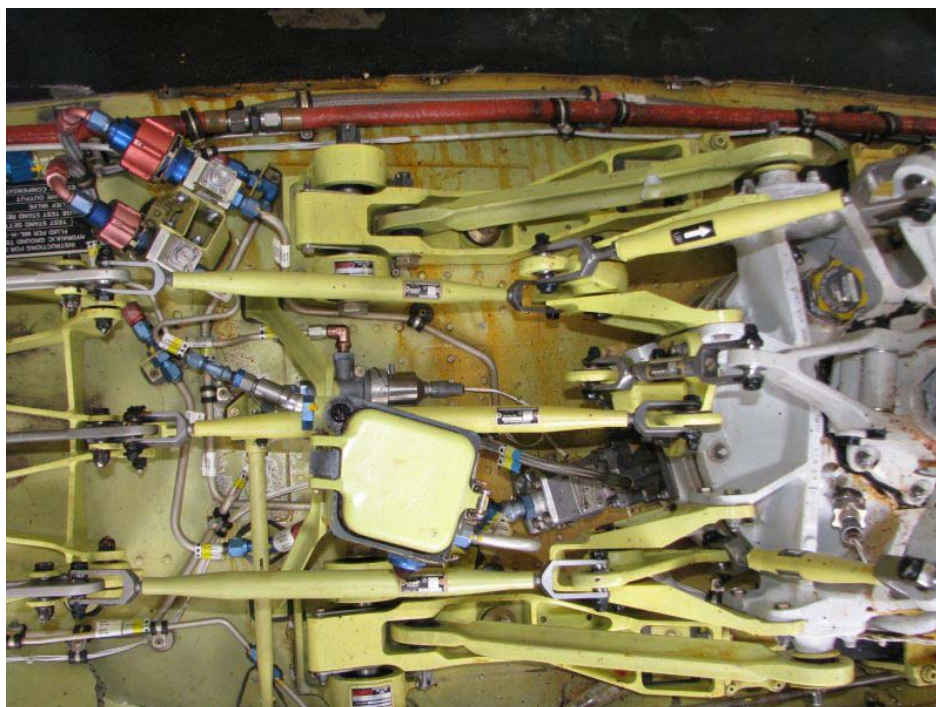
Photo 9  
Intact fixed controls between servos and swashplate/collective lever

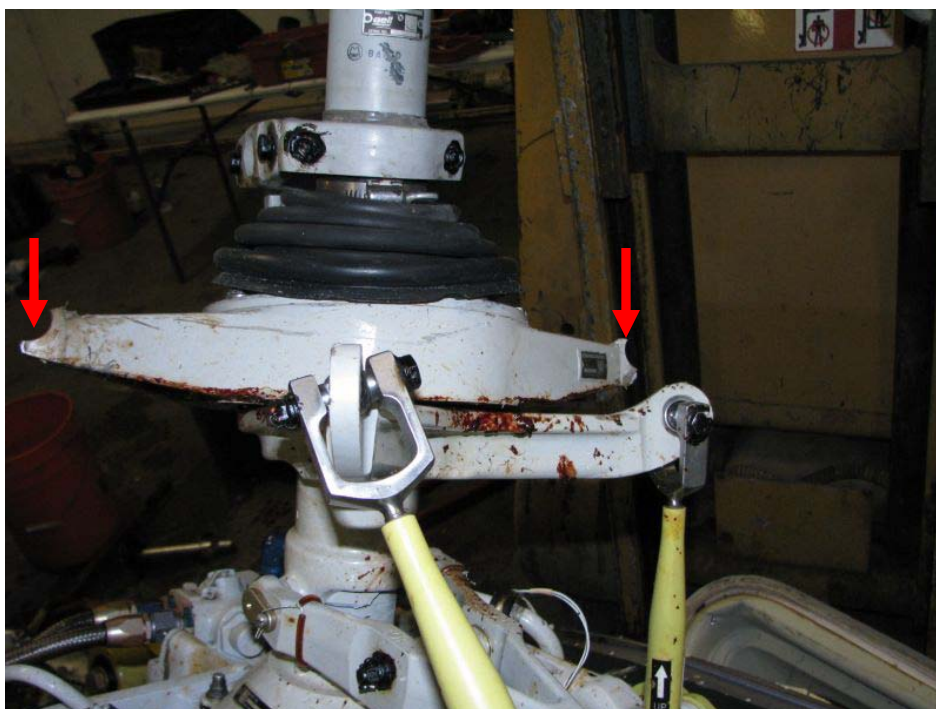
Both outer ring rotating swashplate attachment ears for the Red and White pitch change links were fractured consistent with overload forces (See Photo 10). The White pitch change link was fractured consistent with overload forces near the bottom of the link (See Photo 13). The location of the White pitch change link tube fracture was in a vertical plane similar to the wirestrike marks on the mast. The bottom of the White pitch change link (approximately 6 inches long) was found on the helicopter roof attached to a swashplate ear and monoball bearing (See Photo 11). Only the top of the Red pitch change link and attached clevis remained attached to the Red pitch horn (See Photo 12).

Photo 10  
Both outer ring swashplate ears fractured consistent with overload forces

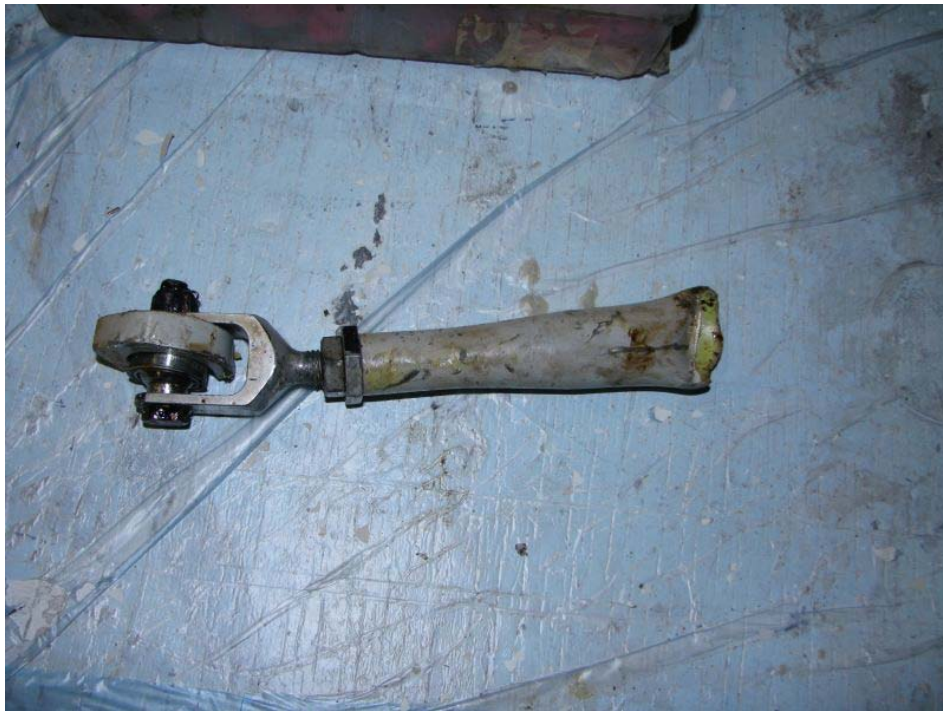
Photo 11  
Bottom fractured section of White pitch change link with attached swashplate ear

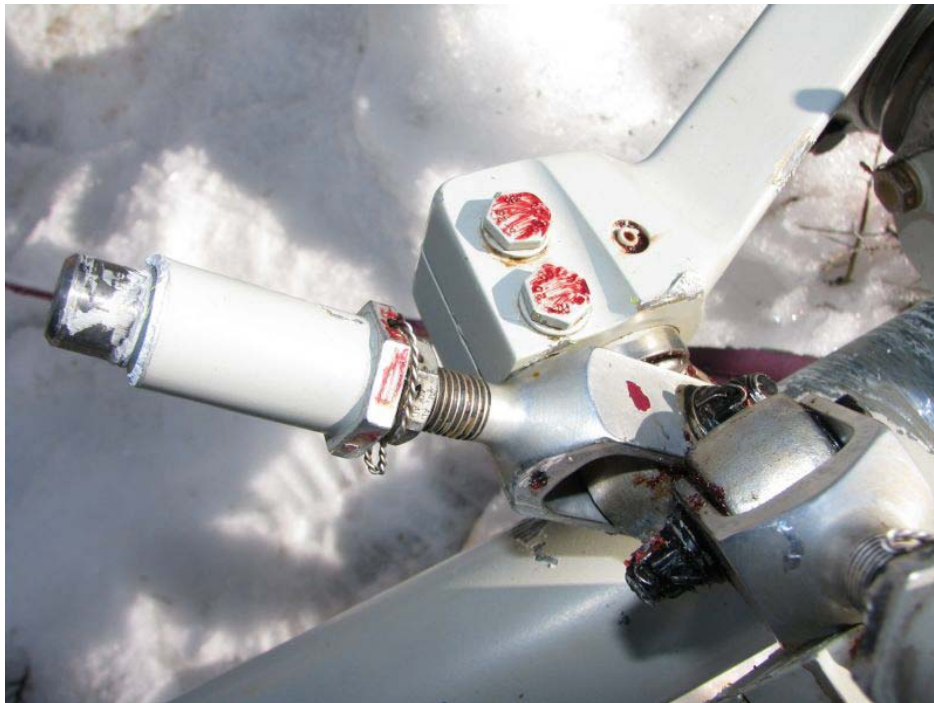
The Red pitch change link fractured near the end of the threaded insert consistent with overload forces. The remainder of the Red pitch change link was not observed.

Photo 12  
Top of Red pitch change link fractured consistent with overload near insert

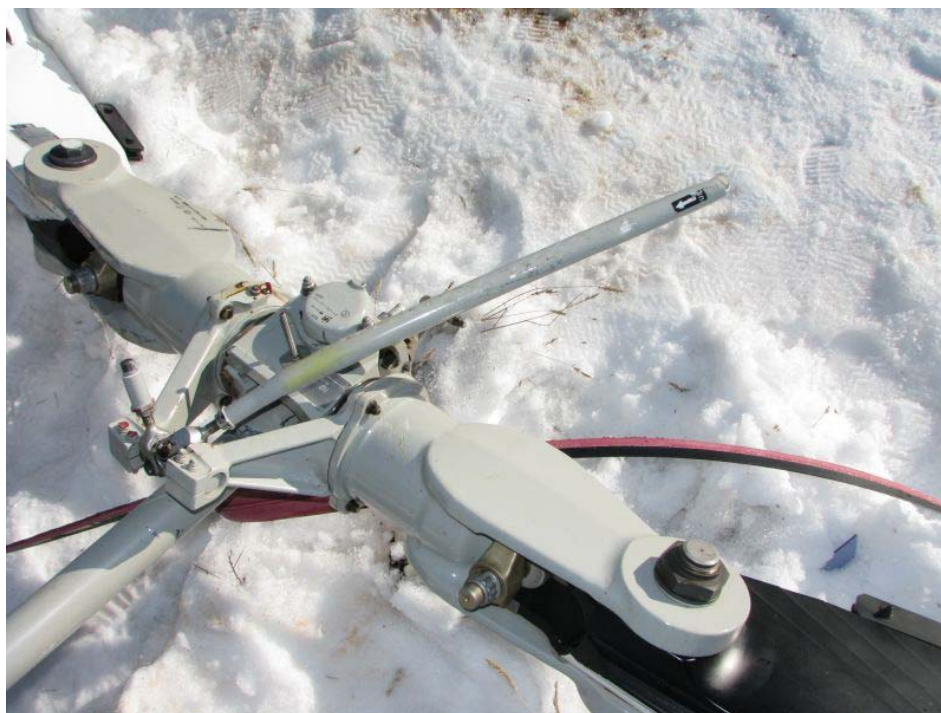
Photo 13

The main rotor hub assembly was intact, although both of the main rotor grips were observed to be over-rotated on the yoke from impact (See Photo 13). The inboard end of each main rotor blade remained attached to the hub. Each blade exhibited chordwise scoring marks on outboard leading edge surfaces consistent with striking the tailboom during the impact sequence (See Photo 14).

Intact main rotor hub assembly with top portion of fractured White pitch change link

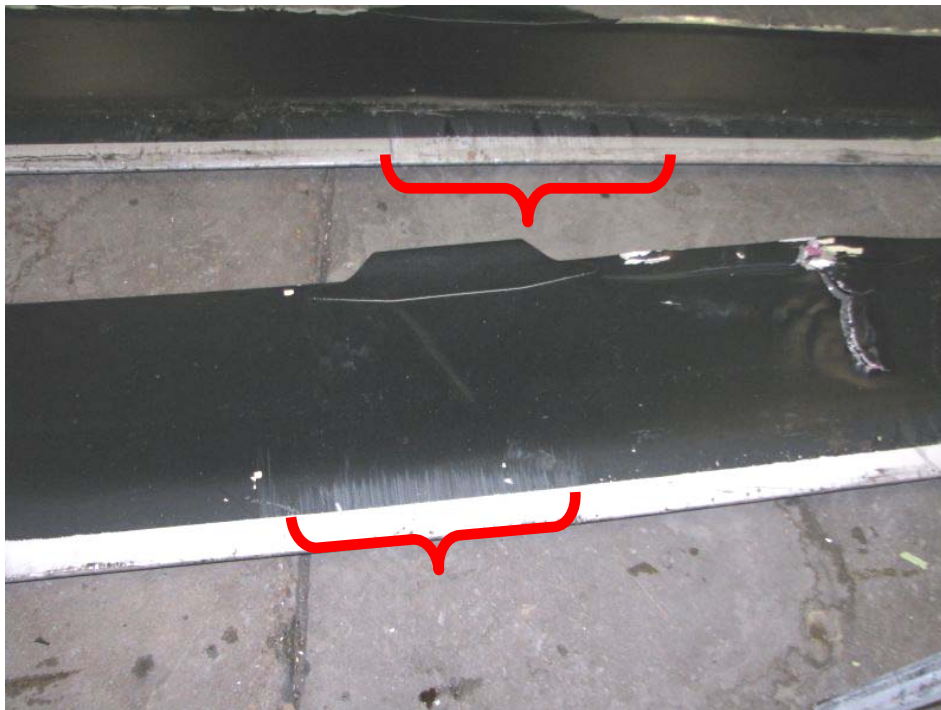
Photo 14

Chordwise scoring marks on outboard blade surfaces from tailboom strikes by main rotor

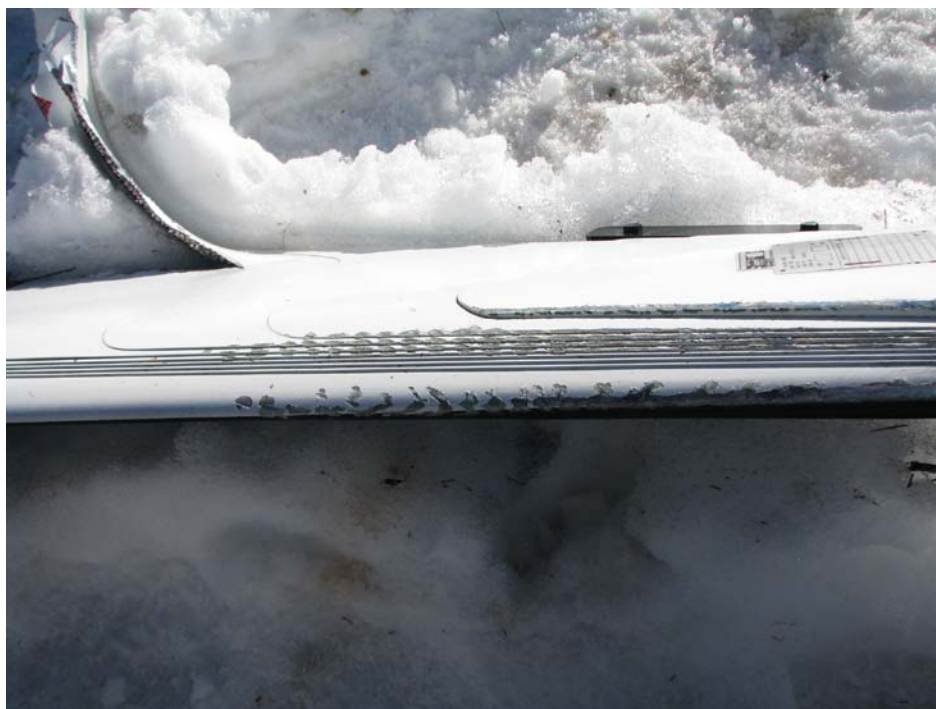
The Red main rotor blade was found with the main wreckage. The inboard blade area exhibited scoring marks on leading edge surfaces consistent with wirestrike marks (See Photo 15). The leading edge of the Red grip also exhibited abrasions consistent with wirestrike damage (See Photo 16). The blade spar fractured at the outboard doubler, but the aluminum trailing edge strip was bent but not fractured.

Photo 15  
Scoring marks on inboard Red blade consistent with wirestrike

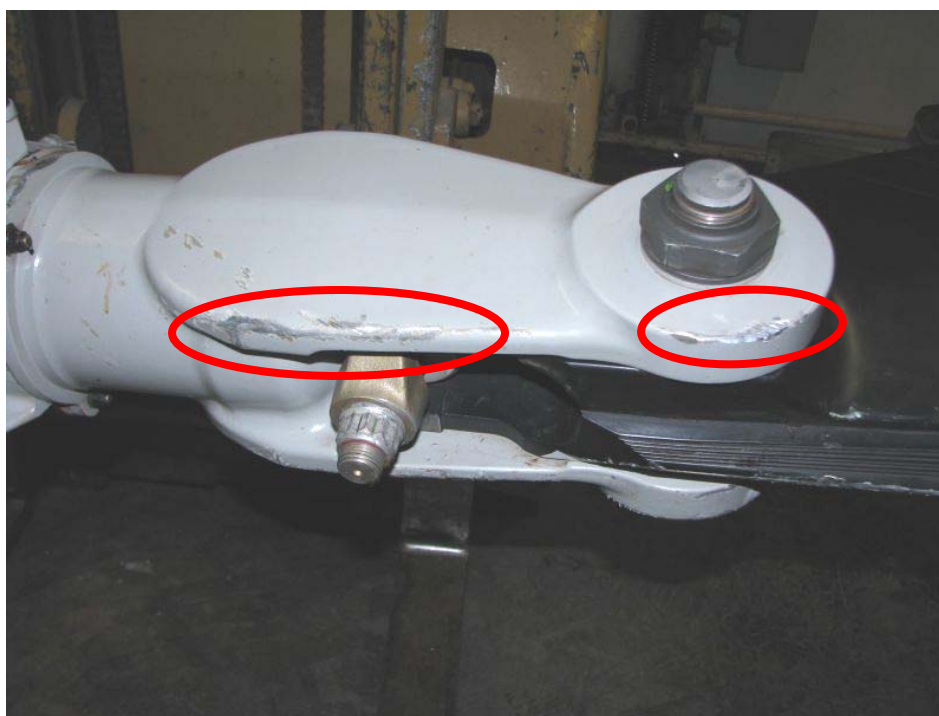
Photo 16  
Red grip leading edge abrasions consistent with wire contact

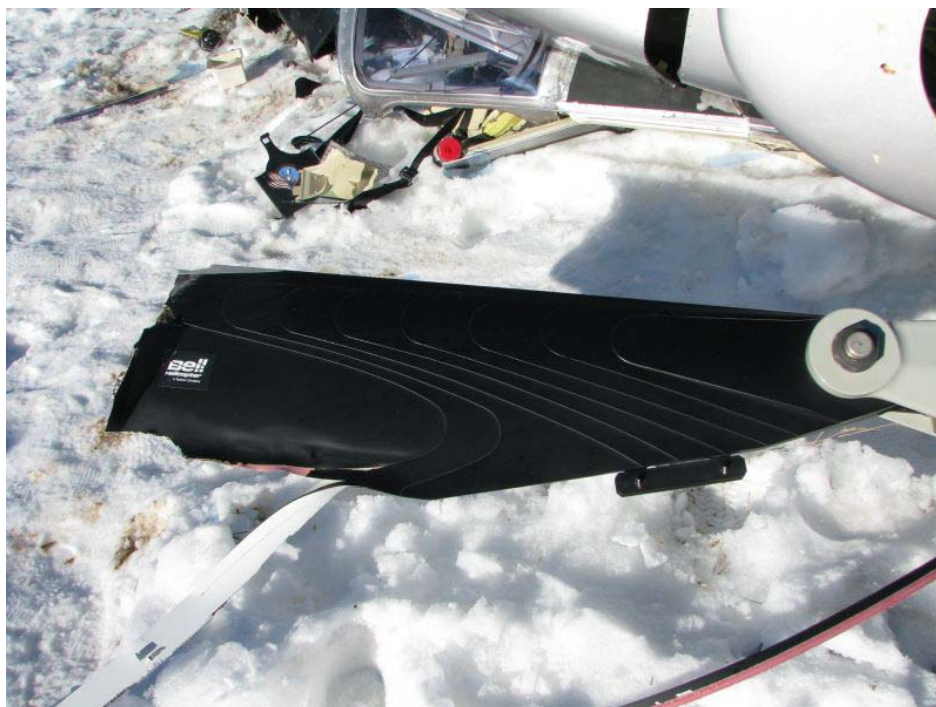
Photo 17

The White main rotor blade was fractured at the outboard doubler and the trailing edge strip separated from the blade (See Photo 17). The White blade was found approximately 50 feet from the main wreckage (See Photo 18).

White main rotor blade inboard section with fracture at outboard doubler

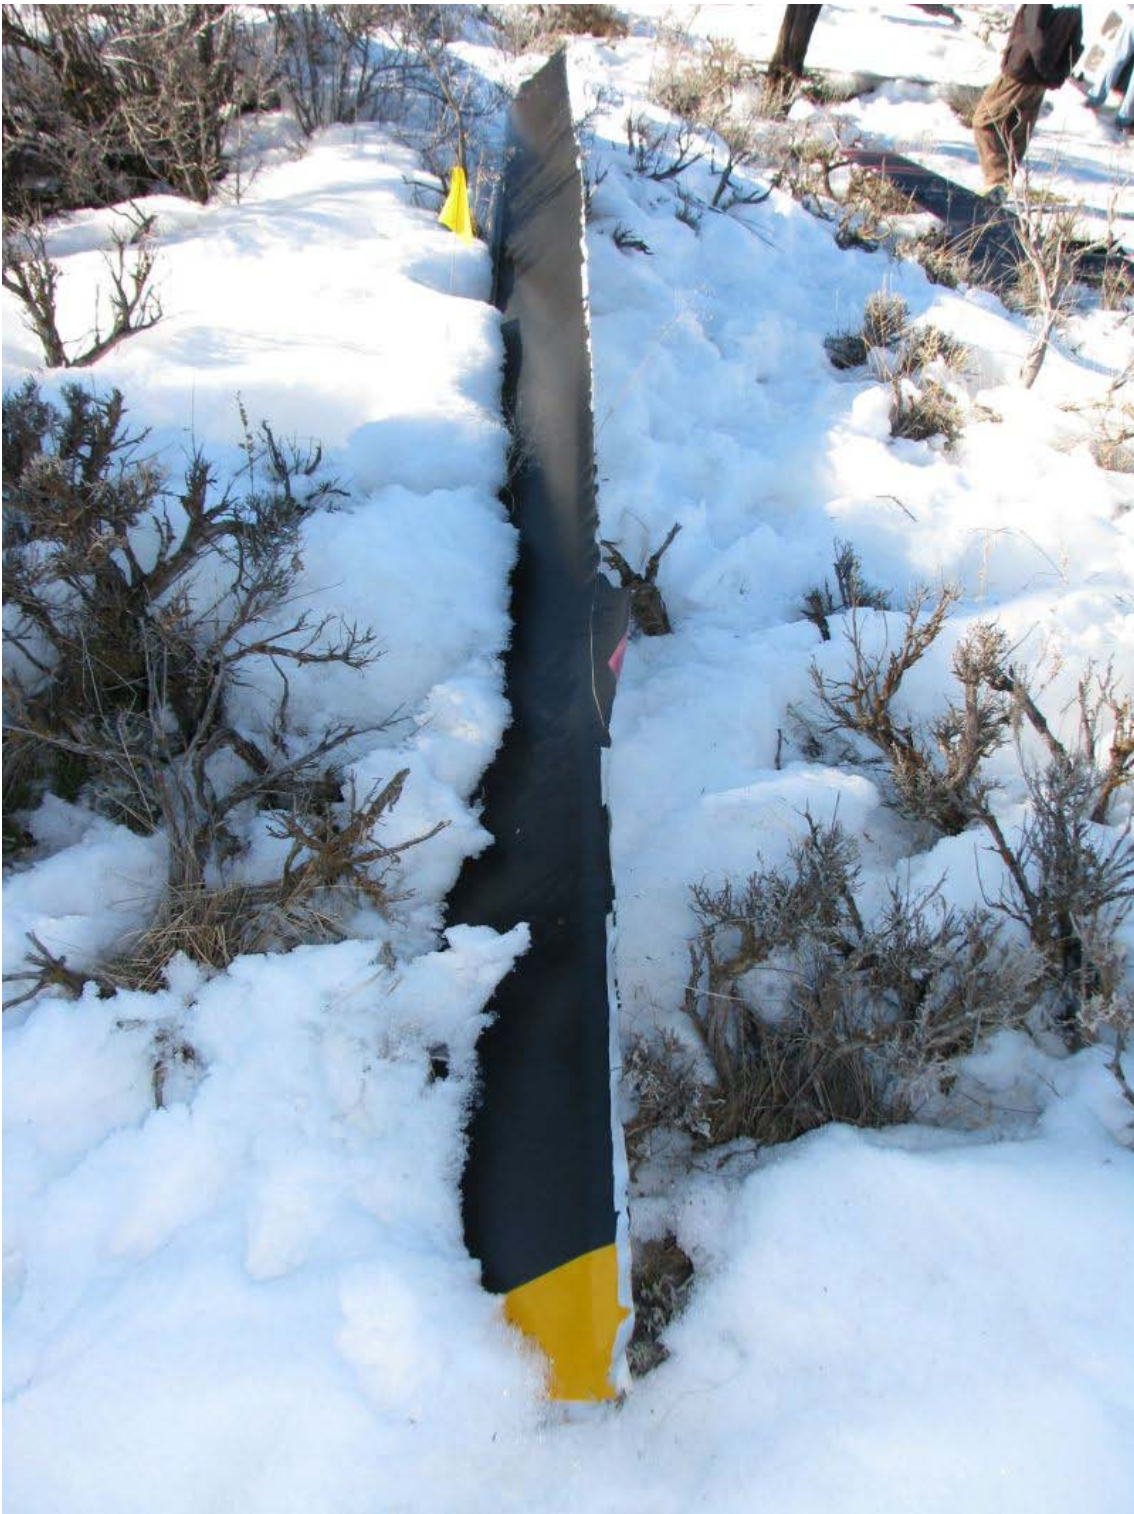
Photo 18  
White main rotor blade outboard fractured section

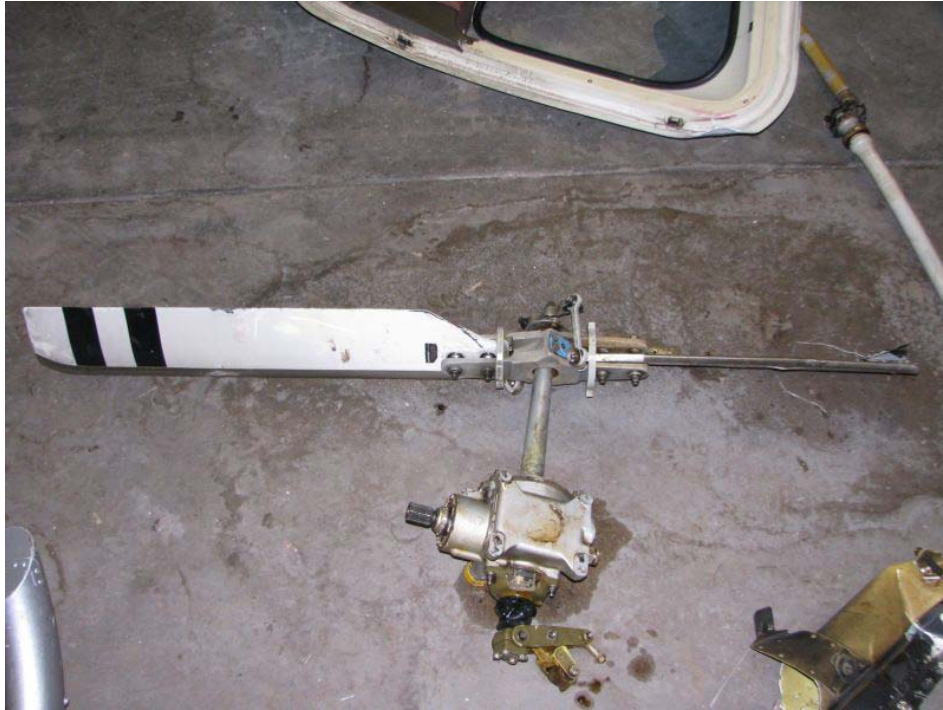
Photo 19

The tail rotor hub assembly remained connected to the tail rotor gearbox output shaft (See Photo 19). Free pitch change movement was demonstrated through the slider rod mechanism to the tail rotor blades. Near the tip of one tail rotor blade, a chordwise fracture was observed, consistent with overload forces. The tail rotor blades were aftermarket blades.

Tail rotor hub attached to tail rotor gearbox output shaft & chordwise T/R blade fracture

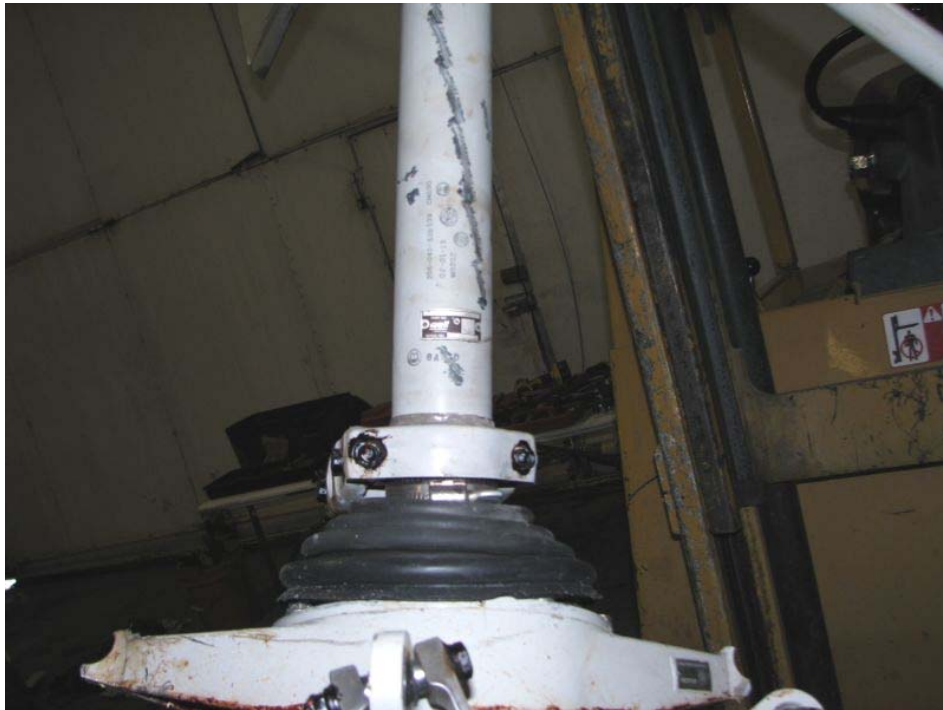
Photo 20

The mast exhibited spiral scoring marks from approximately 8-10 inches above the outer ring swashplate to just below the main rotor hub (See Photos 20 & 21). The scoring marks were consistent with wirestrike marks. The input drive attaching flange on the main transmission was rotated by hand and corresponding rotation of the mast through the main transmission was observed (See Photo 22). The driveshaft rear outer coupling (engine end) was intact and all over-temperature indicating dots were white in color, indicating that the coupling had not overheated (See Photo 23). The driveshaft forward outer coupling (transmission end) was found with axial fractures consistent with overload forces from misalignment at impact (See Photo 24). The outer coupling teeth were intact and covered with typical black-colored Bell specified driveshaft coupling grease. The inner coupling teeth exhibited fractures and smearing (See Photo 25) consistent with rotating contact on the right side transmission restraint assembly fitting after fracture of the forward outer coupling (See Photo 26). The left front transmission mount leg was fractured consistent with overload during impact.

Wirestrike spiral scoring marks on mast commence about 8-10 inches above swashplate

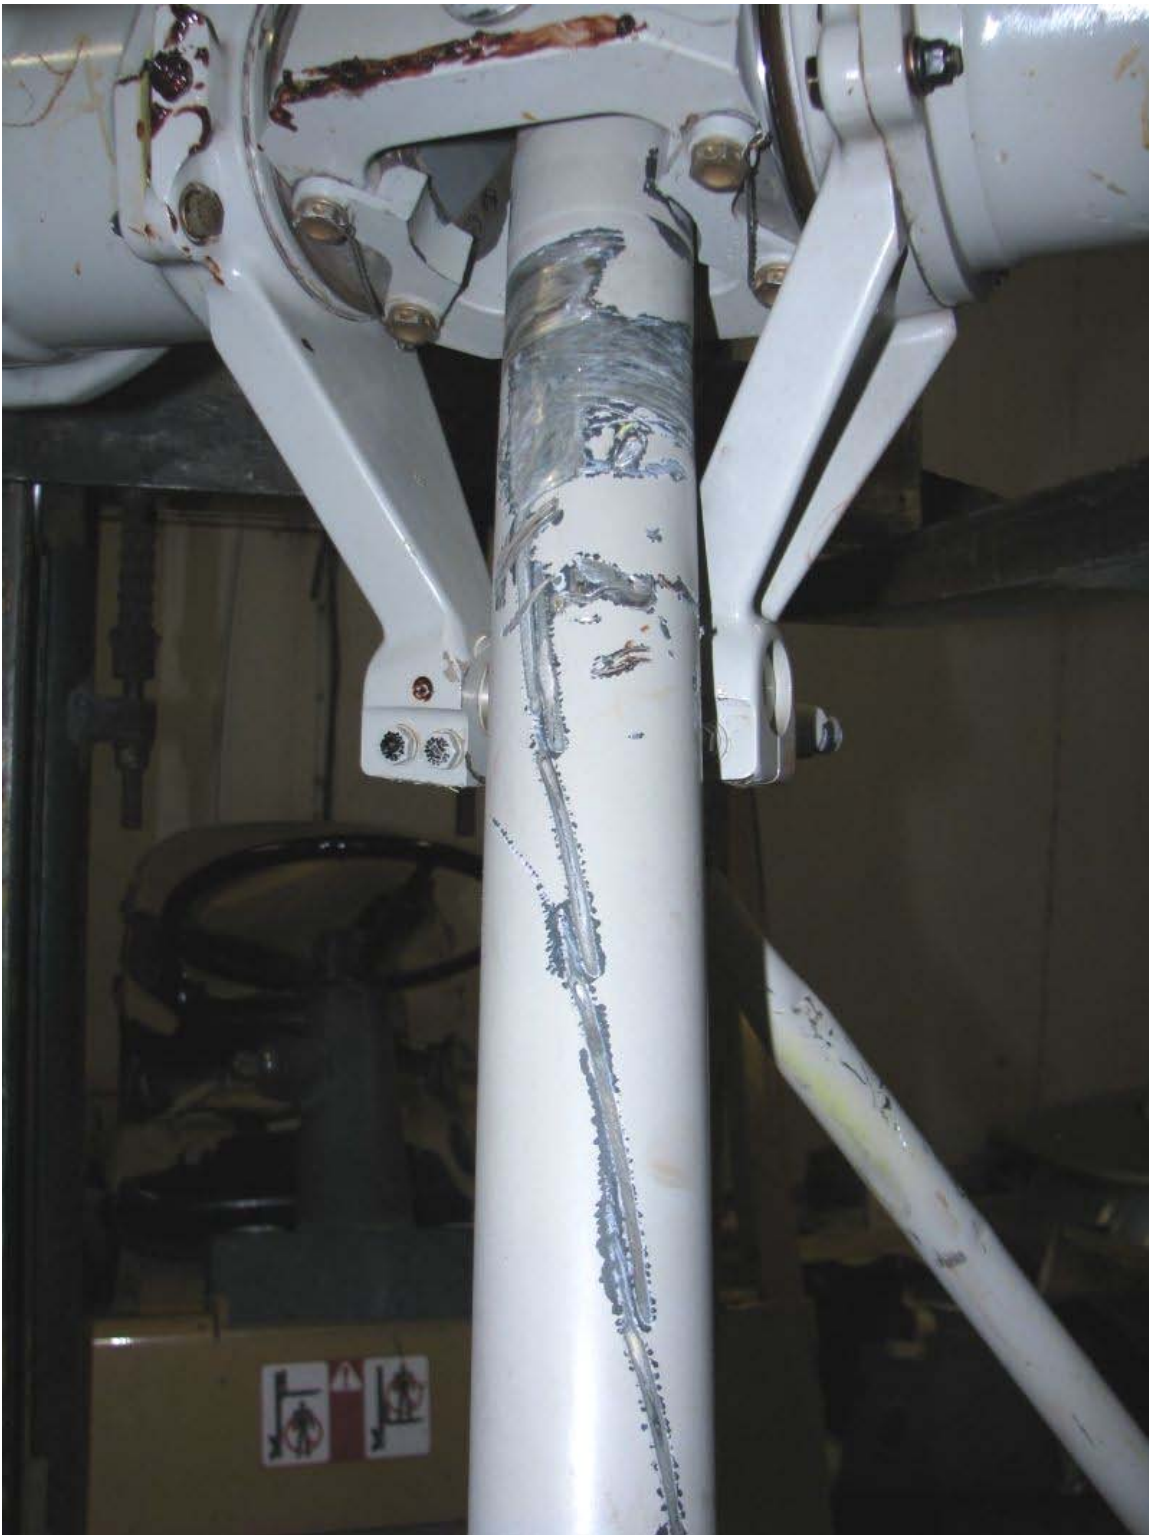
Photo 21  
Wirestrike scoring marks on mast terminate at bottom of main rotor hub

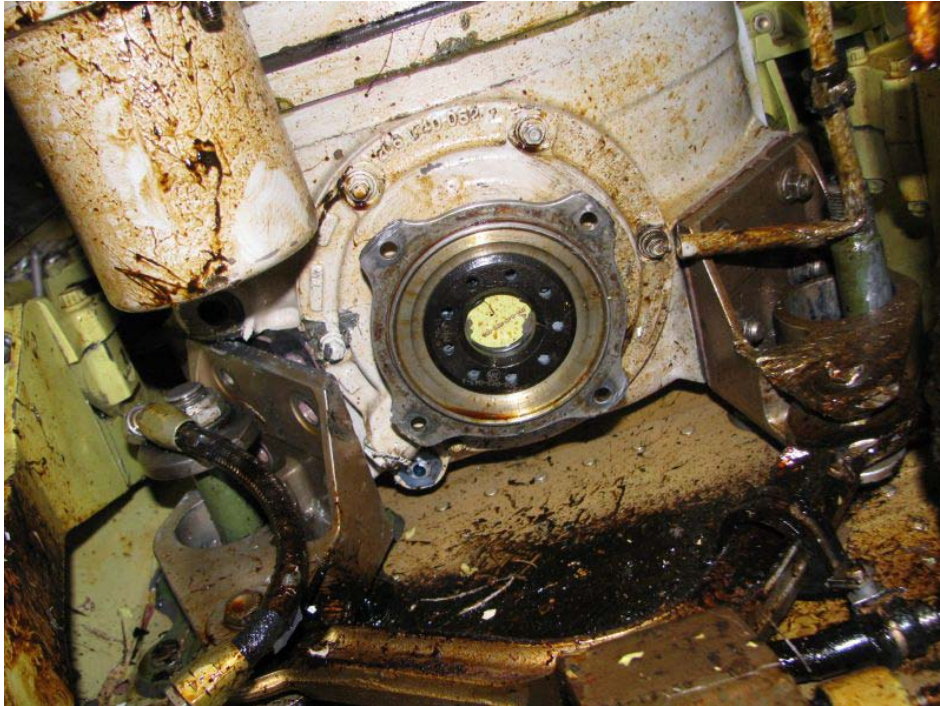
Photo 22  
Input flange to main transmission

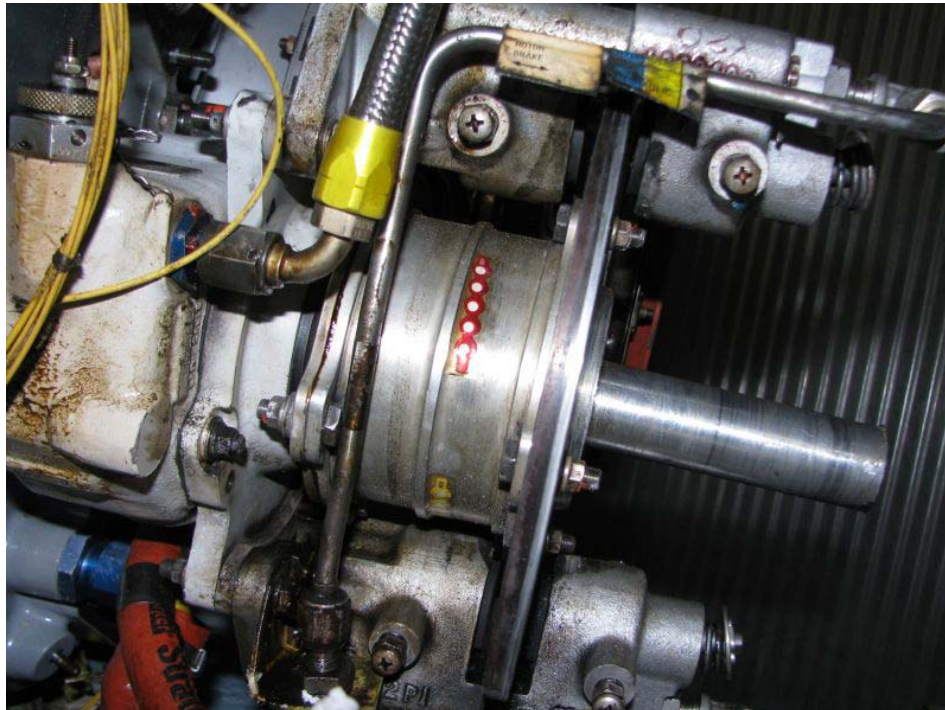
Photo 23  
Engine end outer coupling for main driveshaft with White colored temperature dots

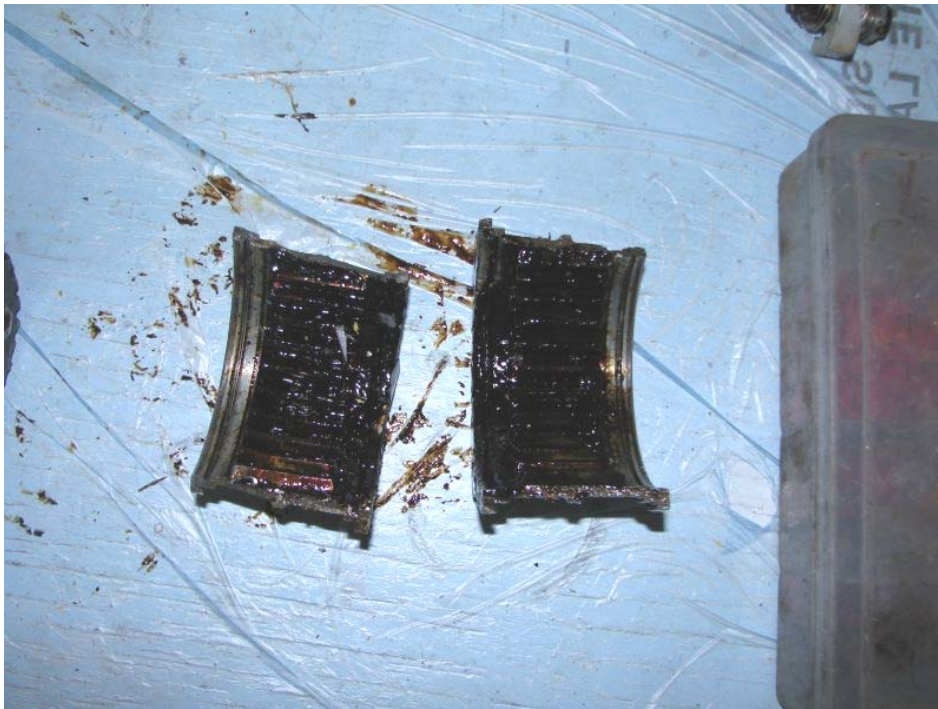
Photo 24

Transmission end main driveshaft outer coupling with axial fractures and intact teeth

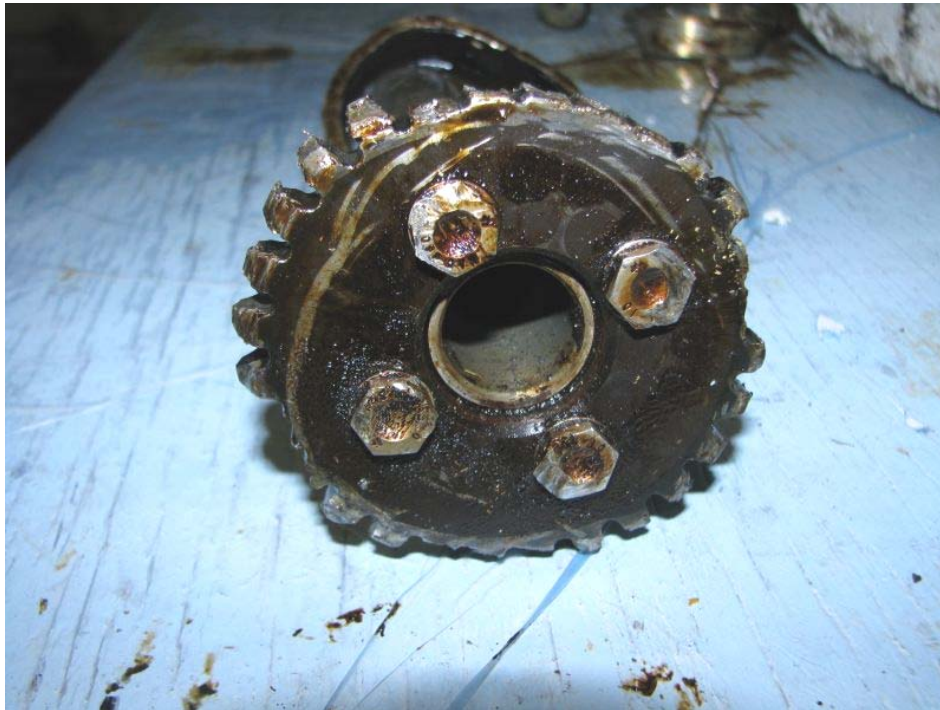
Photo 25

Fractured and smeared inner coupling teeth from rotating contact with restraint assembly

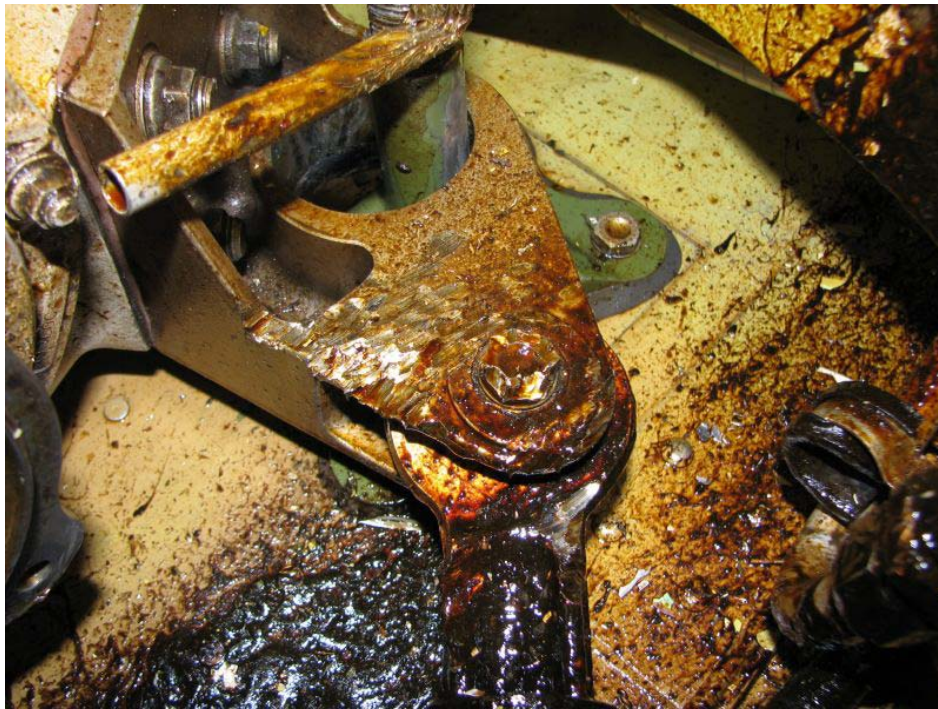
Photo 26

Right side restraint assy with damage from contact with rotating inner coupling teeth

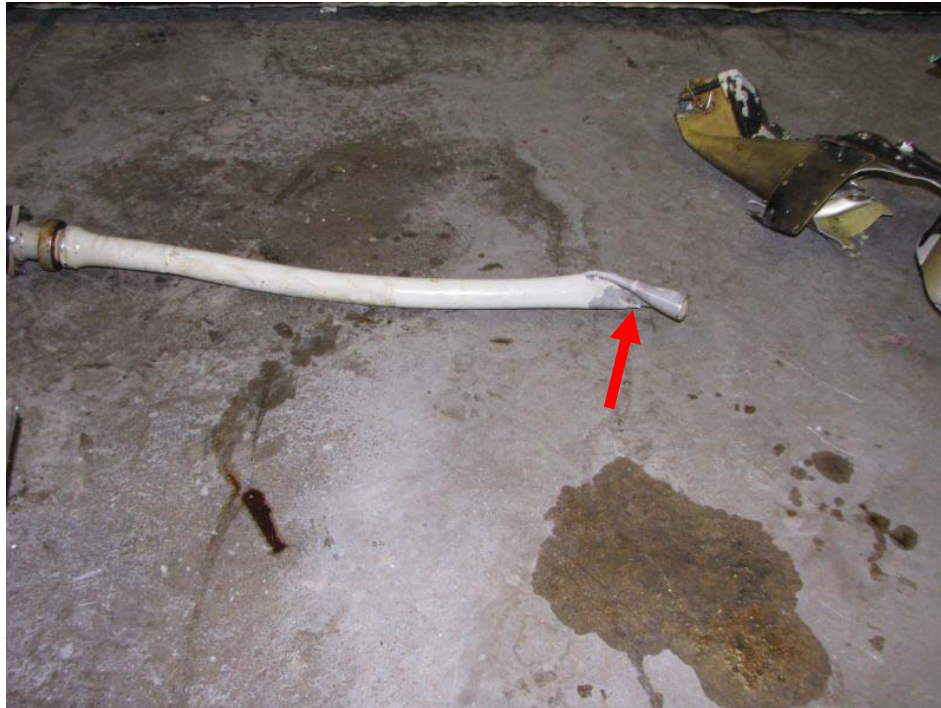
Photo 27

The tail rotor gearbox was located with the aft tailboom section; all four attachment studs were fractured consistent with overload forces at impact. The tail rotor gearbox rotated freely by hand. The tail rotor driveshafts on the tailboom exhibited several areas of main rotor strike damage. The #2 (See Photo 27) and #4 (2<sup>nd</sup> to last tail rotor driveshaft) tail rotor driveshaft sections on the tailboom both exhibited main rotor strike damage. The #4 shaft (See Photo 28) was found approximately 100 feet from the main wreckage. The #3 shaft, located near the tailboom aft fracture, was not recovered from the accident scene. The #2 shaft on the tailboom, the #1 shaft on the tailboom, and the short shaft from the aft fuselage remained connected together (See Photo 29), but had separated from their hanger bearing mounts and were found near the aft tailboom fractured section. The steel oil cooler tail rotor driveshaft could not be rotated by hand because of deformation to the oil cooler shroud consistent with impact forces. The steel tail rotor driveshaft located under the engine exhibited bending overload at mid-span (See Photo 30).

#2 tail rotor driveshaft on tailboom with main rotor strike
