Flight Safety Dept  
Engineering

**Factual Observations of Helicopter Mishap**  
**Bell 206L3; Serial Number 51546; N207DS**  
**Owner/Operator: Delta Bravo Sierra, Inc.**  
**Date of Accident: January 27, 2014**  
**Location of Accident: Silt, CO**

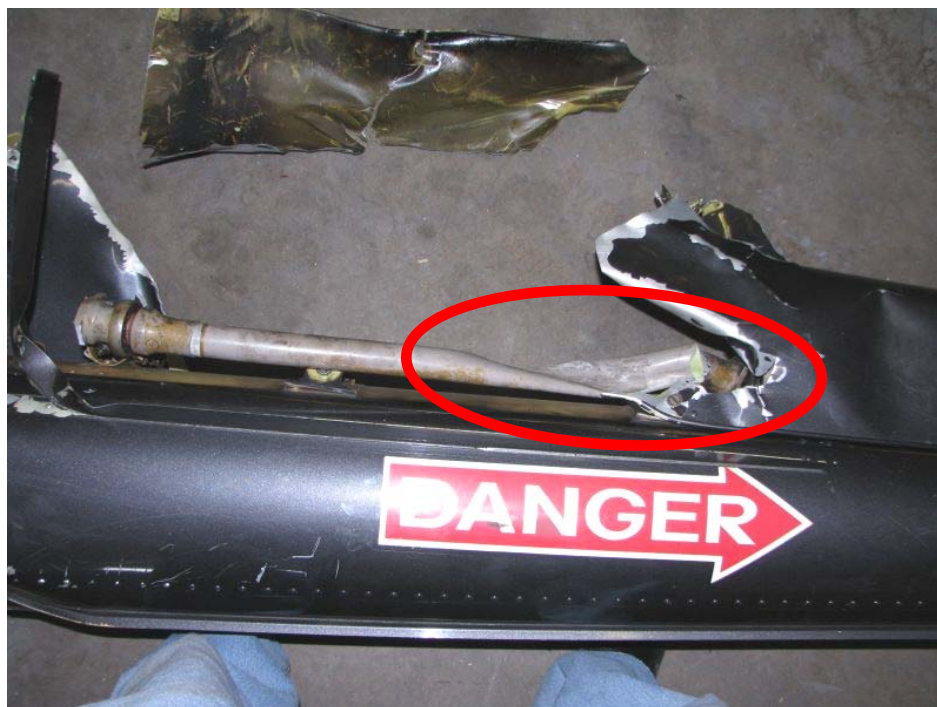
Copyright 2014 Bell Helicopter Textron Inc.

#4 tail rotor driveshaft on tailboom and driveshaft cover with main rotor strike evidence

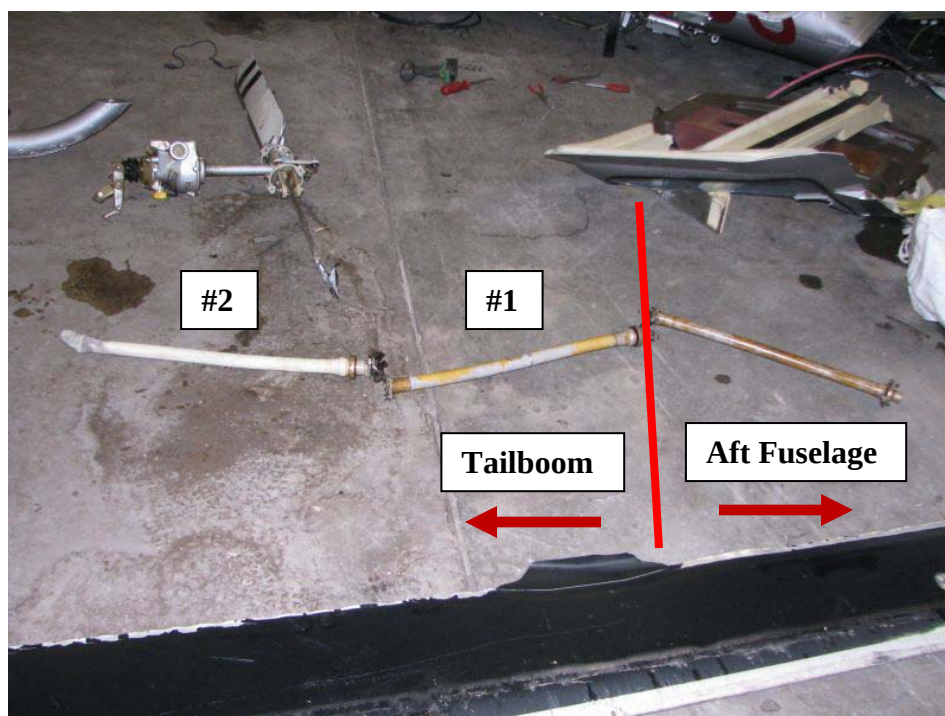
Photo 29

Tail rotor driveshaft segments: From left to right—#2, #1, aft fuselage shafts

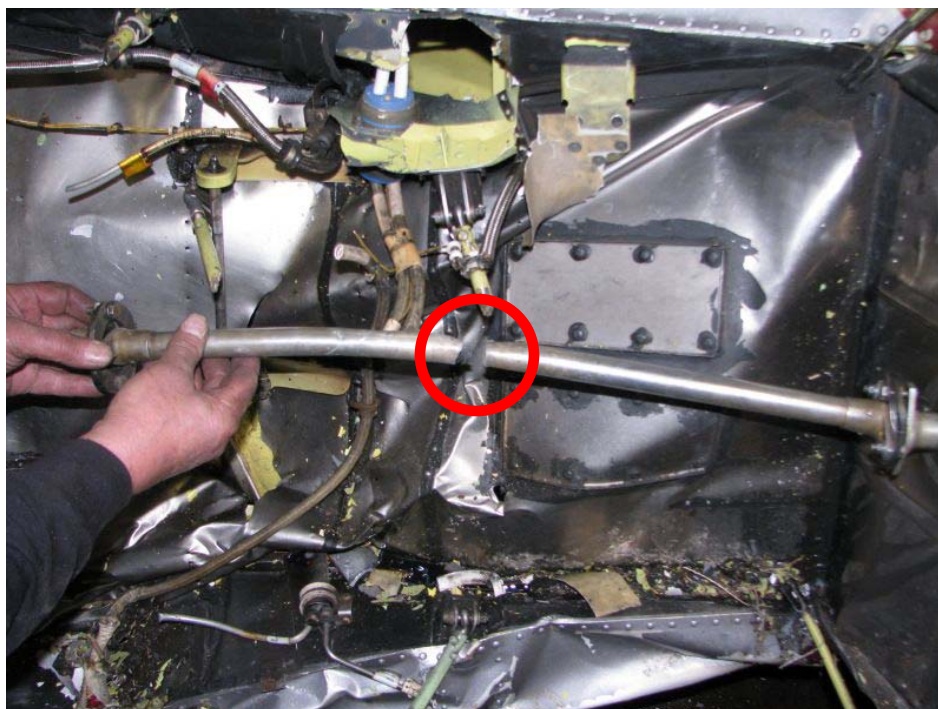
Photo 30

Bending overload fracture of steel tail rotor driveshaft located under the engine
