## **Engine Investigation Report**

**Allison Model 250-C30P  
Engine CAE 890513**

**Bell 206L3  
Registration: N207DS**

**Accident date: 27 January, 2014  
Investigation date: 28 – 29 January, 2014  
Report date: 1 December, 2014**

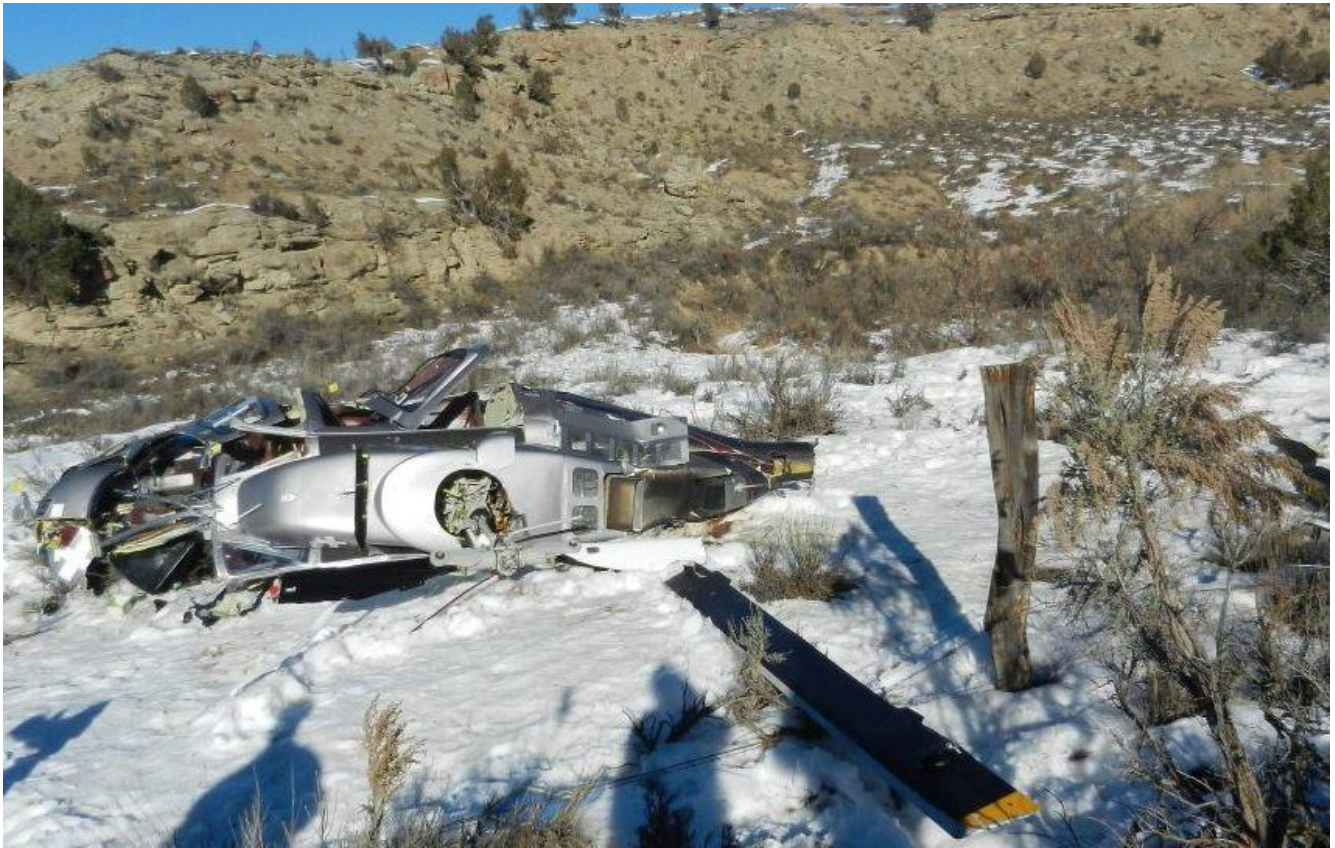
**Fig 1: Main Wreckage On-Site**

Examination of the accident site revealed that the helicopter impacted the ground in a valley just south of the severed static wire. The helicopter was found on its left side and sustained substantial damage **Fig 1**. The tailboom was separated from the main wreckage and broken into two pieces. The forward portion of the tail boom to include the horizontal stabilizer was located approximately 150 feet from the main wreckage. The aft portion of the tail boom including the tail rotor gearbox and tail rotor was located near the main wreckage **Fig 2**. All other major structural components were located within or near the main wreckage **Fig 3 & Fig 4**. Scoring marks consistent with a wire strike were observed on one of the main rotor blades and the main rotor mast. The engine was located within the engine compartment of the helicopter positioned on its left side with all engine mounts intact **Fig 5**. The aircraft fuel filter bowl sustained impact damage and was dented inward on the aft side with a portion of the o-ring protruding from the housing. The 'B' nut on fuel line to the engine was also loose at the filter bowl housing, likely due to impact. The majority of visible impact damage to the engine was isolated to the left side air discharge tube and outer combustion case **Fig 6**. The wreckage was transported to Beegles Aircraft Service in Greeley, Colorado for further examination.

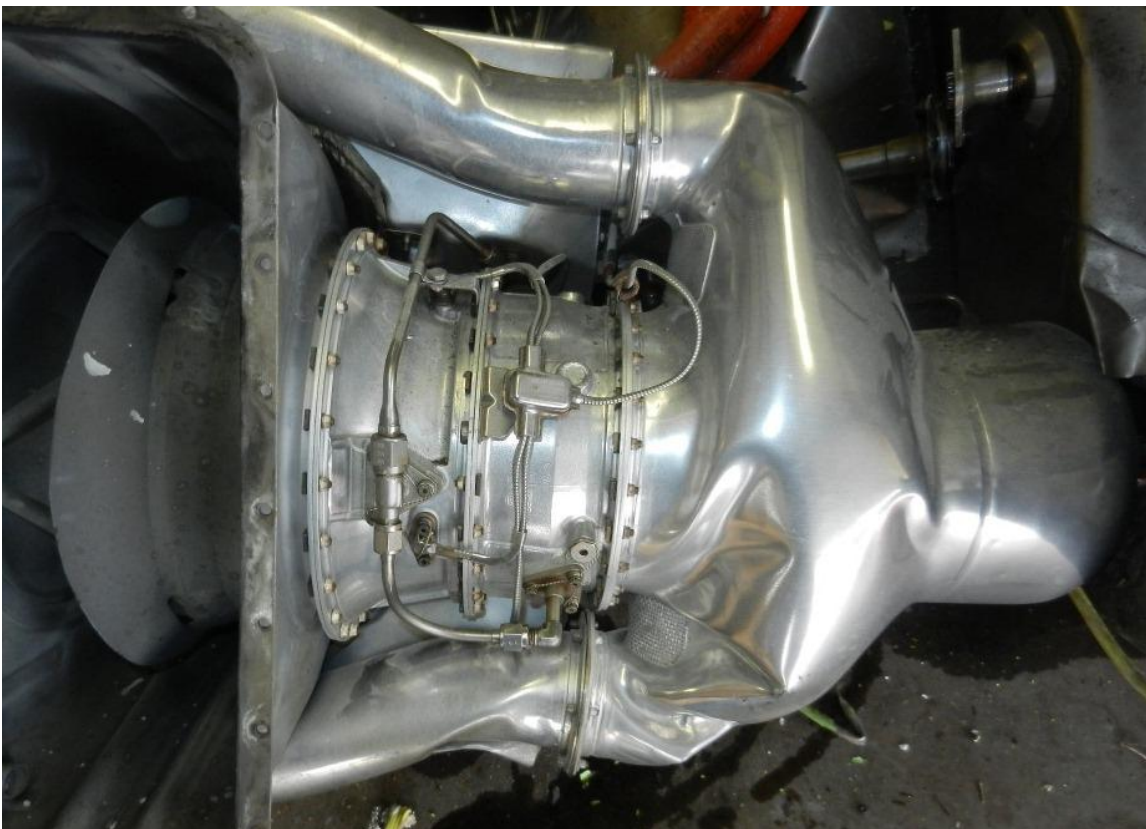
There was no visible damage to the compressor **Fig 11**. The N1 drive train could be rotated by hand and was continuous to the starter generator. As previously noted the left side air discharge tube displayed impact damage. It was dented and pushed upward, but remained attached at both the scroll and outer combustion case. The right side air discharge tube had a small dent, but was otherwise unremarkable and connected at both ends.

The outer combustion case has heavily damaged from impact. It was dented/pushed inward on the lower and left sides. The engine fuel line between the check valve and fuel nozzle remained in position and attached at both ends. The line was removed from the fuel nozzle and a small amount residual fuel drained out. The fuel nozzle was removed for examination and found undamaged and normal in appearance.

**Fig 6: Impact Damage to the Left Air Discharge Tube & Outer Combustion Case**

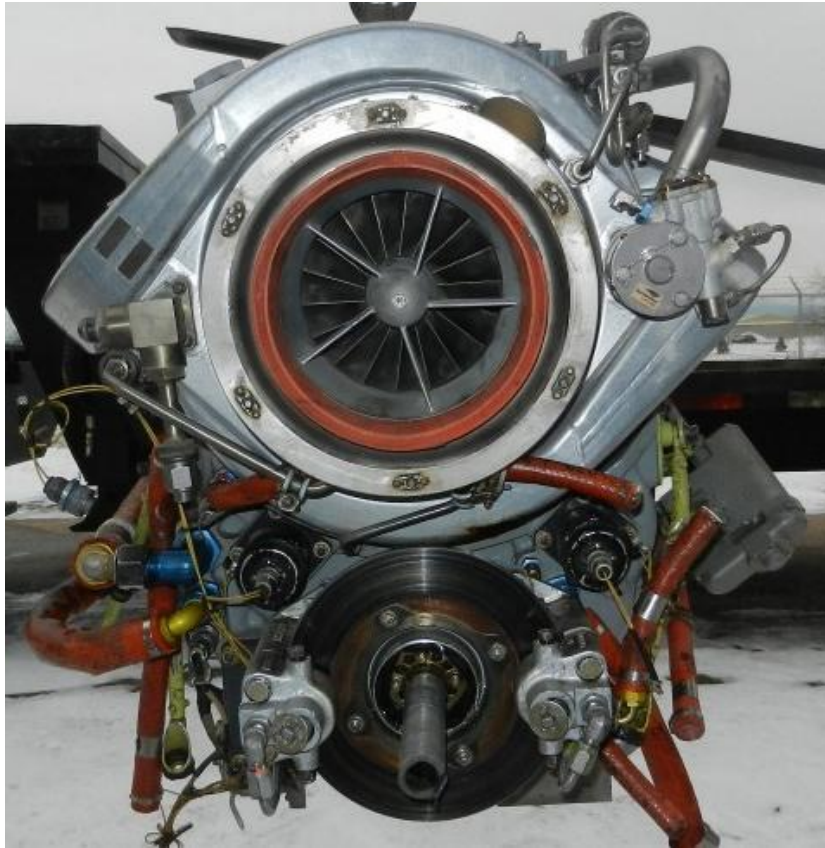
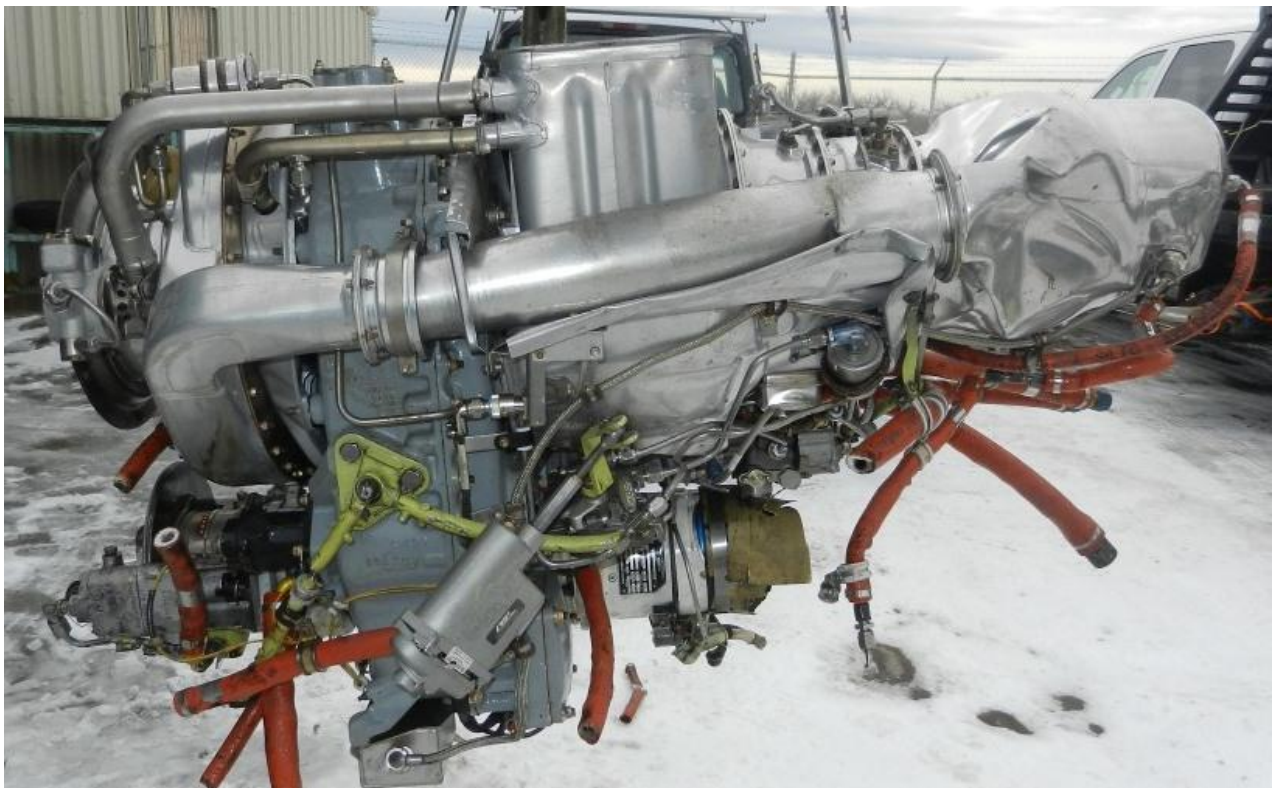
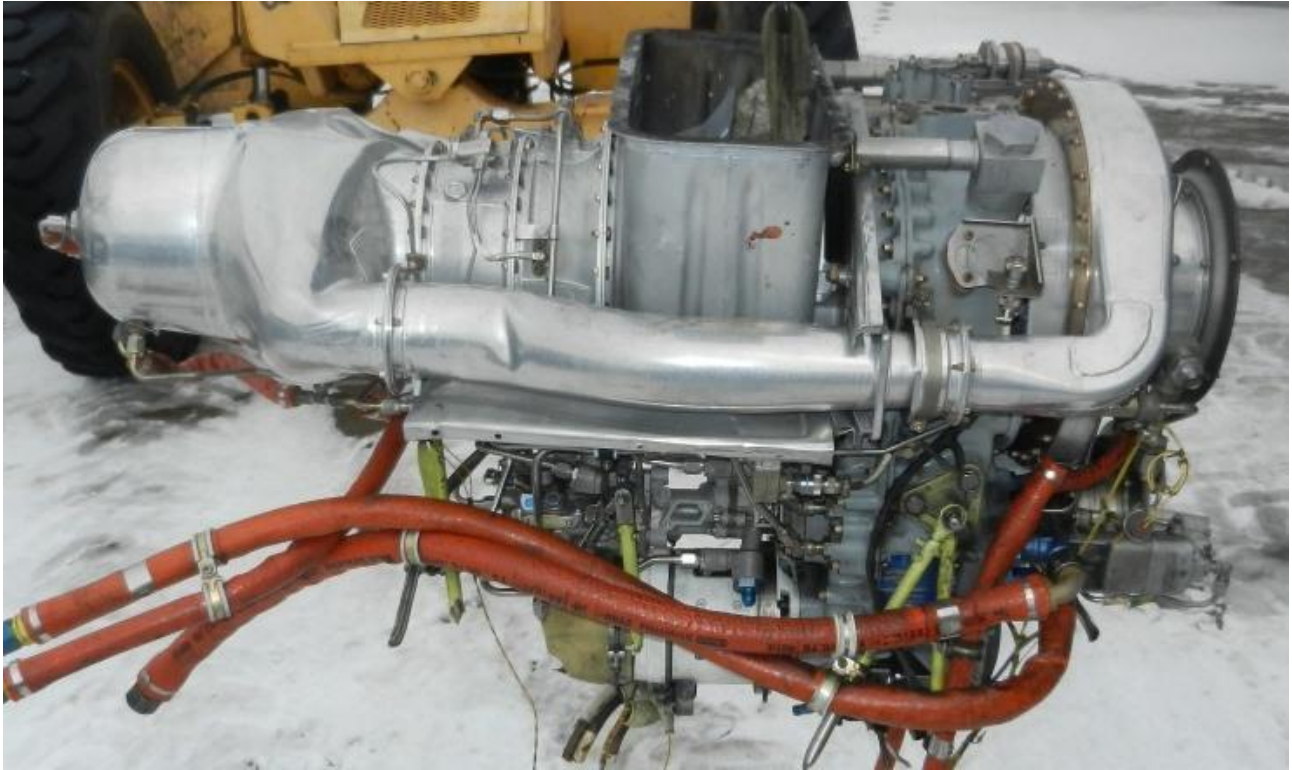
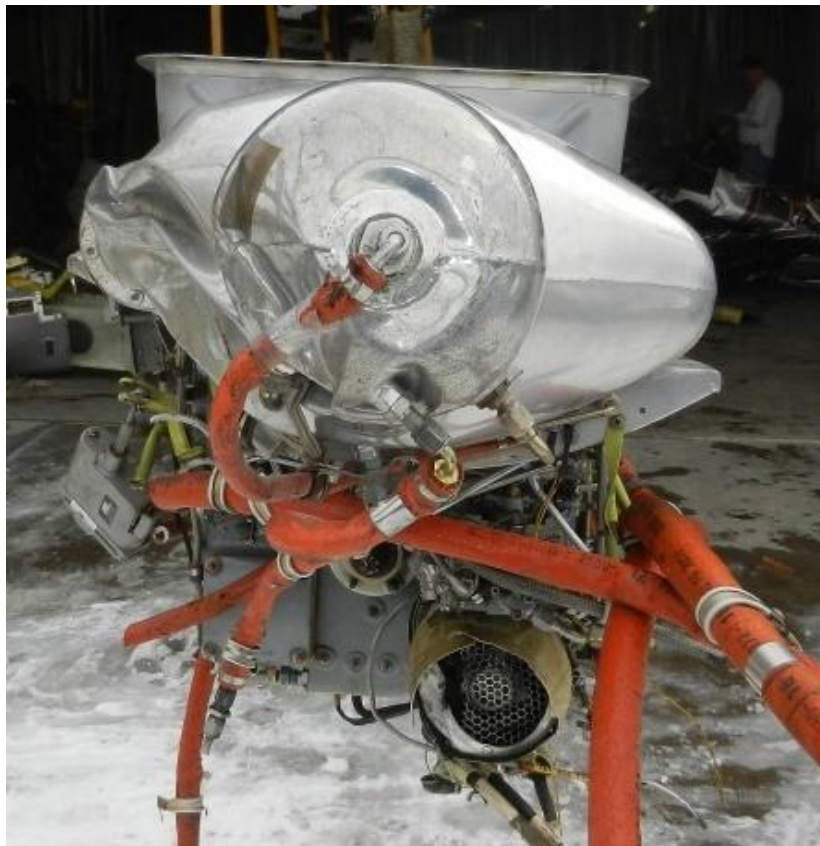
On 30 January, 2014 representatives from Rolls-Royce, NTSB, and Bell helicopters gathered at Beegles Aircraft Service in Greeley, CO for a detailed examination of the engine and aircraft wreckage. The engine was removed from the main wreckage and the following engine observations were noted: **Fig 7, Fig 8, Fig 9, & Fig 10**

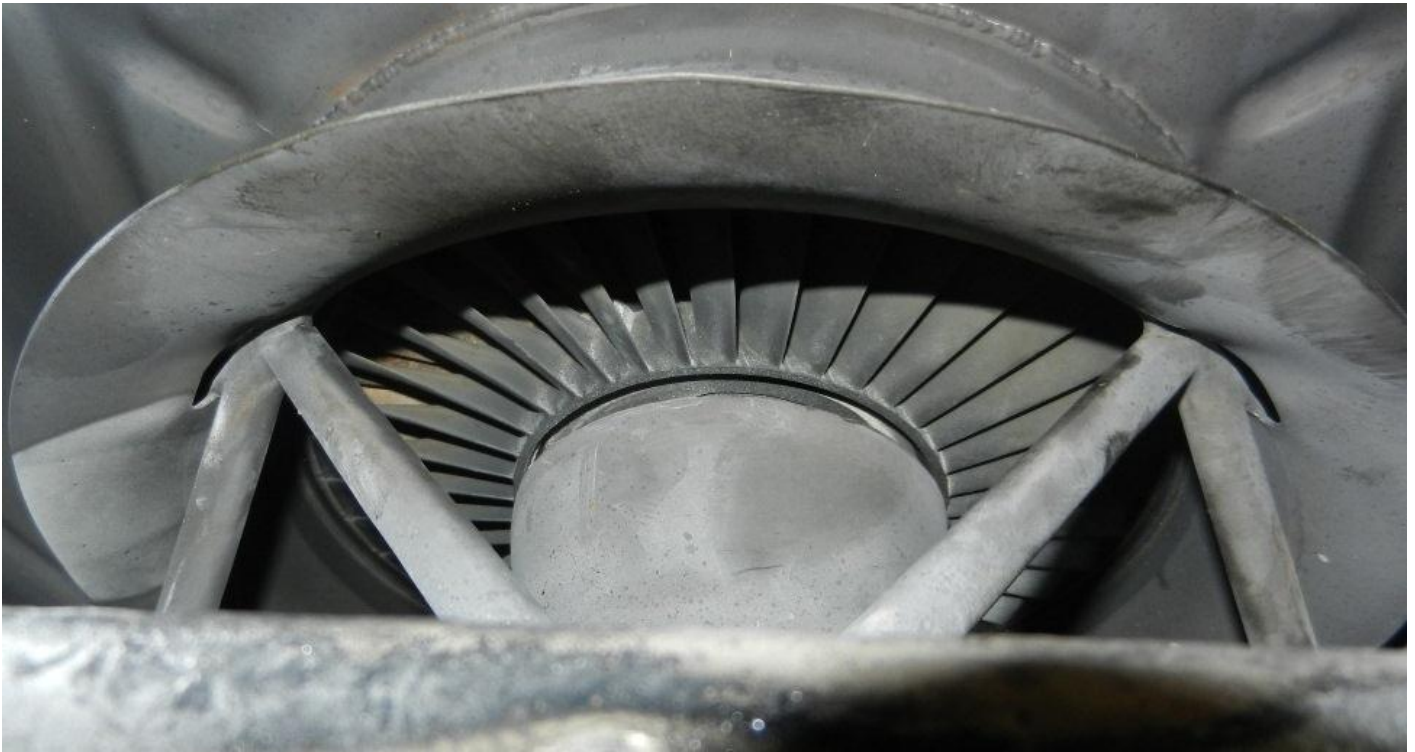
**Fig 12: 4<sup>th</sup> Stage Turbine Wheel as Viewed Through the Exhaust Collector**

The 4th stage turbine wheel, as viewed through the exhaust collector, was undamaged **Fig 12**. The N2 drive train was free and continuous from the 4th stage turbine wheel to the power takeoff gear during manual rotation. Both the gas producer and power turbine supports were normal in appearance and displayed no impact damage. The number 6/7 and 8 bearing oil delivery tubes were removed for examination **Fig 13 & Fig 14**. Both were oil coated and normal in appearance. The oil pressure screen was clean and unremarkable. The outer combustion case and combustion liner were removed to facilitate further inspection. The combustion liner was dented inward due to impact, but was otherwise normal in appearance with no unusual damage or streaking **Fig 15**. Examination of the 1<sup>st</sup> stage turbine nozzle and visible portions of the 1<sup>st</sup> stage turbine wheel did not reveal any signs of damage **Fig 16**. The gas producer turbine rotated smoothly when the compressor was turned by hand.

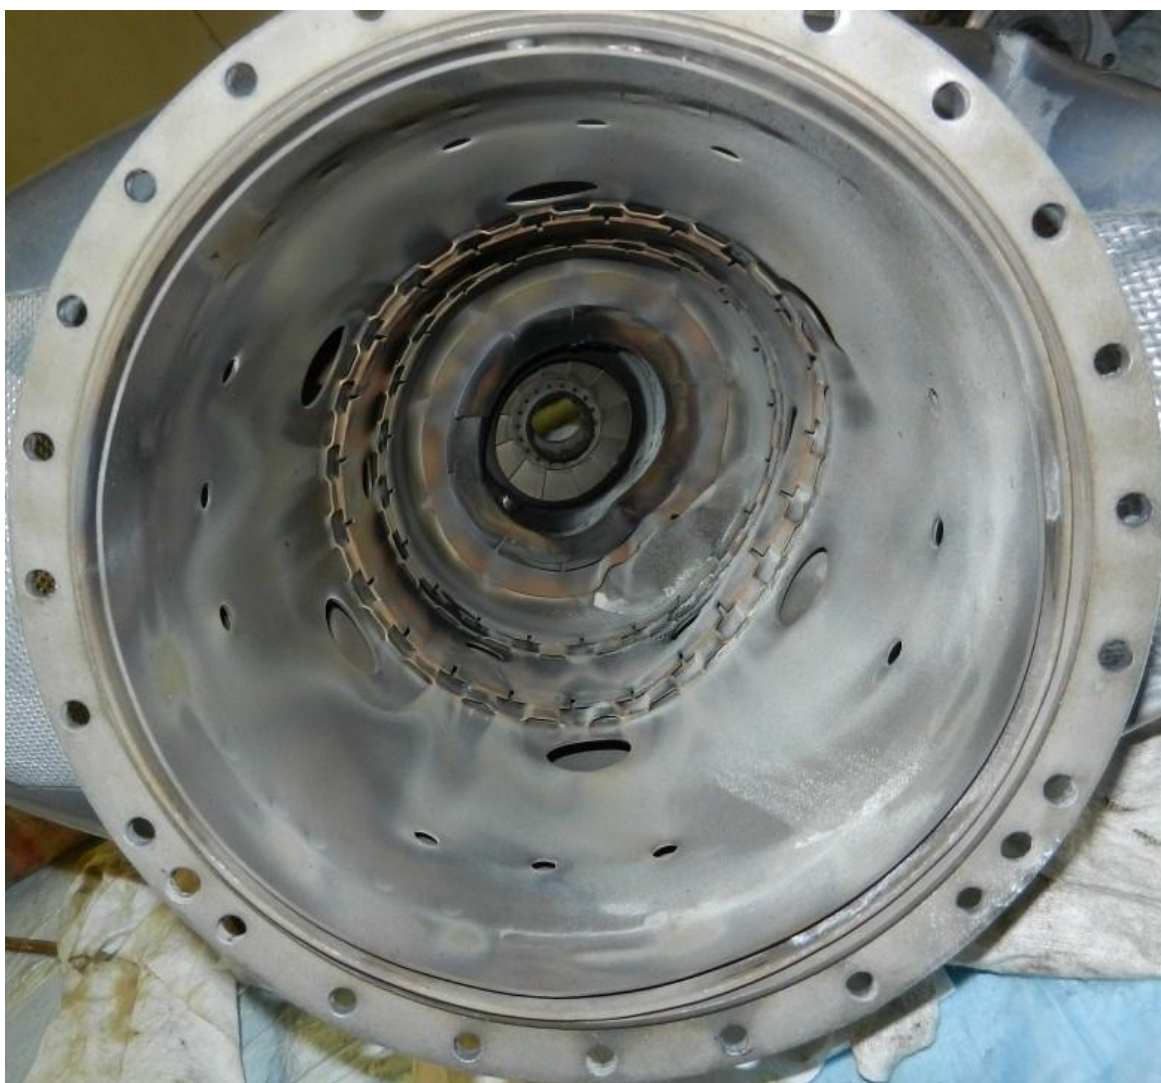
**Fig 15: Impact Damage to the Combustion Liner**

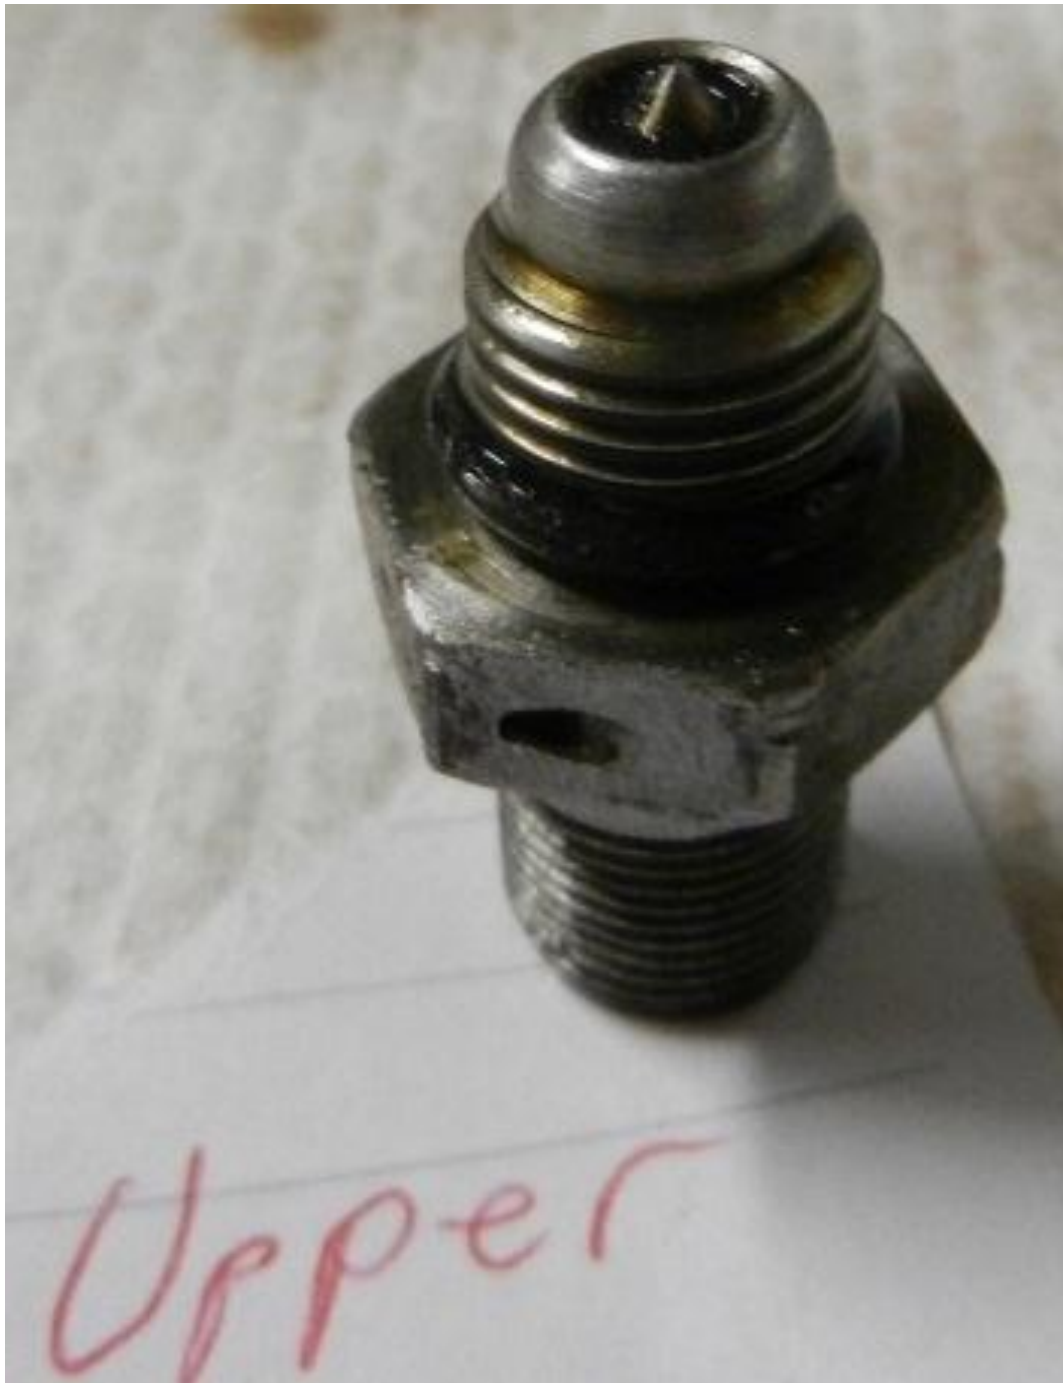
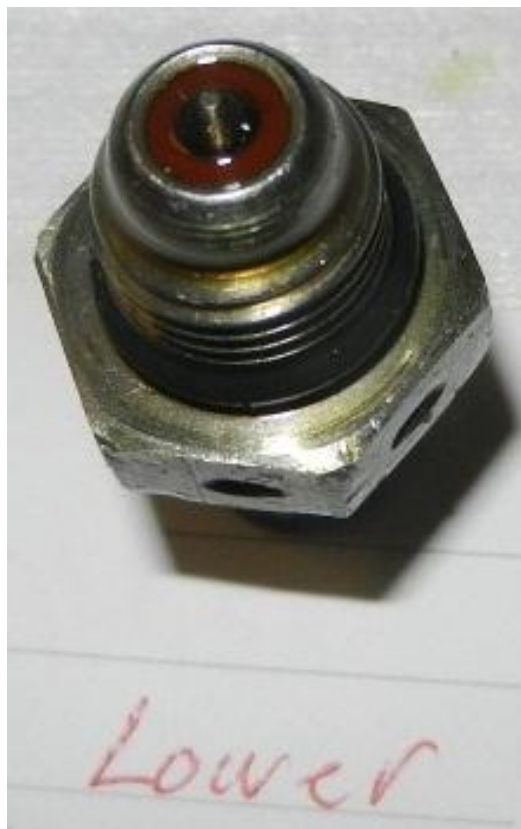
The accessory gearbox was undamaged and normal in appearance. The upper and lower chip detectors were removed and visually examined. Both chip detectors were free of metallic debris. The oil filter was removed and was clean **Fig 17 & Fig 18**. All accessories were removed for inspection. The fuel control unit and fuel pump were undamaged. The fuel control drive shaft rotated freely and the throttle arm had full, smooth travel from stop to stop. All three mounts on the power turbine governor were fractured, separating the governor from the accessory gearbox. The governor drive shaft rotated freely. The governor arm had full travel from stop to stop. The PC air line "T" fitting at the power turbine governor was fractured and broke away at the governor **Fig 19**. The "B" nut on the same fitting going to the fuel control was loose. All other pneumatic lines and associated fittings were secure when checked by hand with no cracks noted. All remaining external oil and fuel lines were undamaged and secure.
