**NATIONAL TRANSPORTATION SAFETY BOARD**  
Vehicle Recorder Division  
Washington, DC 20594

## **On Board Image Recorder**

**Specialist's Summary Report**  
**By George Haralampopoulos**

| Aircraft: | Bell 206-L3, N207DS |

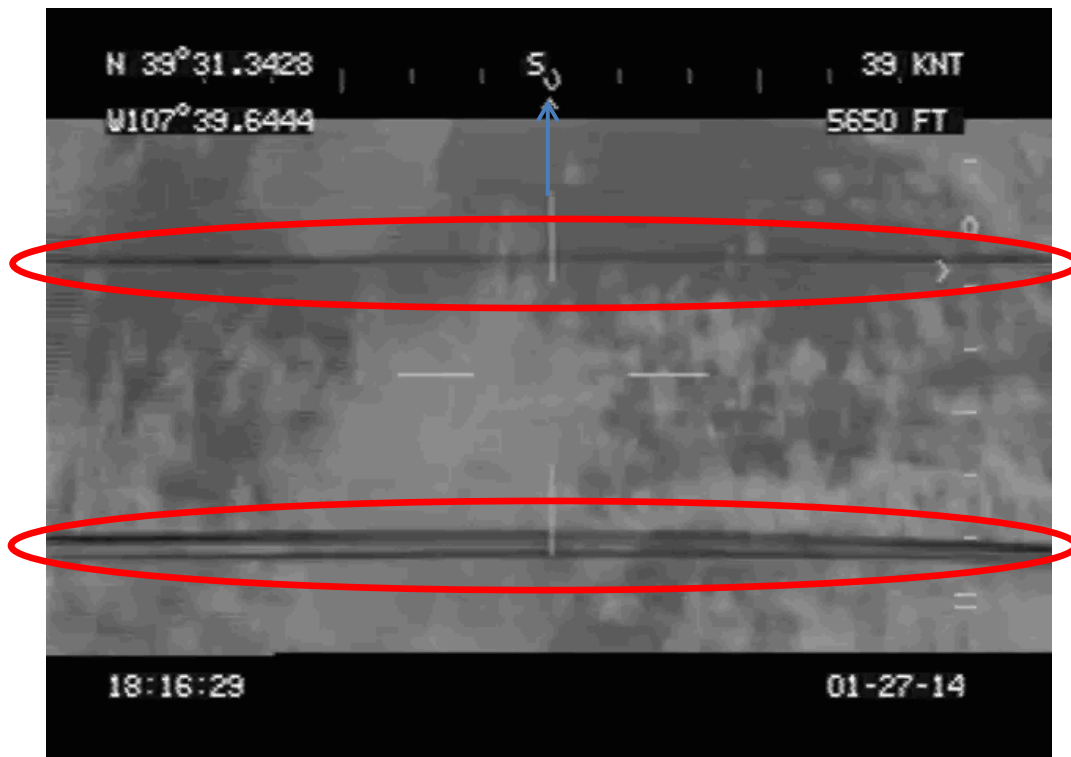
At 1816:29, intersecting power lines came into the screen (figure 1), immediately after the power lines passed, the video began to shake, with expletives heard in the background. The camera shaking intensified and discordant audio was audible until the end of the recording at 18:16:36.

**Figure 1. Photo extracted from video showing intersecting power lines. Blue line depicts direction of travel.**
